Robustness considerations from failures in two large-span timber roof structures

Summary

This sheet deals with the failures of two large span timber roof structures. One is the Siemens Arena in Ballerup, Denmark and the other the Bad Reichenhall Ice-Arena in Germany. The principal structures are described as well as the flaws that are believed to have caused the failures. The robustness of the structures is discussed, including the consequences of the one structure to be statically determined and the other to be in-determined.

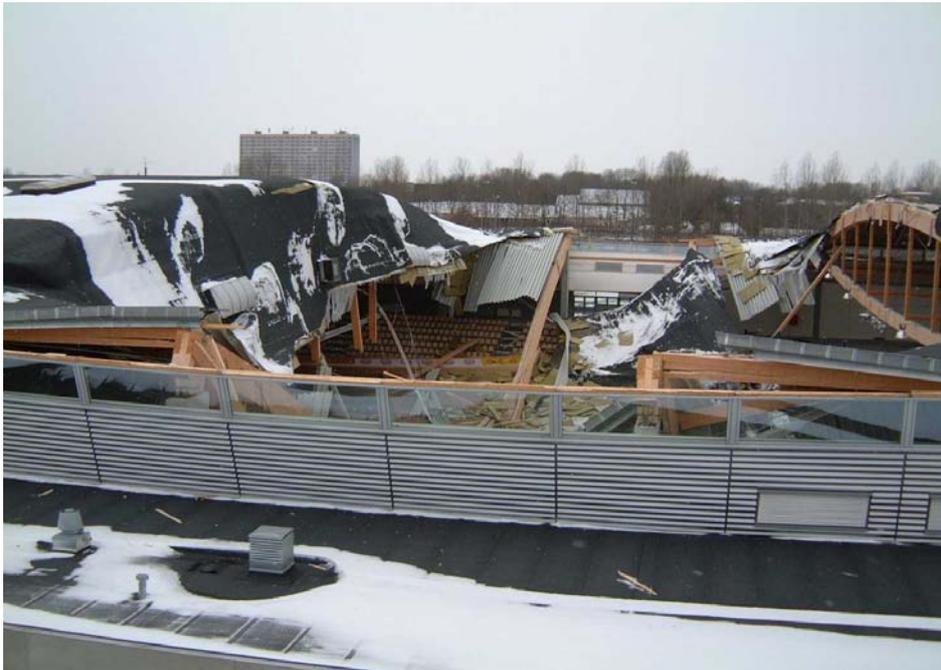
Two of the trusses collapsed without warning at a time with almost no wind and only a few millimetres of snow. The partial collapse happened just a few months after the inauguration of the arena. No people were present in the arena during the collapse.

Figure 1: The Siemens Arena roof structure after the collapse of two trusses. An intact truss can be seen on the right

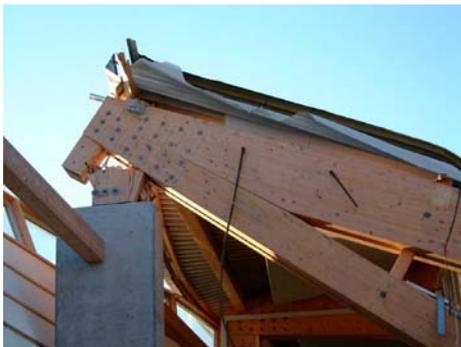
Figure 2: Corner connection with concealed steel plates, connecting the timber parts through bolts (visible) and dowels (not visible)

- The reduced height of the cross section near the ends of the arches, see Figure 2, was not considered
- The reduction of the timber cross section due to steel plates, bolts and dowels, see Figure 3, was not considered

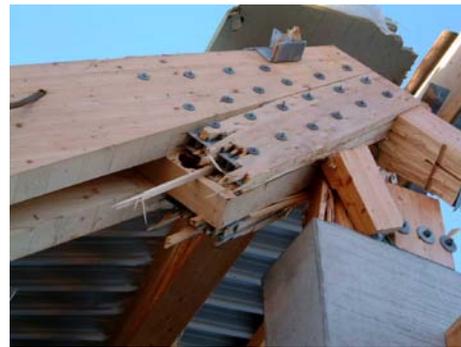
Figure 3: Rupture at the critical cross section in the corner connection. Note the dowels and steel plates

An investigation showed that the cause of the failure could be localised to one critical cross-section in the tension arch near the support, where the strength was found to be between 25 and 30% of the required strength, see Figure 3. By mistake, this cross-section was not considered at all in the design. Three critical design errors were identified:

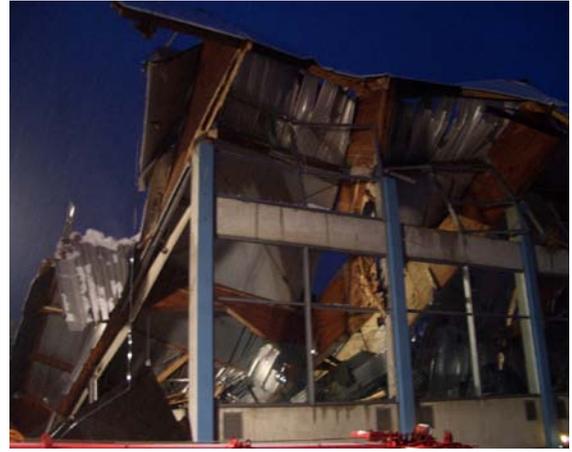
On the 2nd of January 2006, the entire roof collapsed without warning during a period of significant snowfall, see Figure 5. However, the snow load was not above the characteristic snow load used in the design.

Figure 5: Partial view of the collapsed roof structure

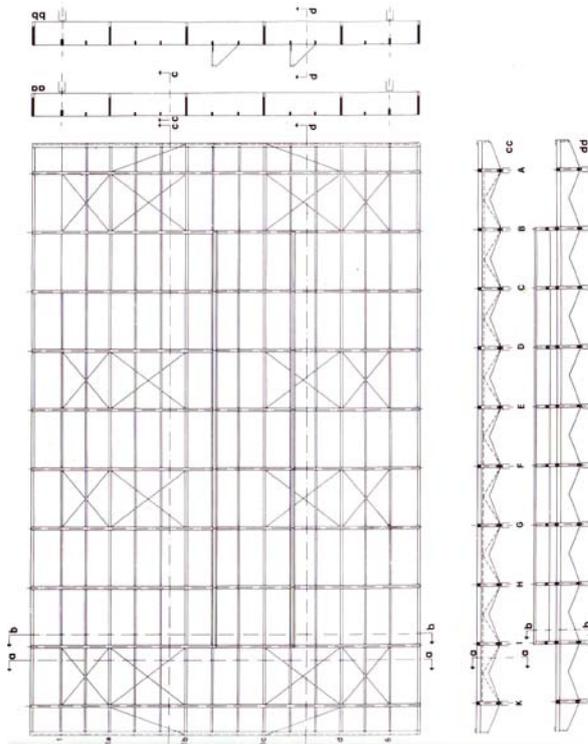
The secondary system was fixed to the sides of the girders and acted both as purlins and as lateral bracing (K-bracing) for the main box-girders, see Figure 6. This enabled the roof structure to redistribute loads between the girders.

Figure 6: Layout of the roof of the Ice-Arena and side view of the girders (Schmidt, H.J. et al. (1974))

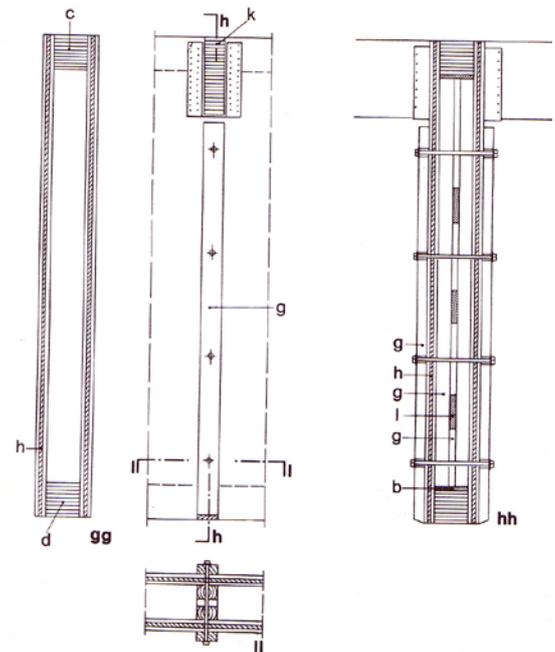
The Bad Reichenhall Ice-Arena, built in 1971/1972, was a structure of approx. 75 m in length and approx. 48 m in width, see Figure 4. The roof was supported by 2.87 m high main girders, which were produced as timber box-girders, see Figure 7. The box-girders featured upper and lower glulam members and lateral web boards made from so-called “Kämpf web boards” - a type of cross laminated timber. The 48 m long girders were produced from three 16 m long sections, which were joined with general finger joints.

Figure 7: Cross-section of the box-girders in the Ice-Arena (Schmidt, H.J. et al. (1974))
