# Failures of timber structures - Considerations on the causes of the fault

Matthias Frese

COST E55

Workshop Ljubljana

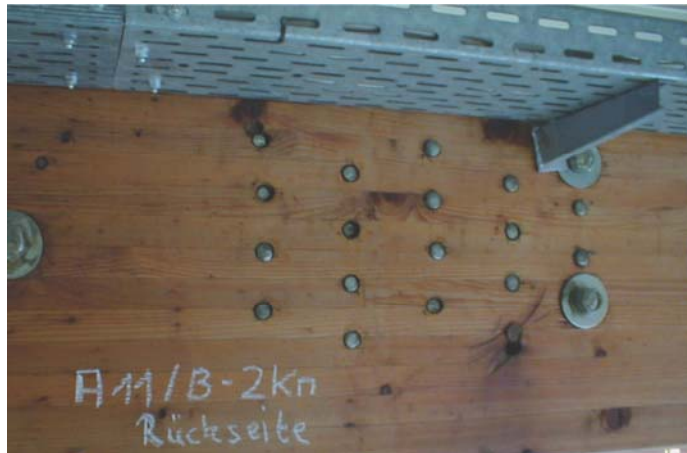
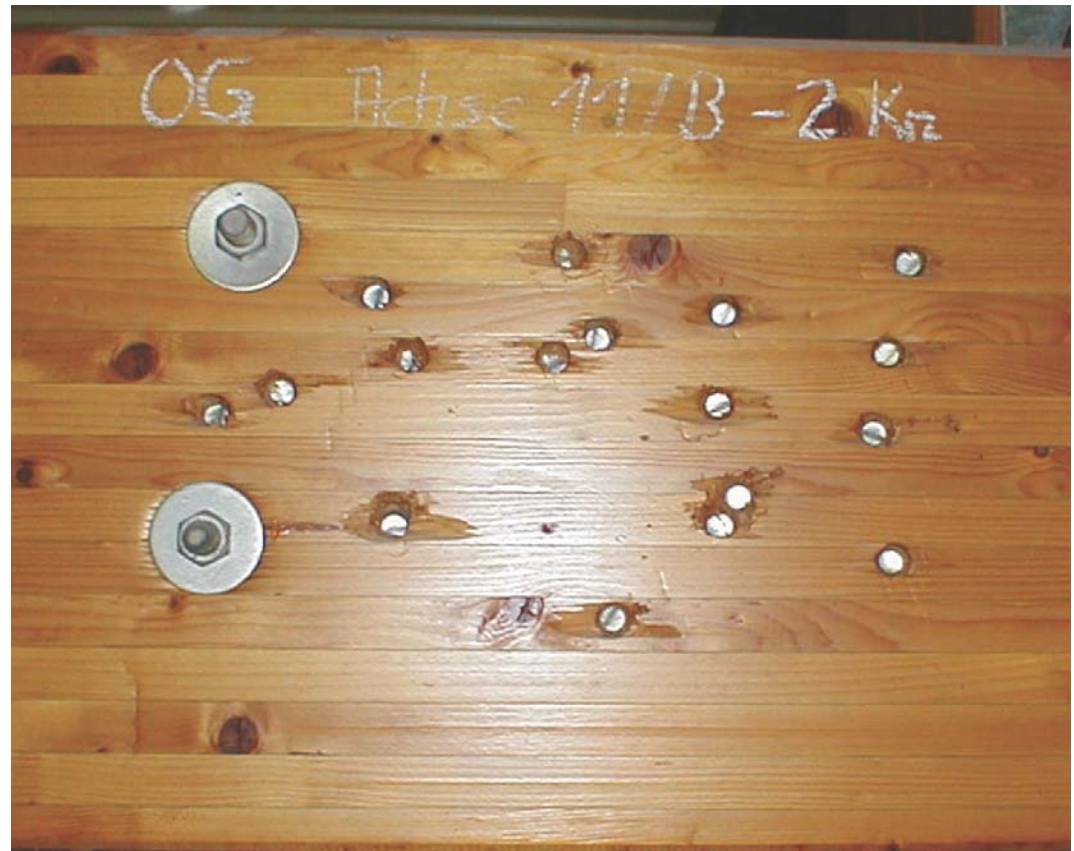
# Poor position of dowel type fasteners

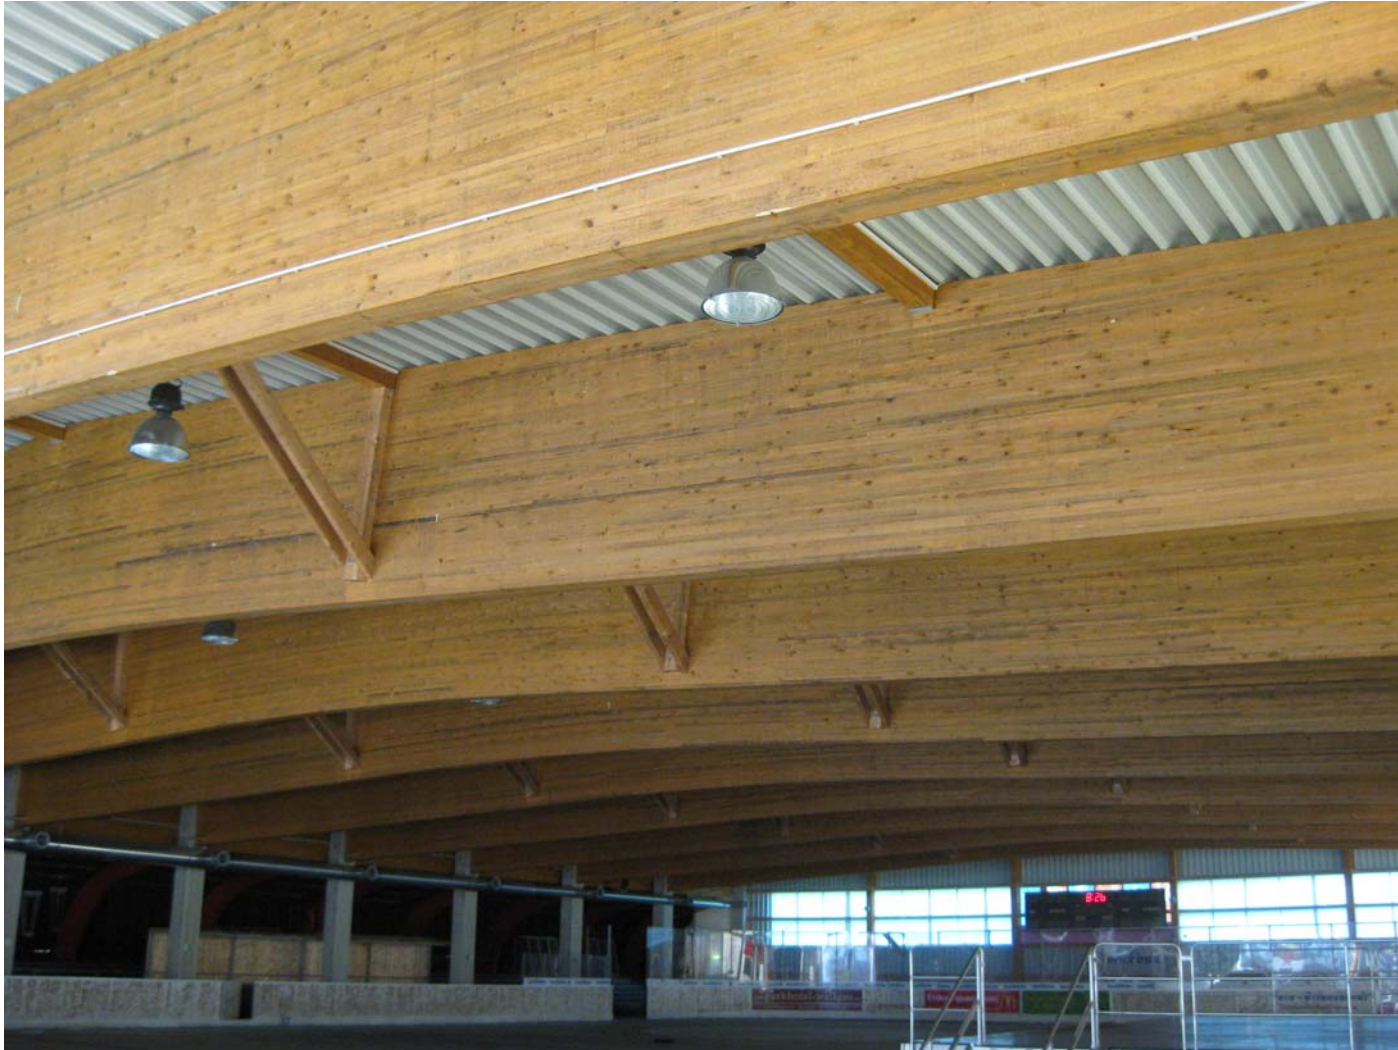
# Discoloration due to condensation

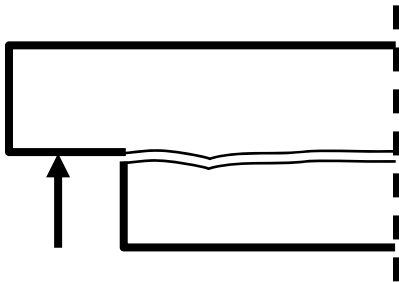
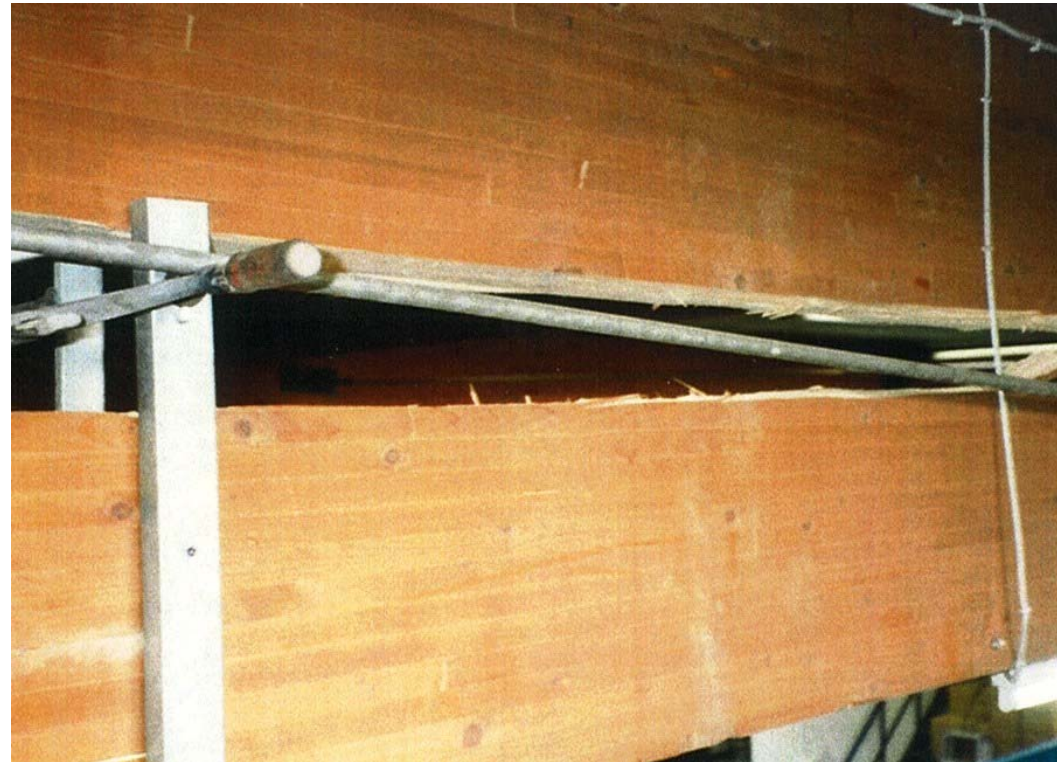
# Typical failure due to non-reinforcing end-notched beams

- Reinforcement missed due to poor structural analysis

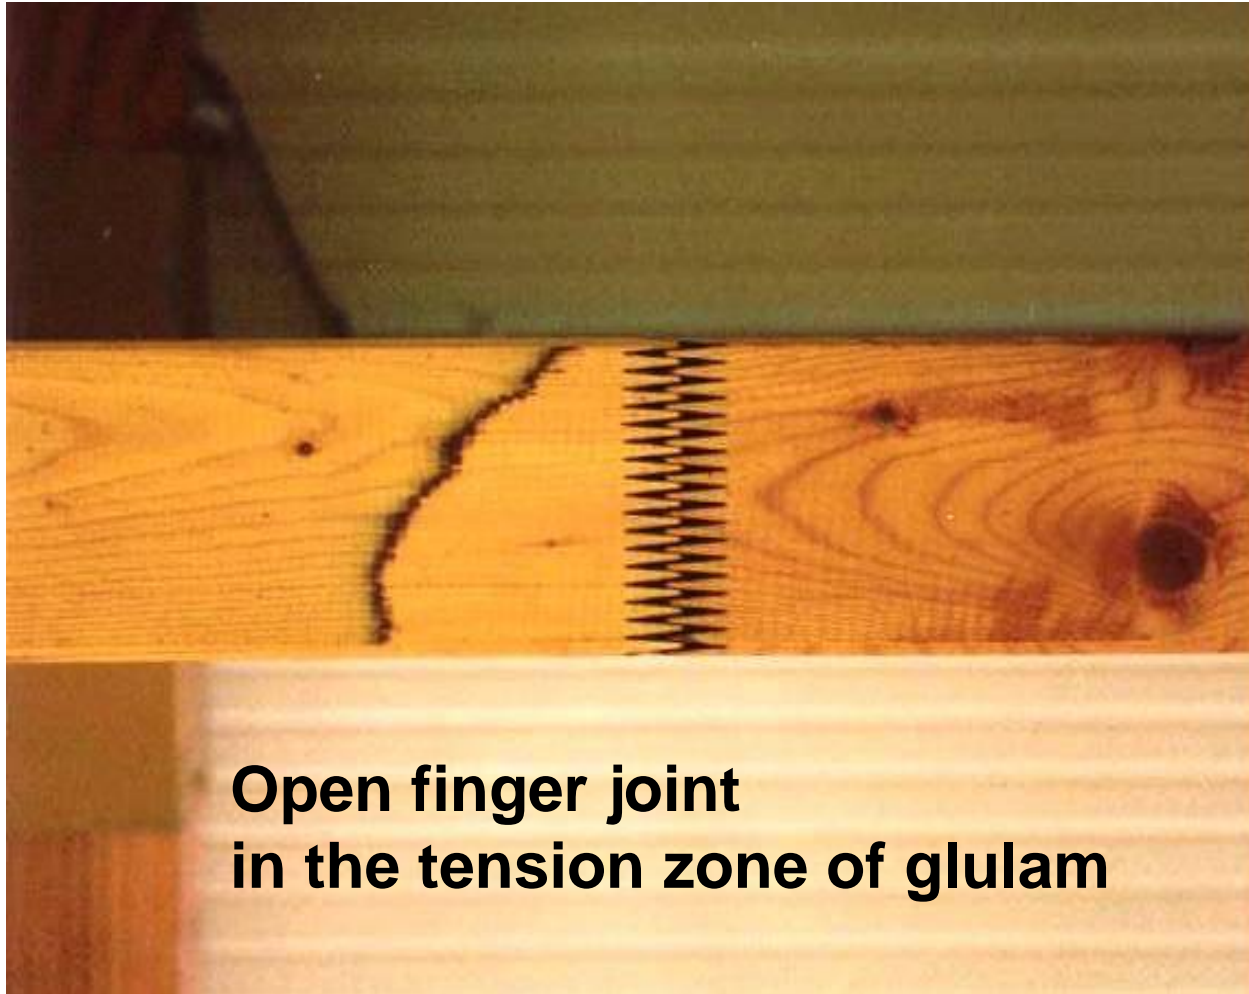
**Open finger joint  
in the tension zone of glulam**

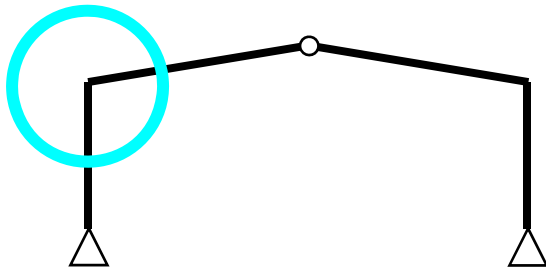
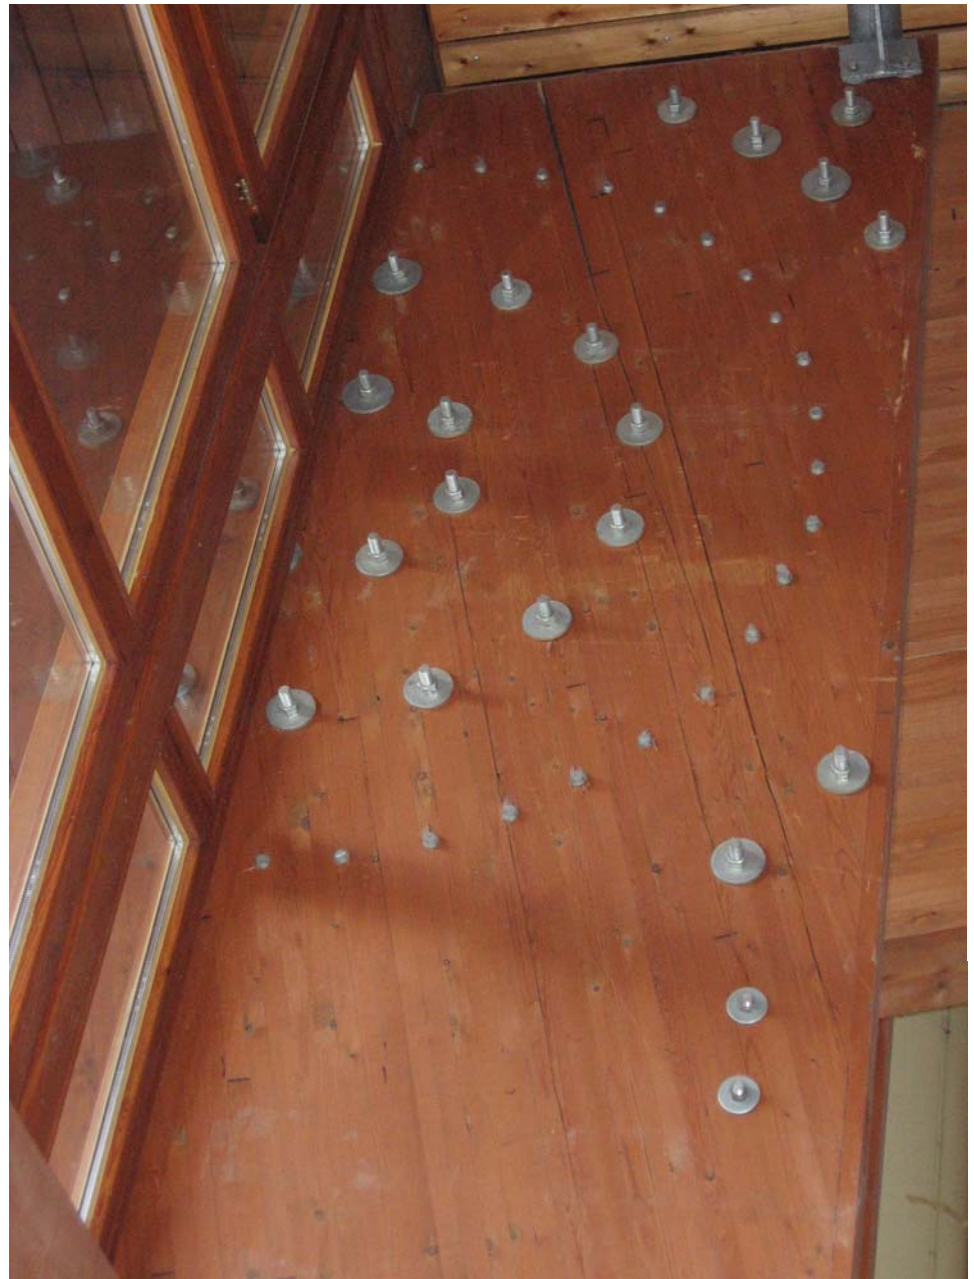
# Shrinking/swelling

- Moisture content decrease
- Differential shrinkage
- Hindrance of shrinkage

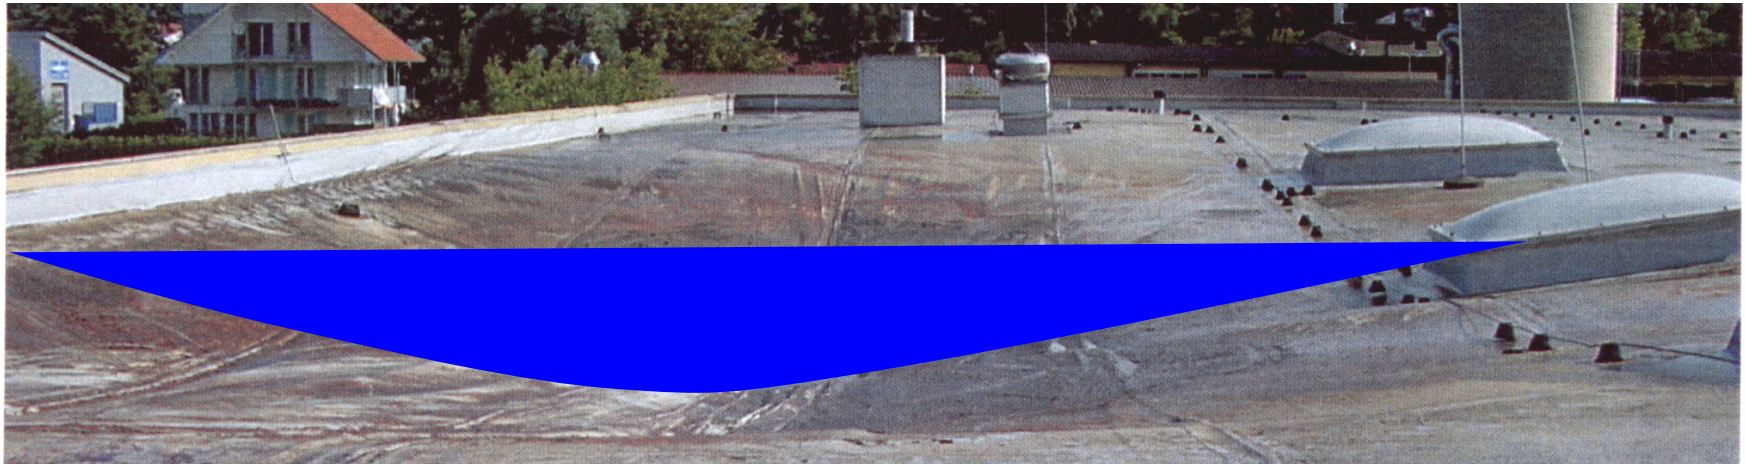
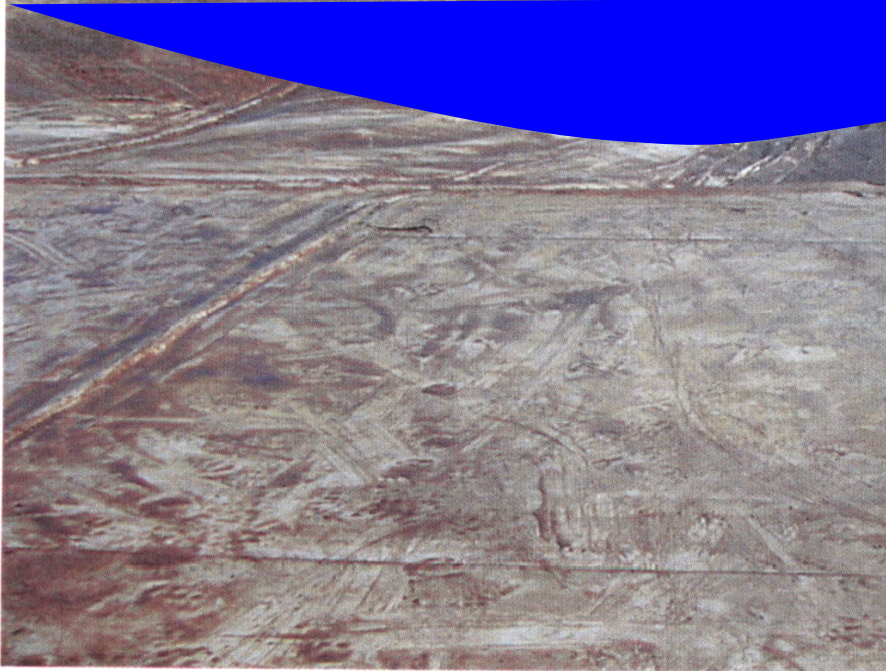
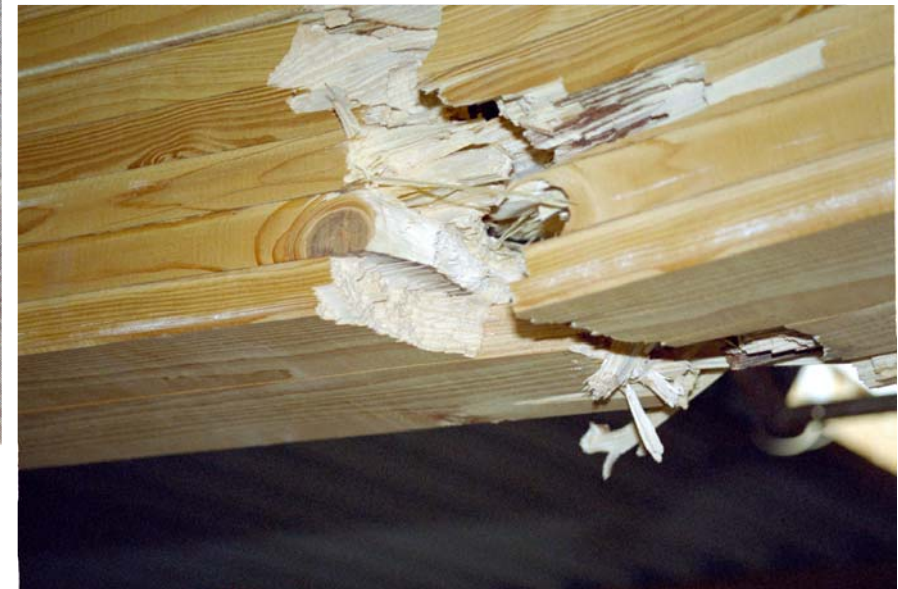
# Collapse due to accumulation of rain water

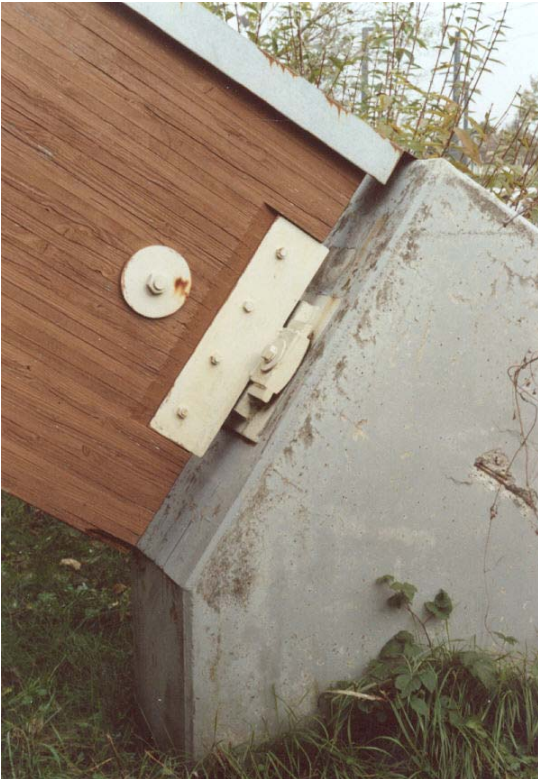
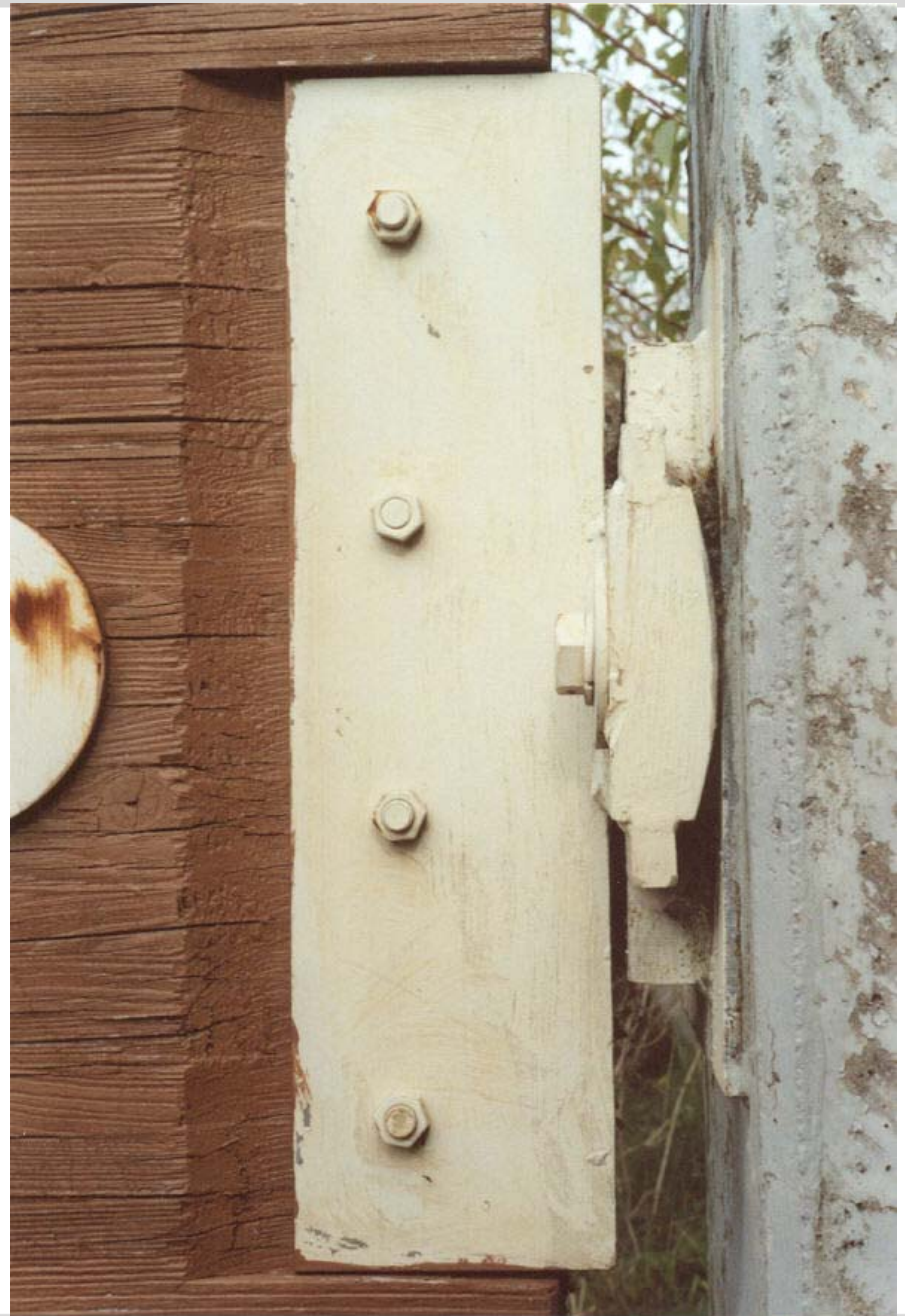
- Alternating climates responsible for cracks in grain direction

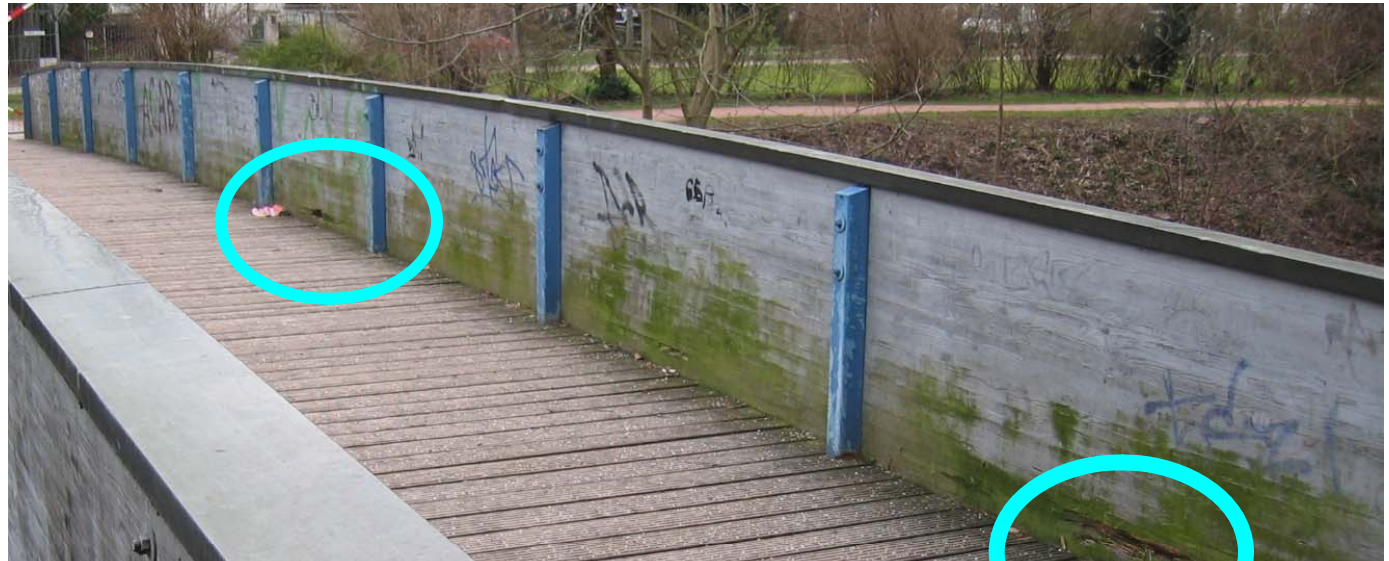
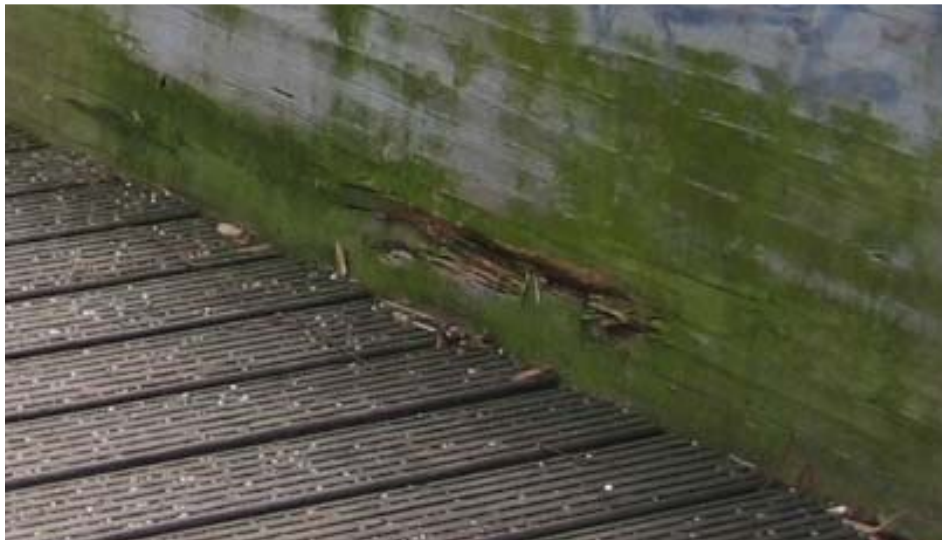
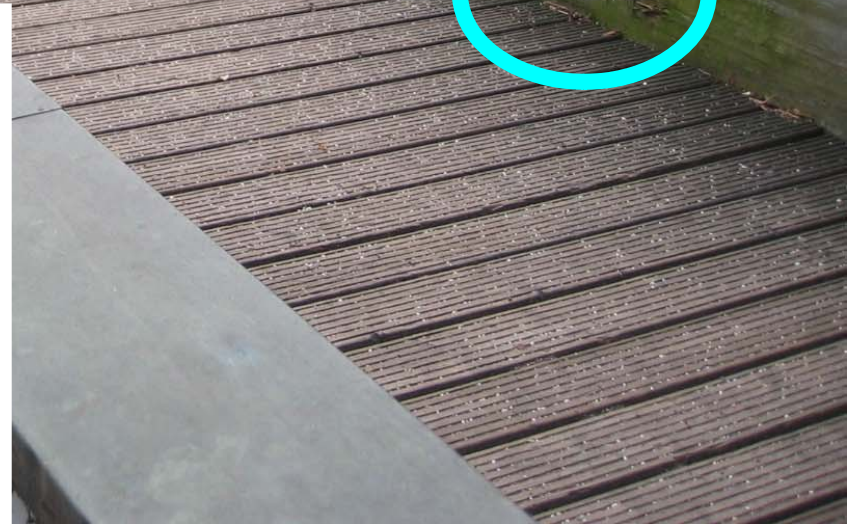
# Timber bridge without cladding

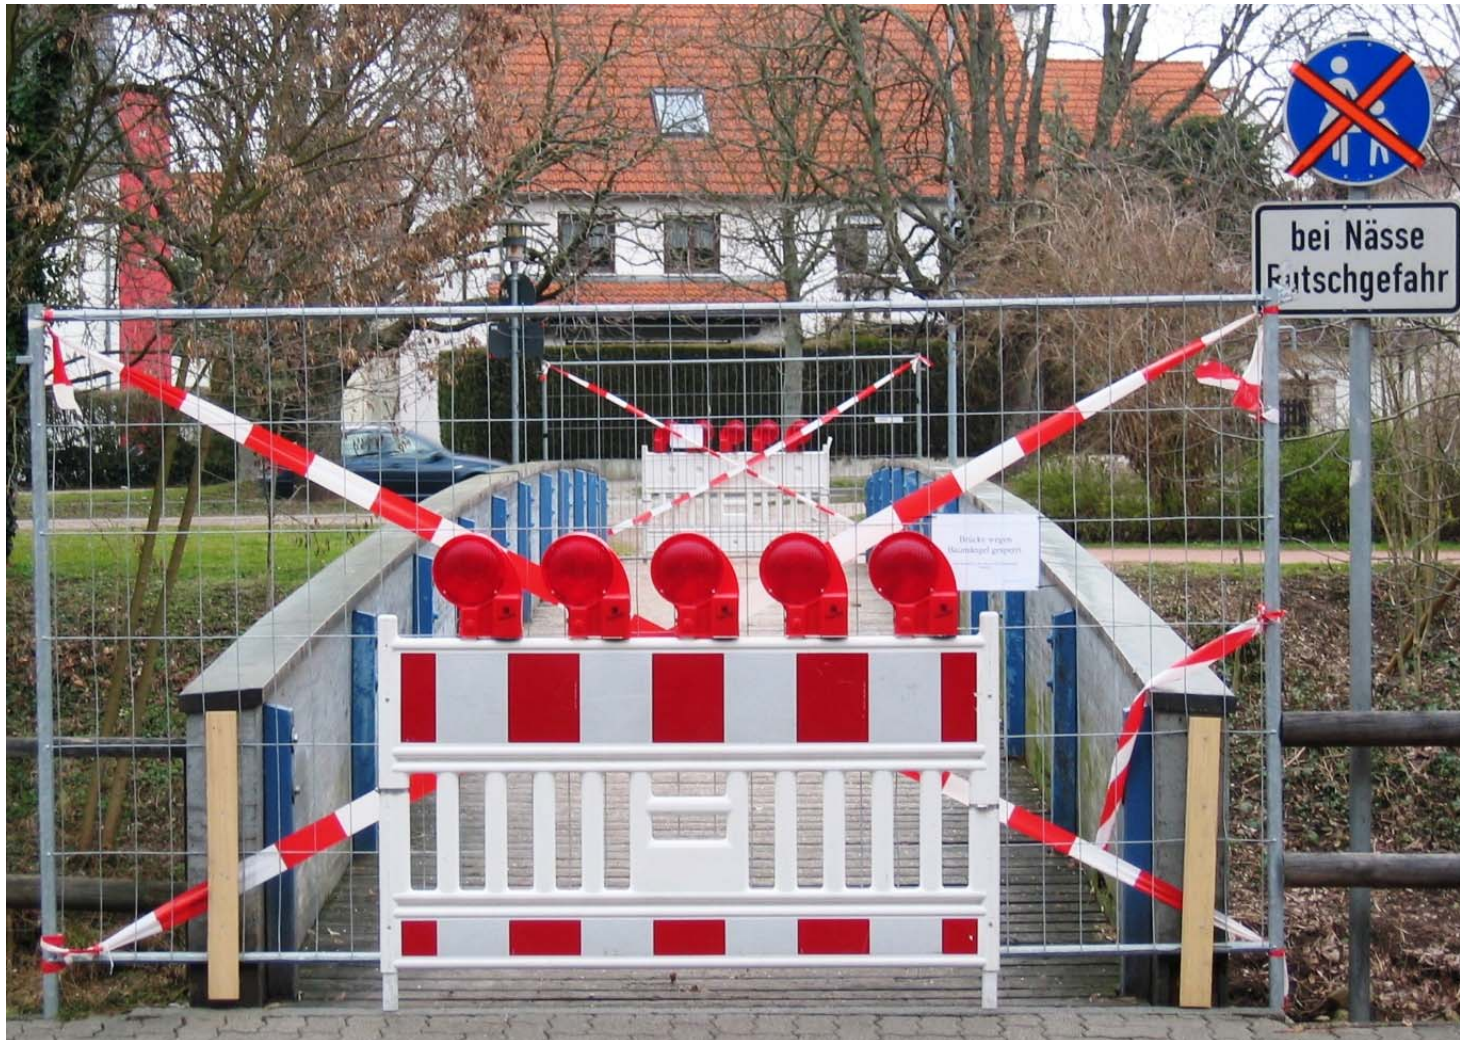
# Closed due to decay
