CONCRETE BUILDINGS SUBJECTED EARTHQUAKES IN TURKEY

Mehmet Inel

This study presents damaged concrete buildings during 2003 Bingol earthquake. All presented data and pictures are obtained from May 1, 2003 Bingol Earthquake report by Ozcebe et al. [11].

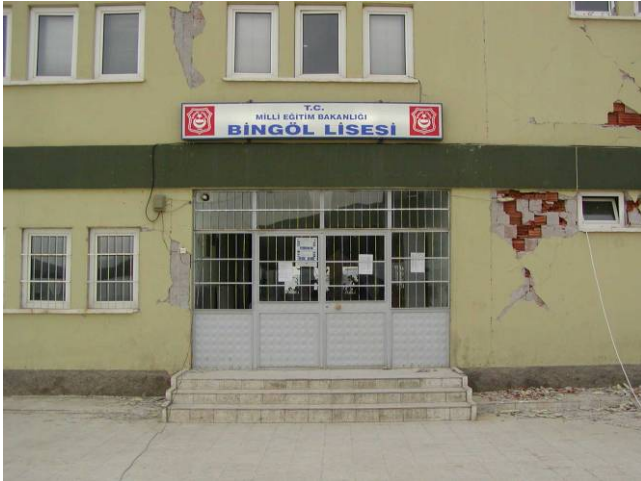
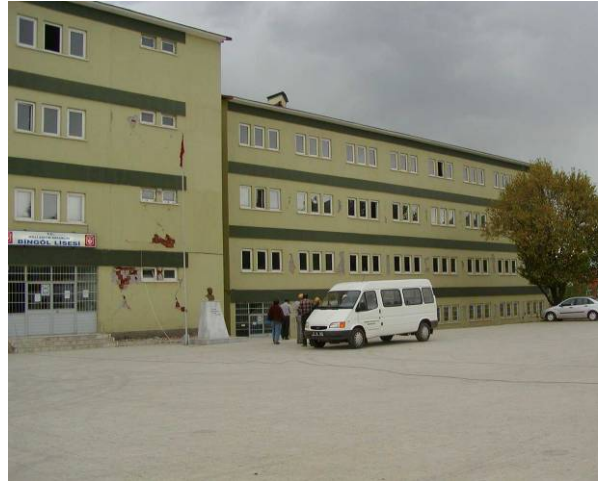
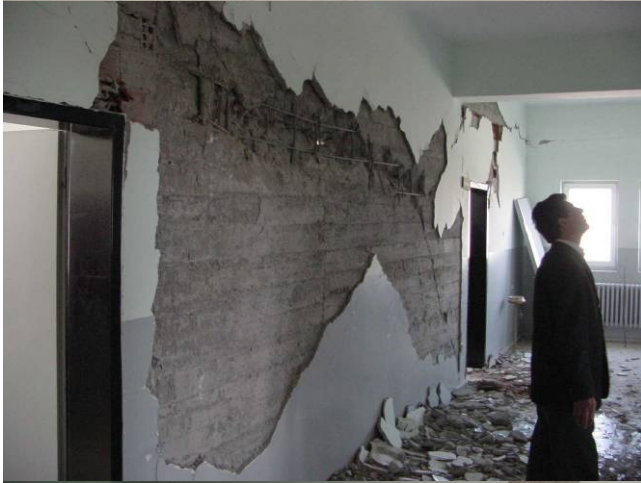
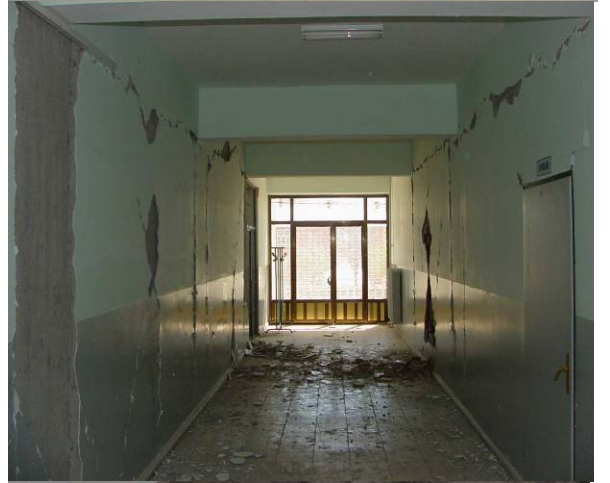
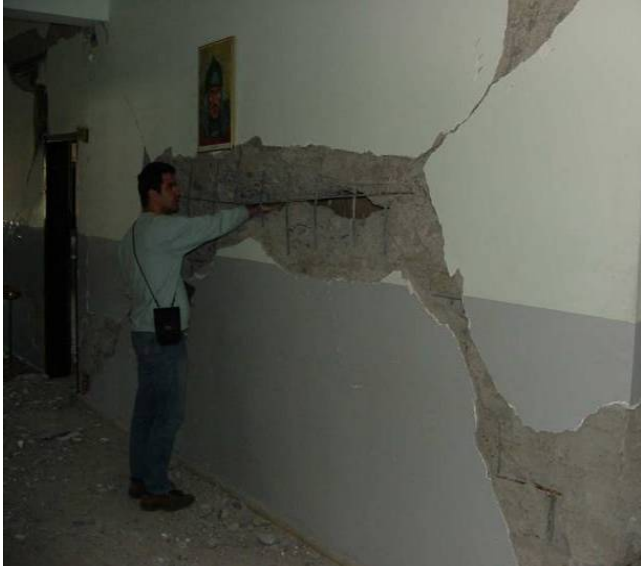
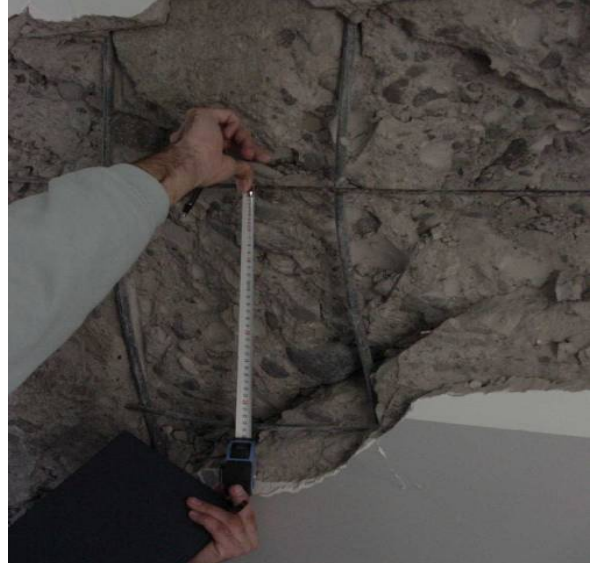
Figure2. Bingöl High School after 2003 Bingöl Earthquake (Heavy)

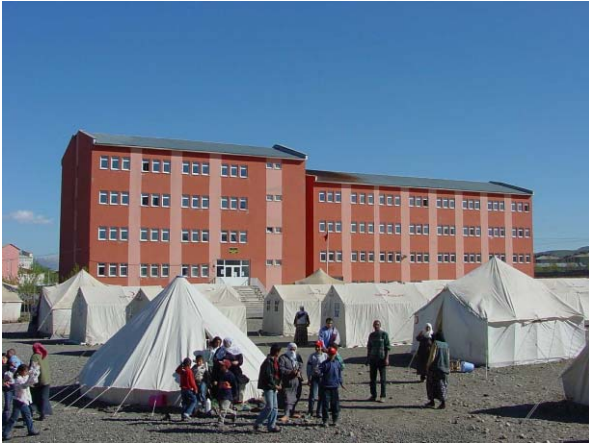
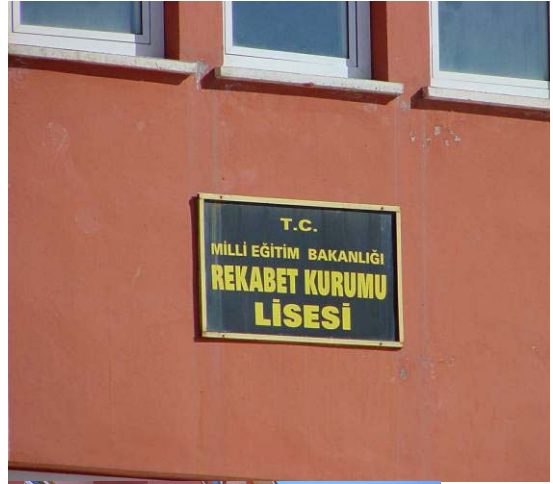
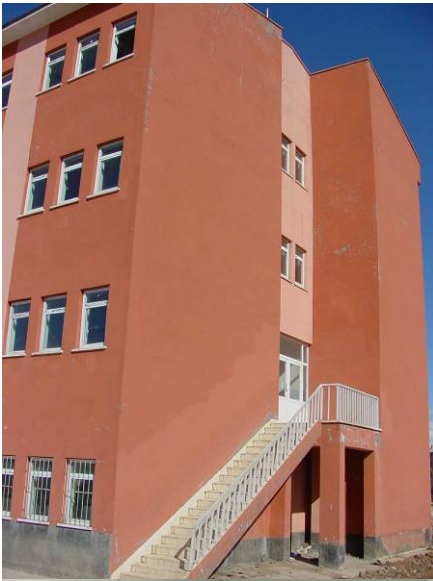
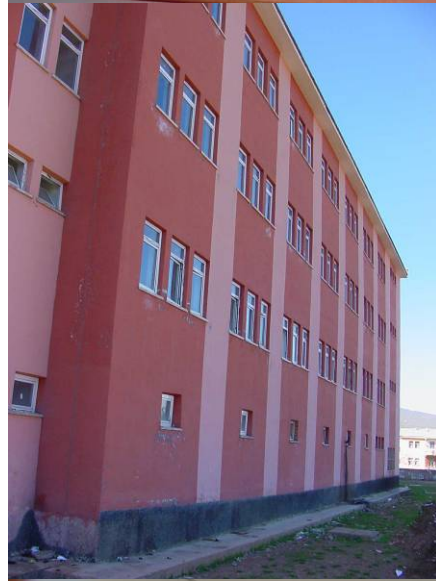
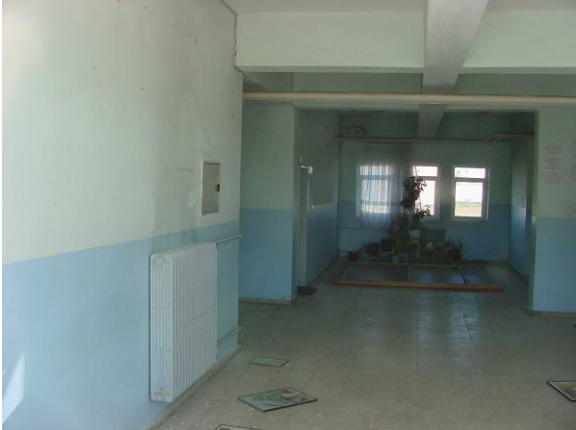
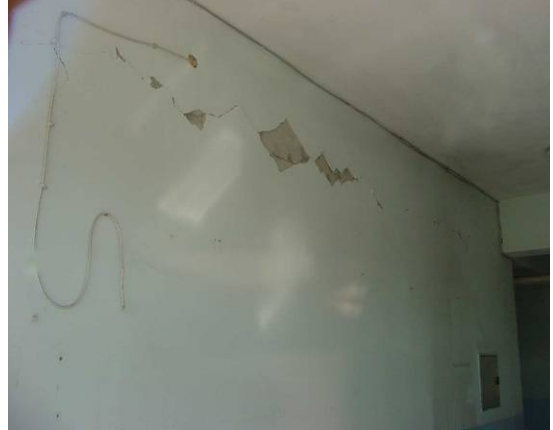
Figure 4. Rekabet Kurumu High School after 2003 Bingol Earthquake (Light)

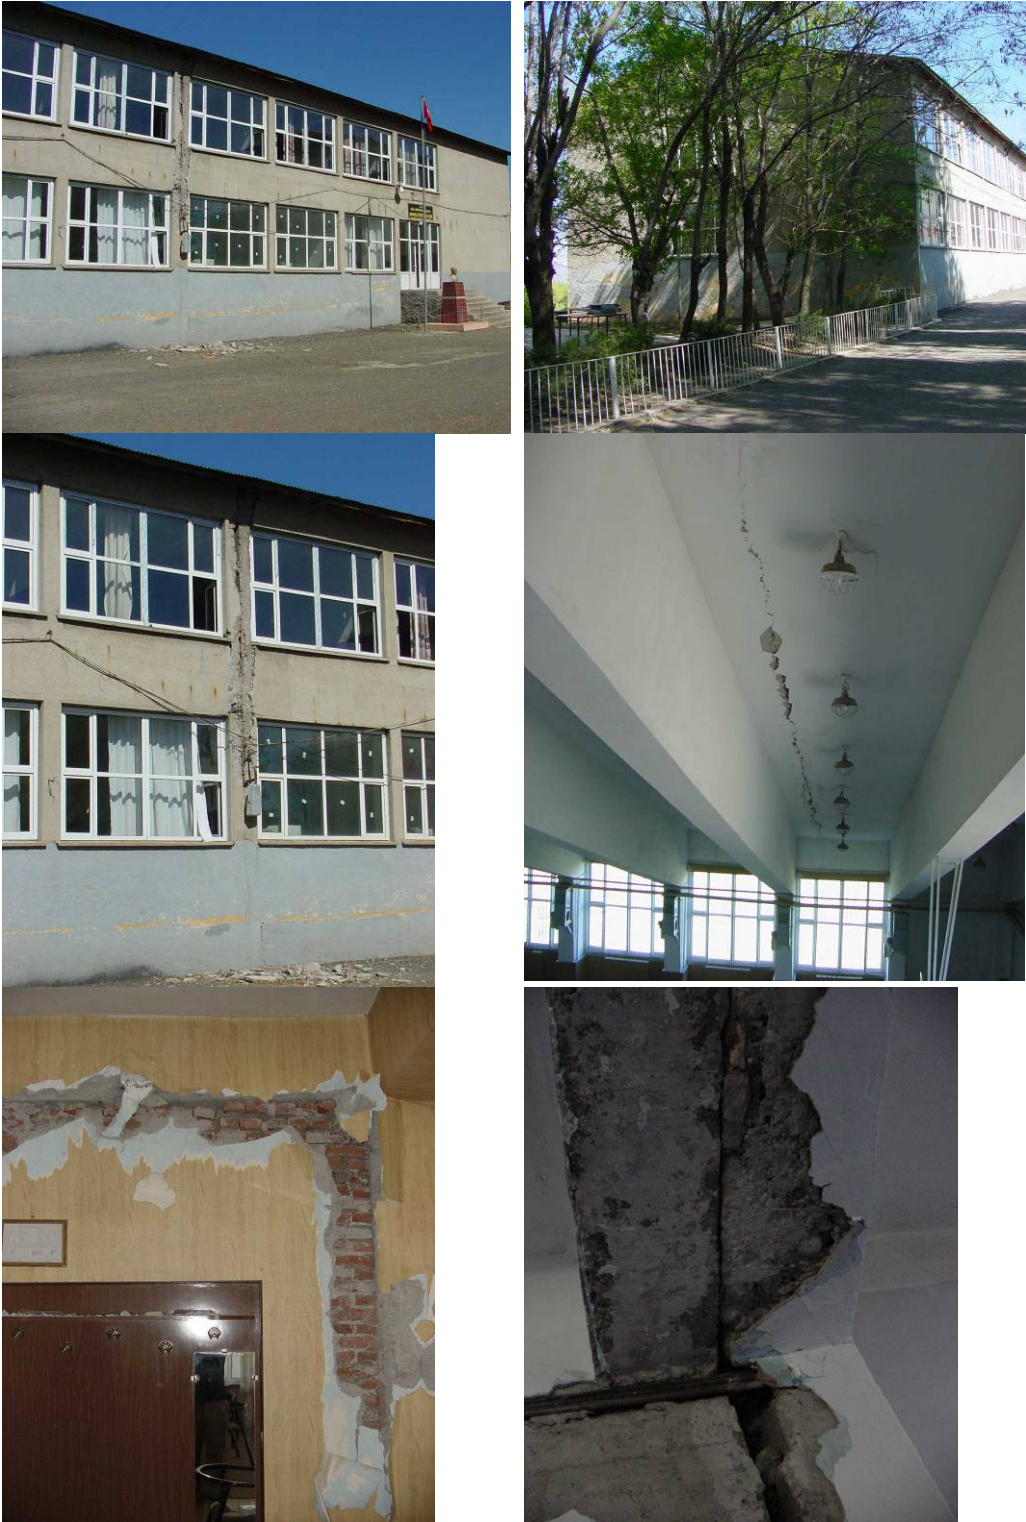
Figure 6. Anadolu Ogretmen High School after 2003 Bingol Earthquake (Moderate)

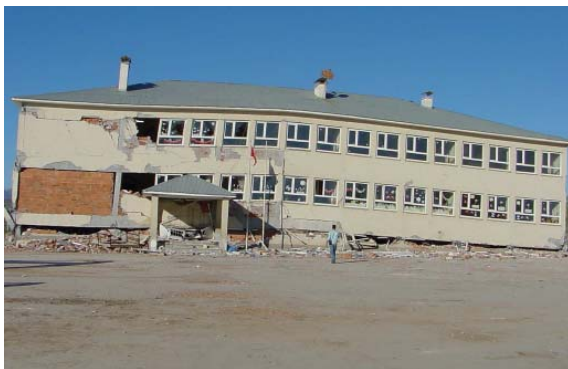
School Building

Figure 8. Celtiksuyu Boarding School after Bingol Earthquake

Building Type	School
Construction Year	NA
# of floors	3
Type	RCF
Damage	Heavy/collapse

The most tragic collapse occurred at Çeltiksuyu Primary Boarding School. Since the earthquake occurred at 3:27 a.m. local time, the majority of the students were asleep in the dormitory in which 84 (out of 195) students and 1 teacher lost their lives.

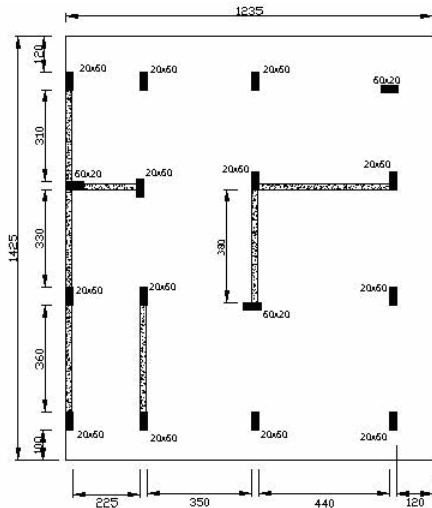
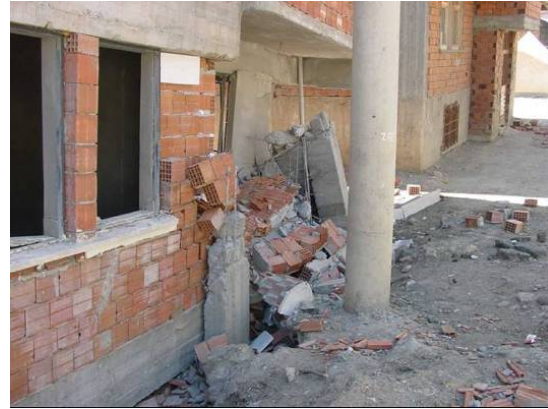
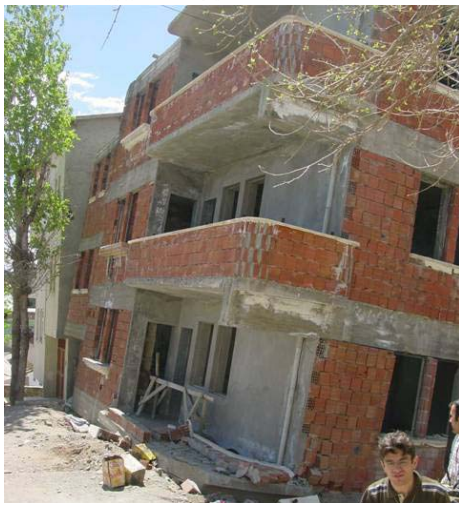
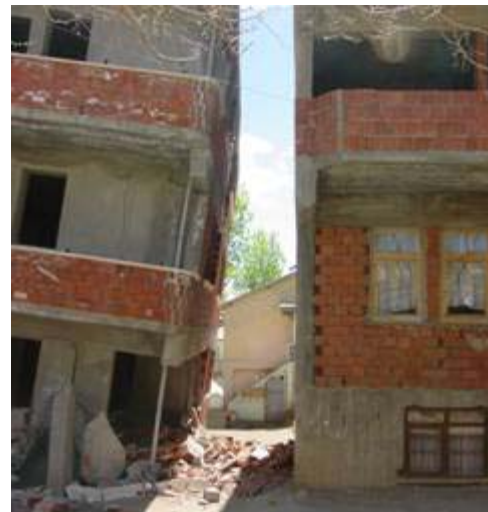
Figure 9. Typical residential building after Bingol Earthquake (ID:BNG-6-4-3)

Building Type	Residential
Construction Year	2003
# of floors	4
Type	RCF
Damage	Heavy/collapse

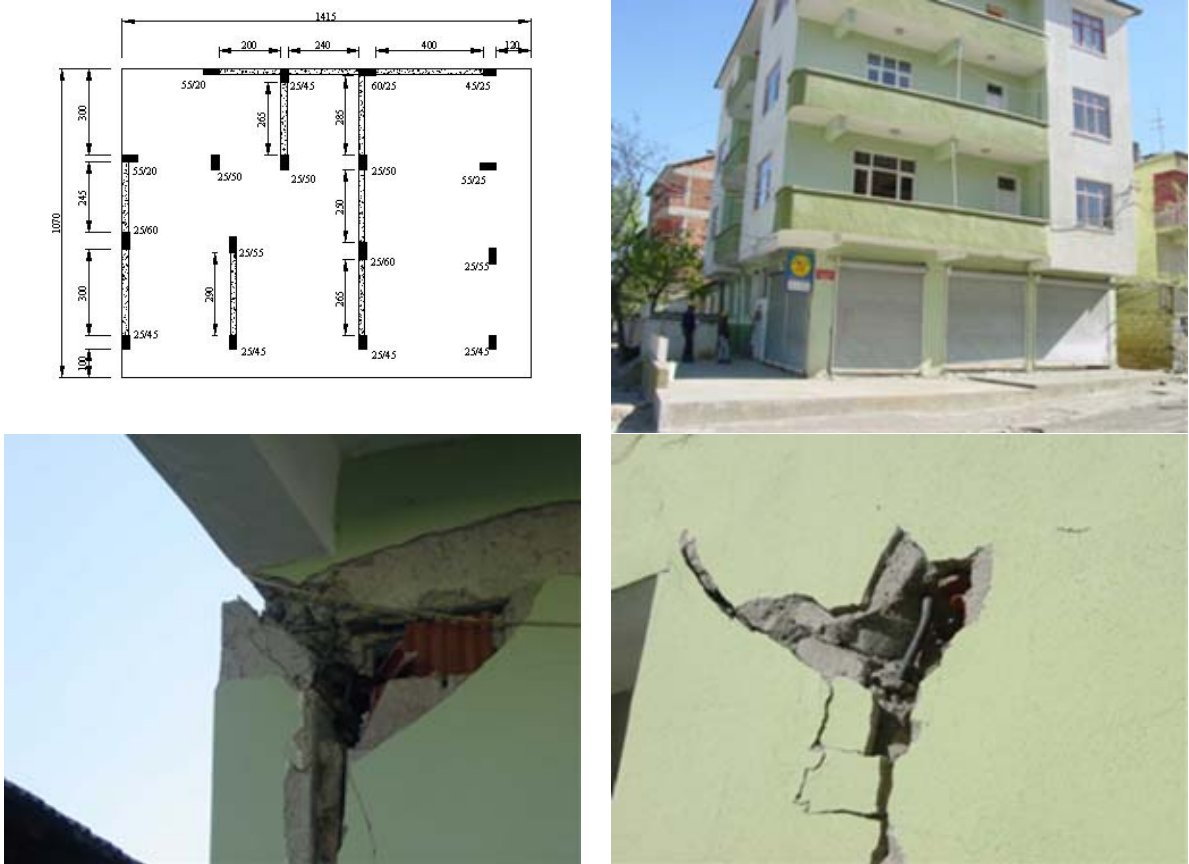
Figure 10. Typical residential building after Bingol Earthquake (BNG-11-4-2)

Building Type	Residential
Construction Year	1989
# of floors	4
Type	RCF
Damage	Heavy/collapse

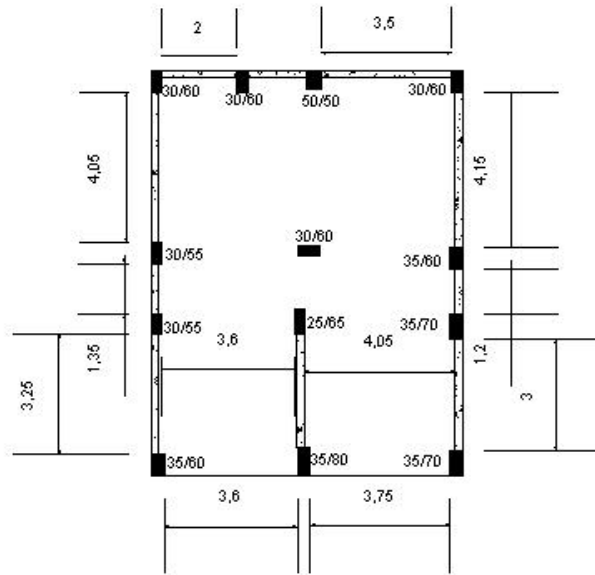
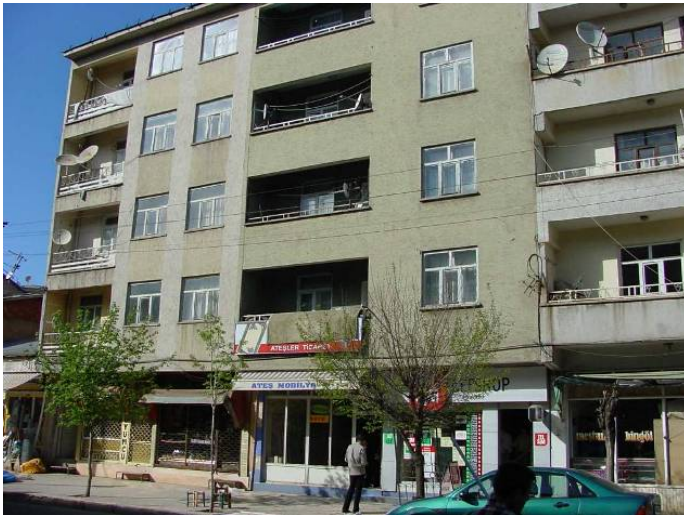
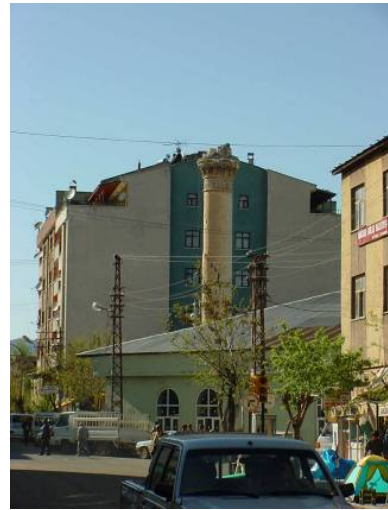
Figure 10. Typical residential building after Bingol Earthquake (BNG-10-5-2)

Building Type	Residential
Construction Year	1988
# of floors	5
Type	RCF
Damage	Light

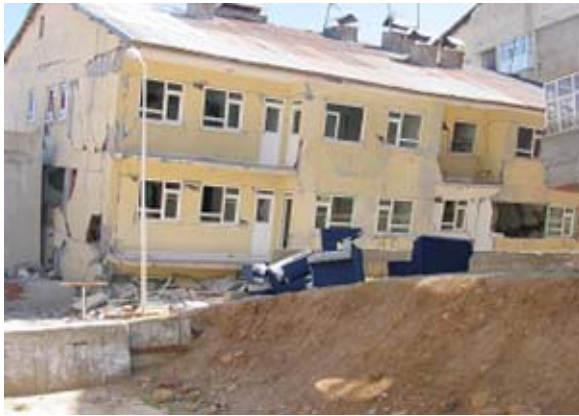
Ground story collapse of 3-story building

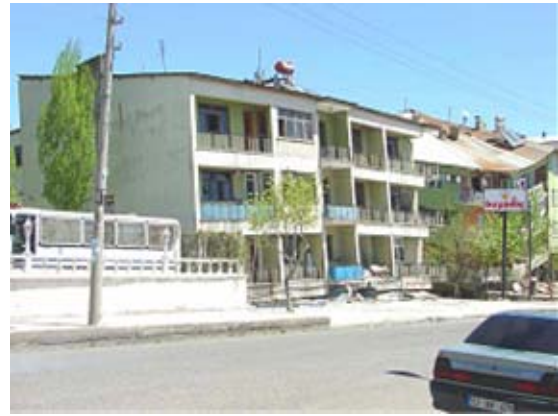
Ground story collapse of 4-story building

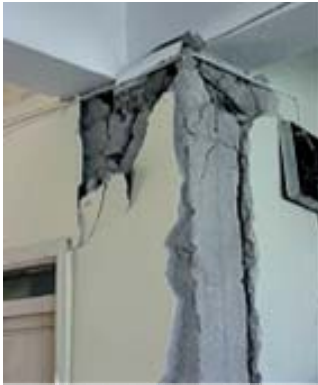
Column and beam damage

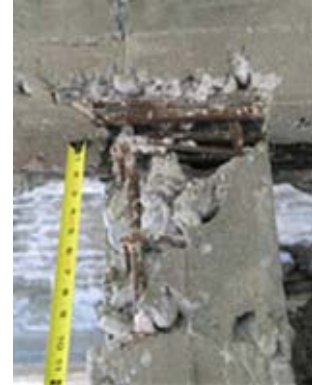
Beam column joint in building under construction

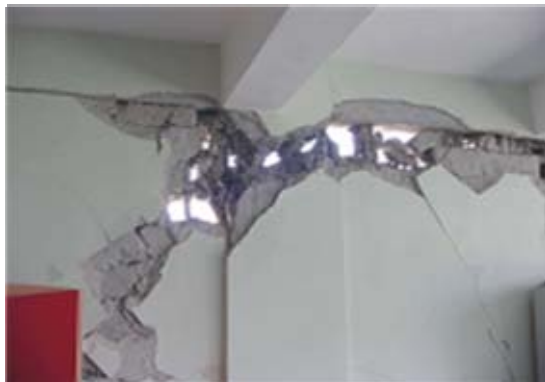
Column end failure

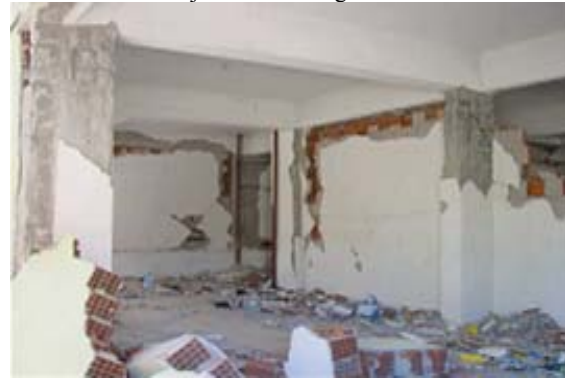
Spalling and crushing concrete due to high axial loads

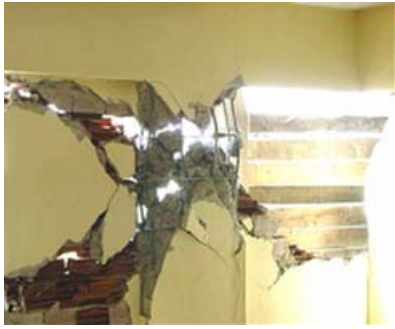
Brittle failure of column and buckling of bars

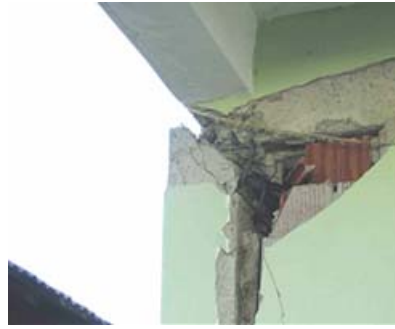
Separation of column due to improper detailing

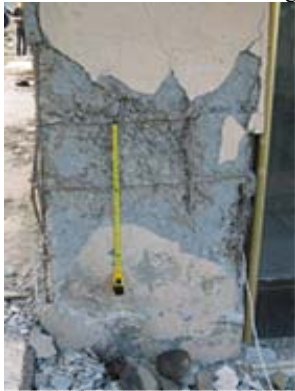
Column detailing in plastic hinge region

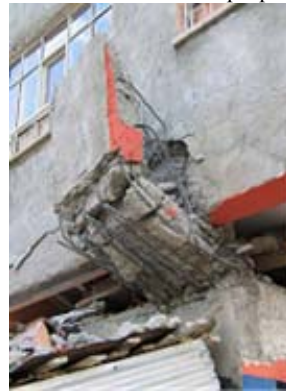
Column splice

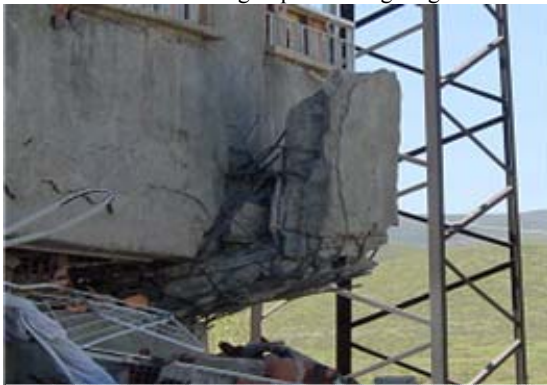
Insufficient confined column

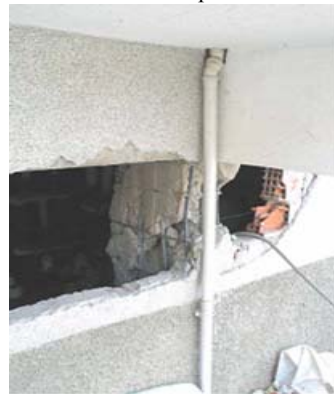
Shear failure of short column

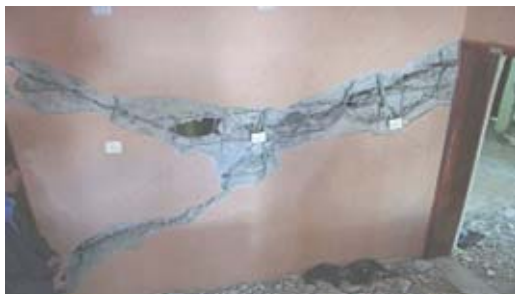
Shear failure of shear walls (at ground and first floor)

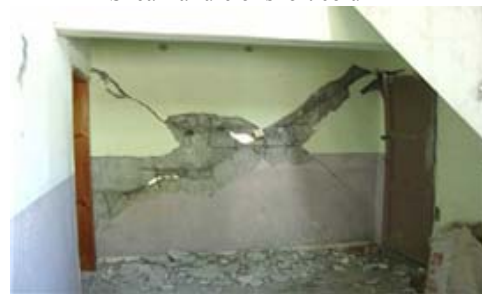
Shear walls failure
