# ASSESSMENT OF FAILURES AND MALFUNCTIONS

Prof. dr. ing. Radu BĂNCILĂ  
Assoc.Prof.dr.ing. Edward PETZEK  
"Politehnica" University of Timisoara

The first step in direction robustness of structures, is the assessment necessity of defects, malfunctions and failures; in the following, this aspect will be exemplified in the field of steel bridges.

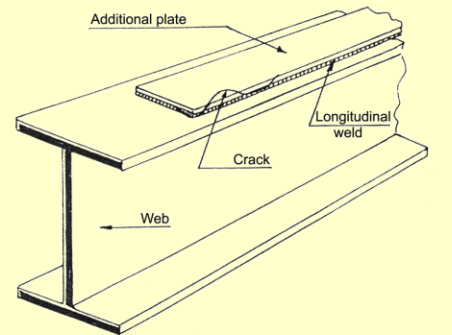
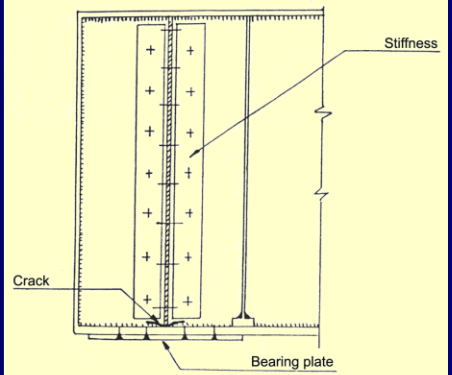
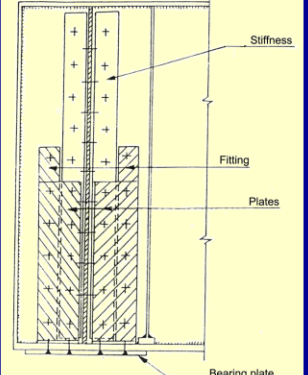
Element	CRACK	REPAIR
0	1	2
Main girder

<ul style="list-style-type: none"> <li>⇒ Grinding</li> <li>⇒ New additional plate</li> <li>⇒ Observation</li> </ul>
Main girder

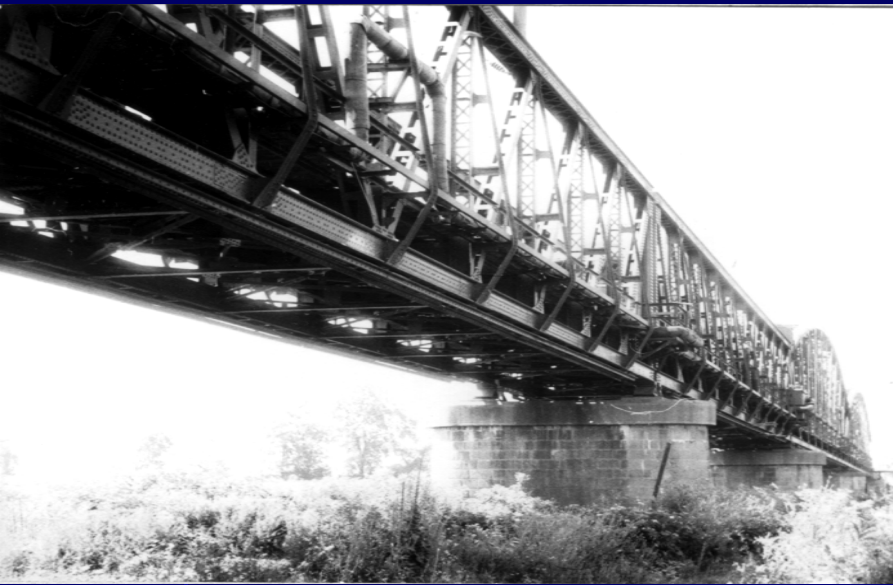
In the railway stringers cracks were detected.

Cause → direct placement of the track on the steel deck; torsional stresses (eccentricity of the rail) appeared.

Repair → difficult and at a high cost

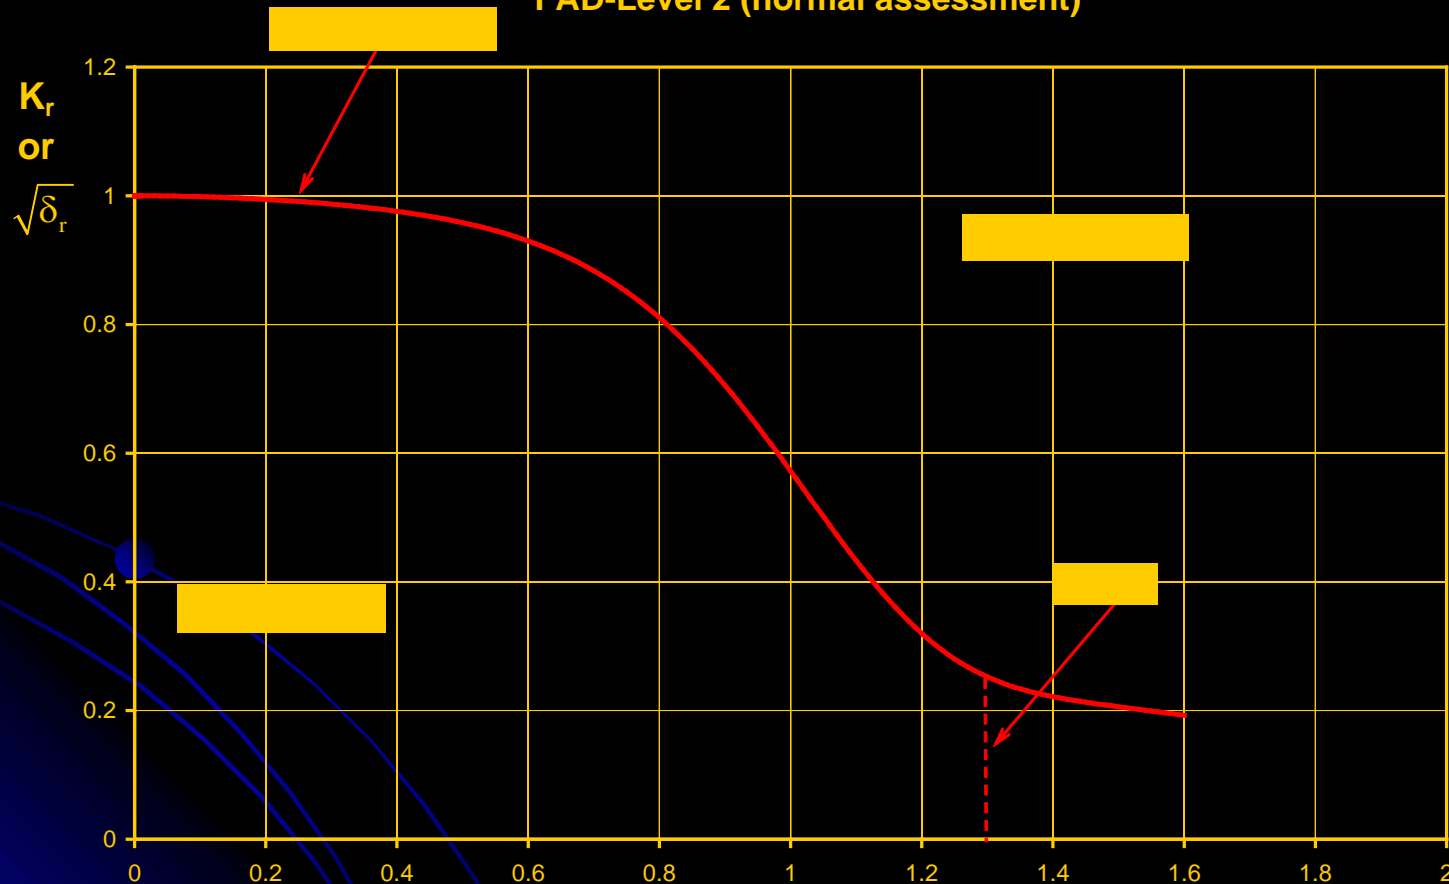
FAD-Level 2 (normal assessment)

→  $a_{crit} = 36,1 \text{ mm}$  (for  $K_{Ic} = 1500 \text{ Nmm}^{-3/2}$  and  $\sigma_{appl} = 118,3 \text{ N/mm}^2$ ) <sup>46</sup>

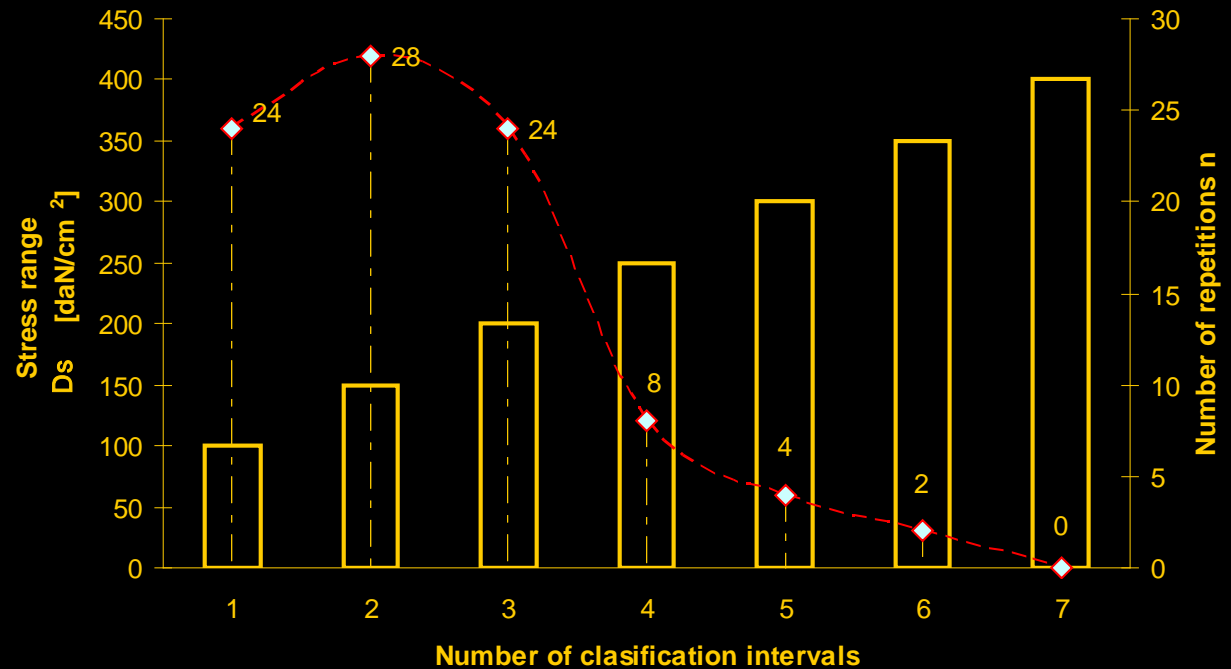
# Stress history – main girder (bridge Săvârșin)

$Ds_e$  [daN/cm<sup>2</sup>] = 221,57 Total/day

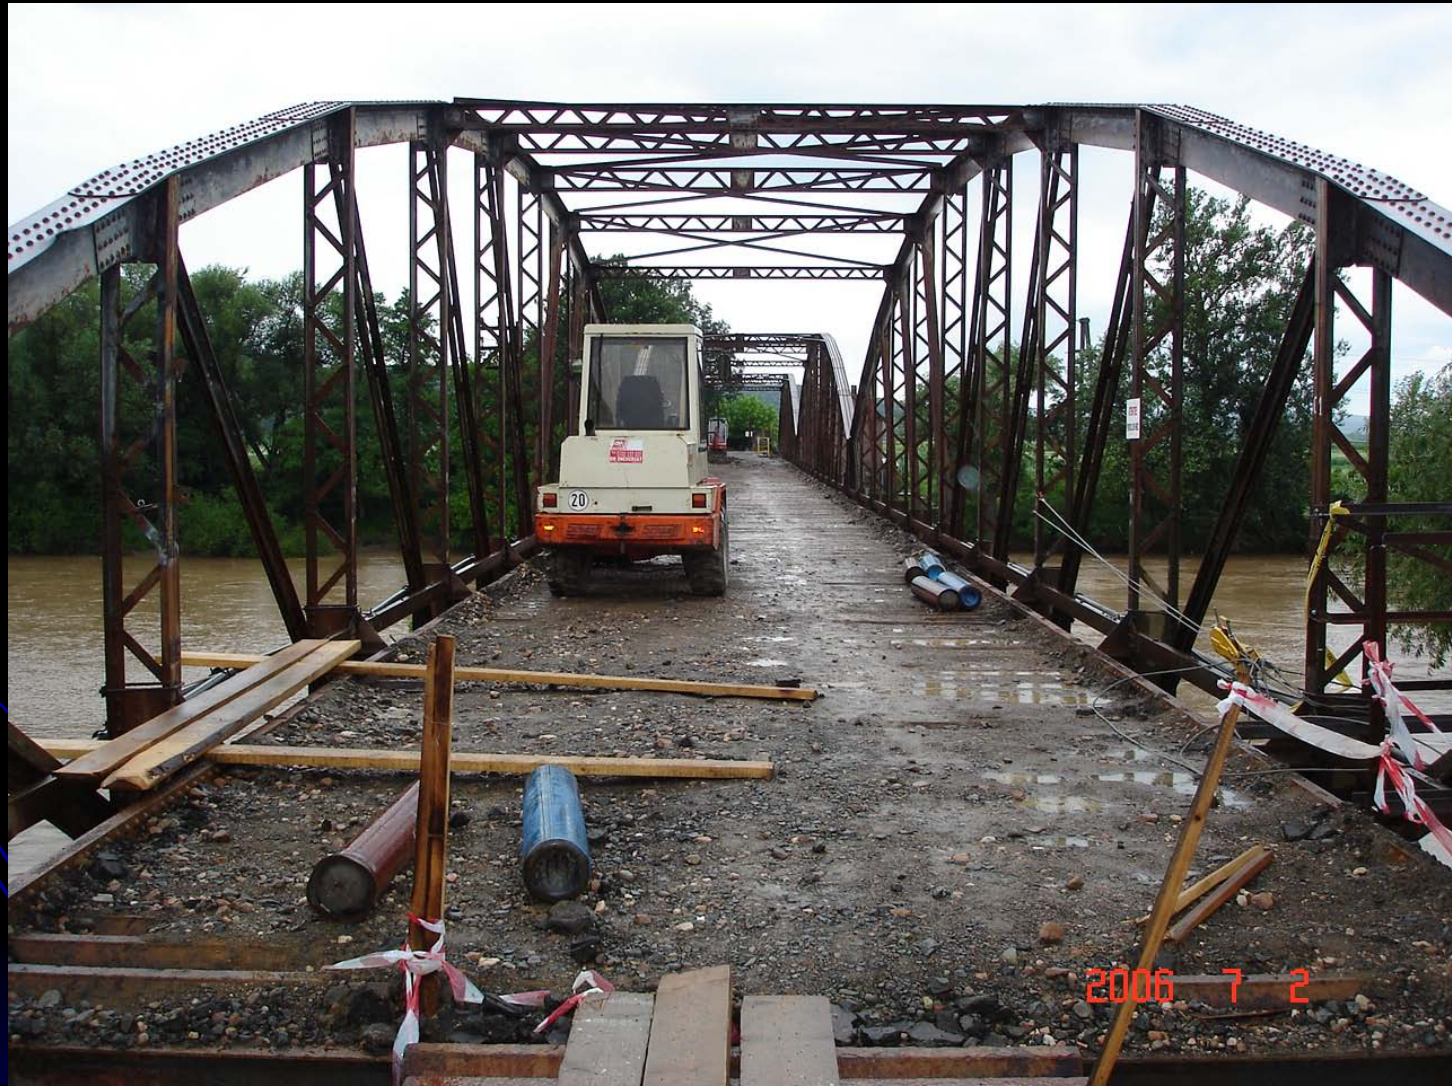
Removing the pavement supported by Zorres profile

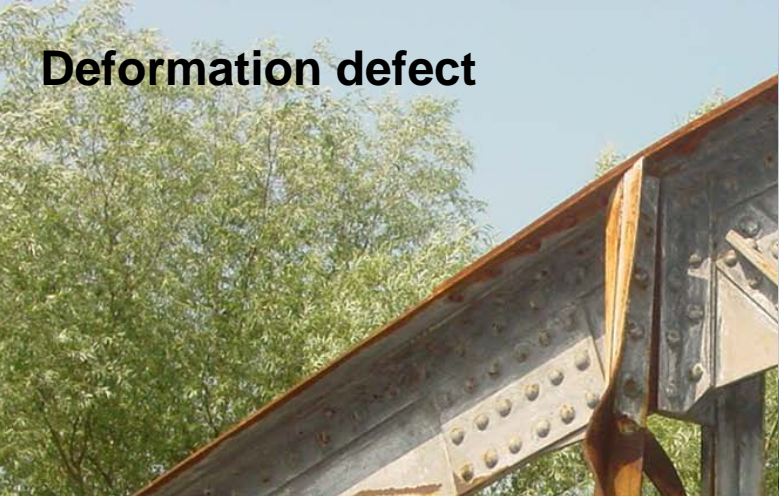
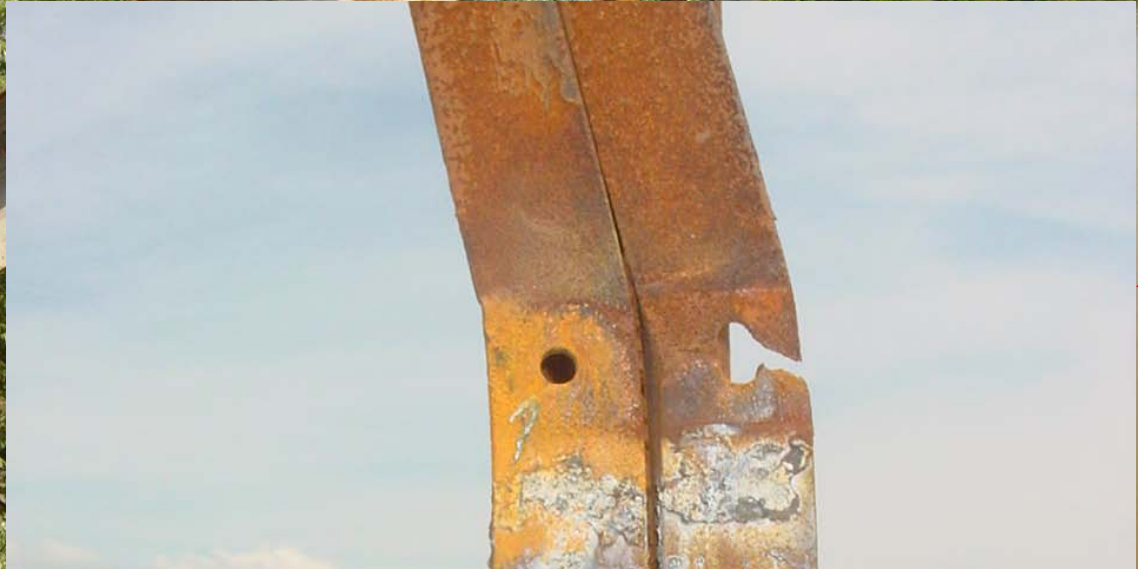
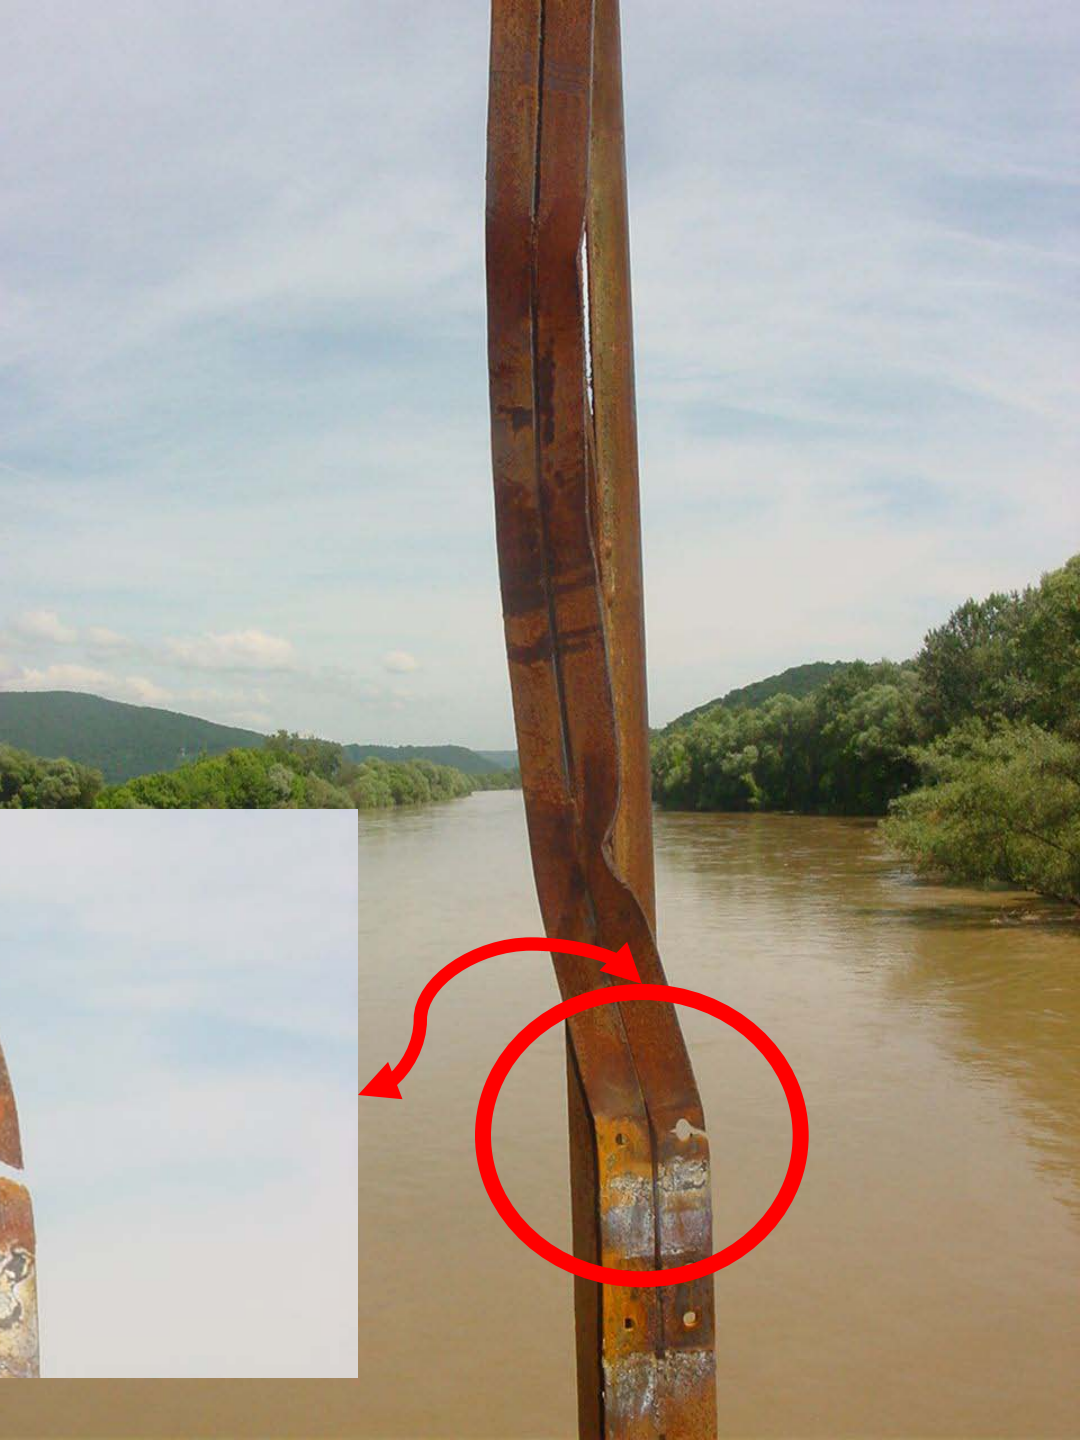
**Deformation defect**

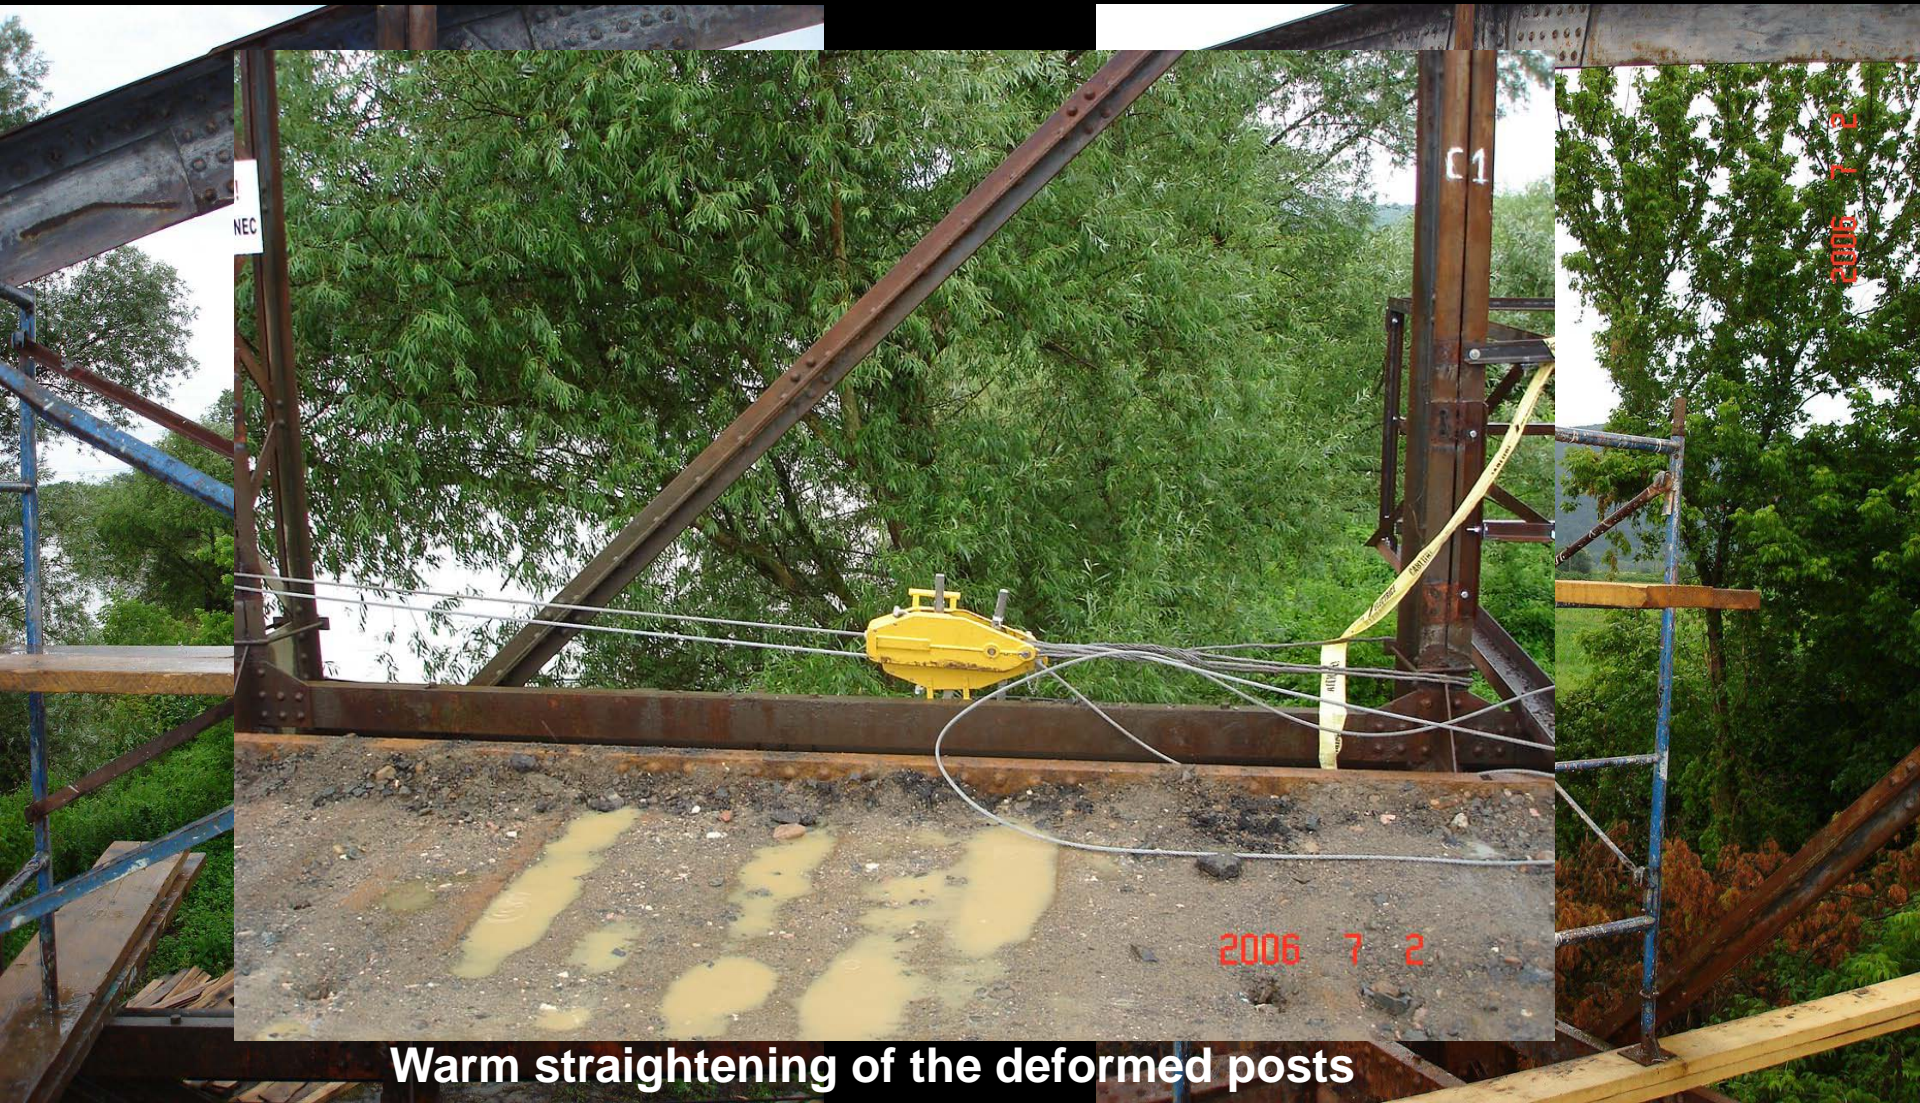
**Warm straightening of the deformed posts**

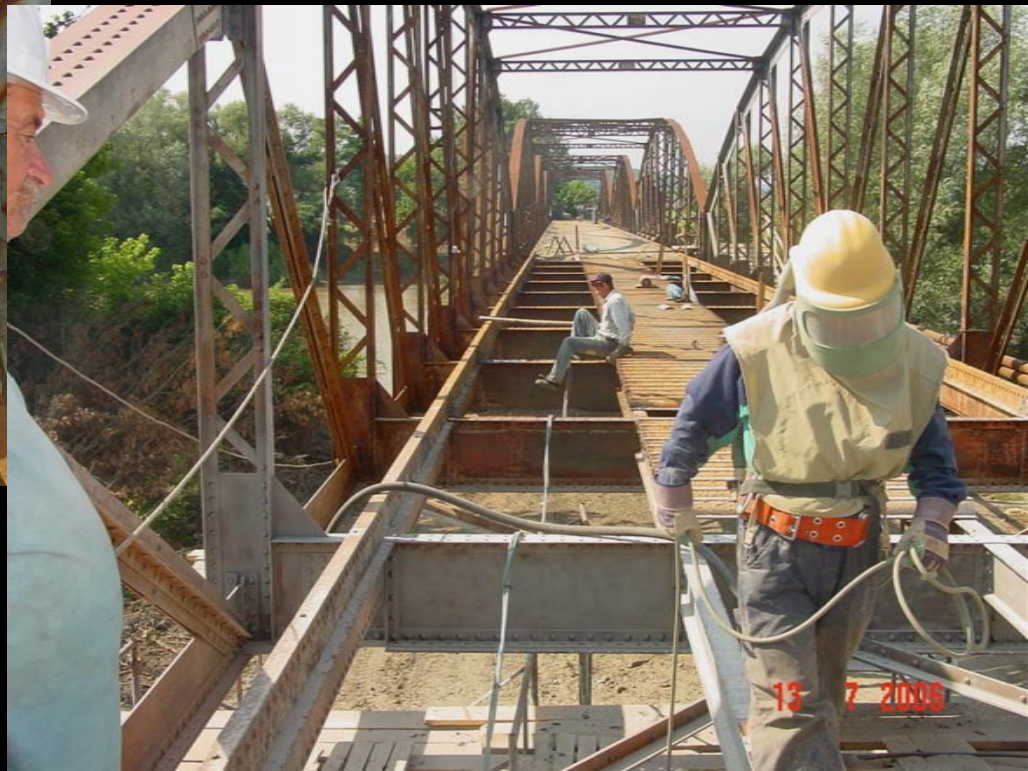
Sand blasting of the structure

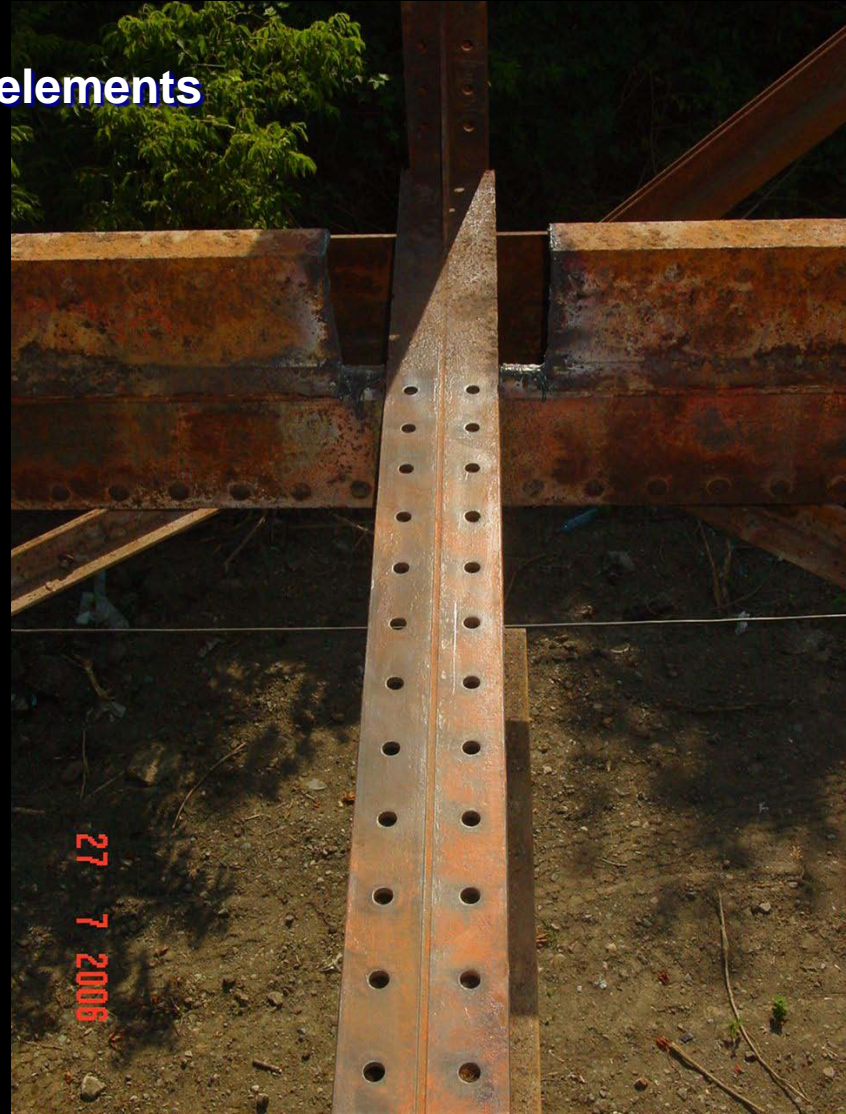
New consolidation elements

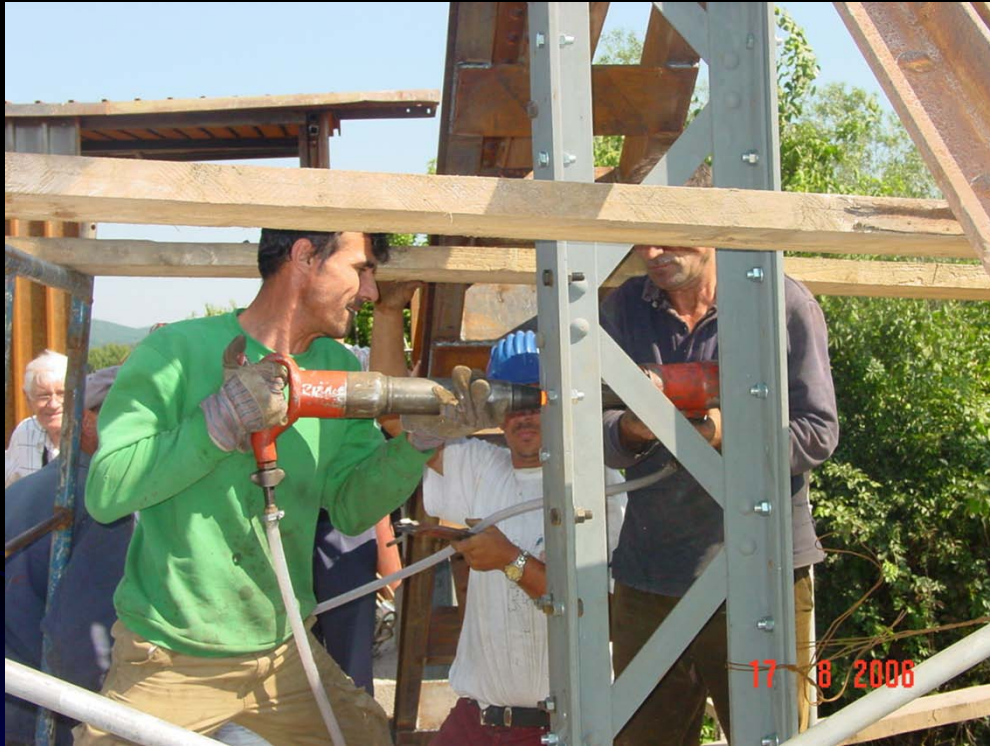
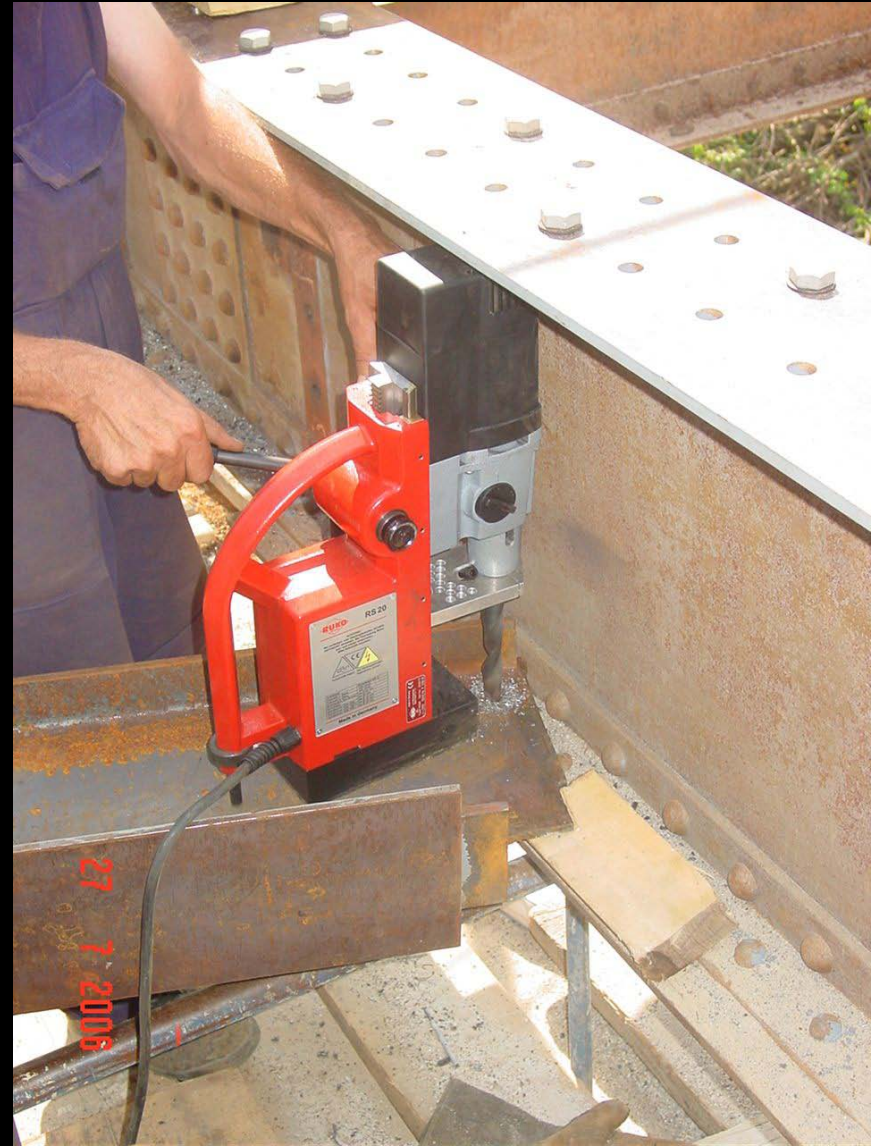
**Riveting of the new steel elements**

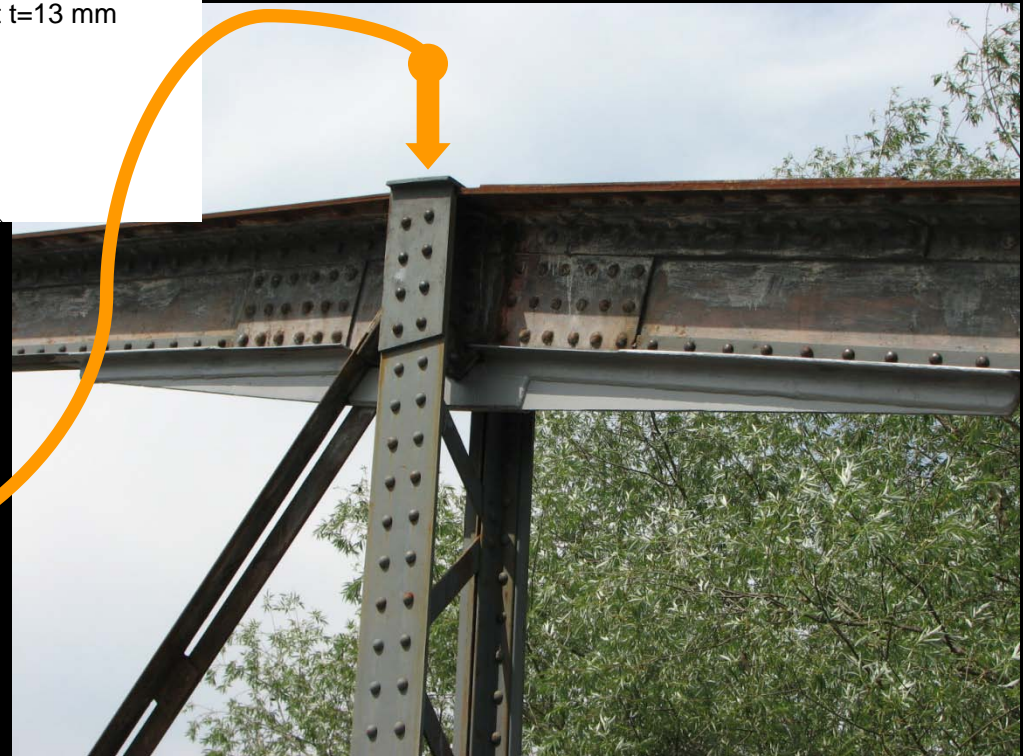
Reinforcement of upper chord joint

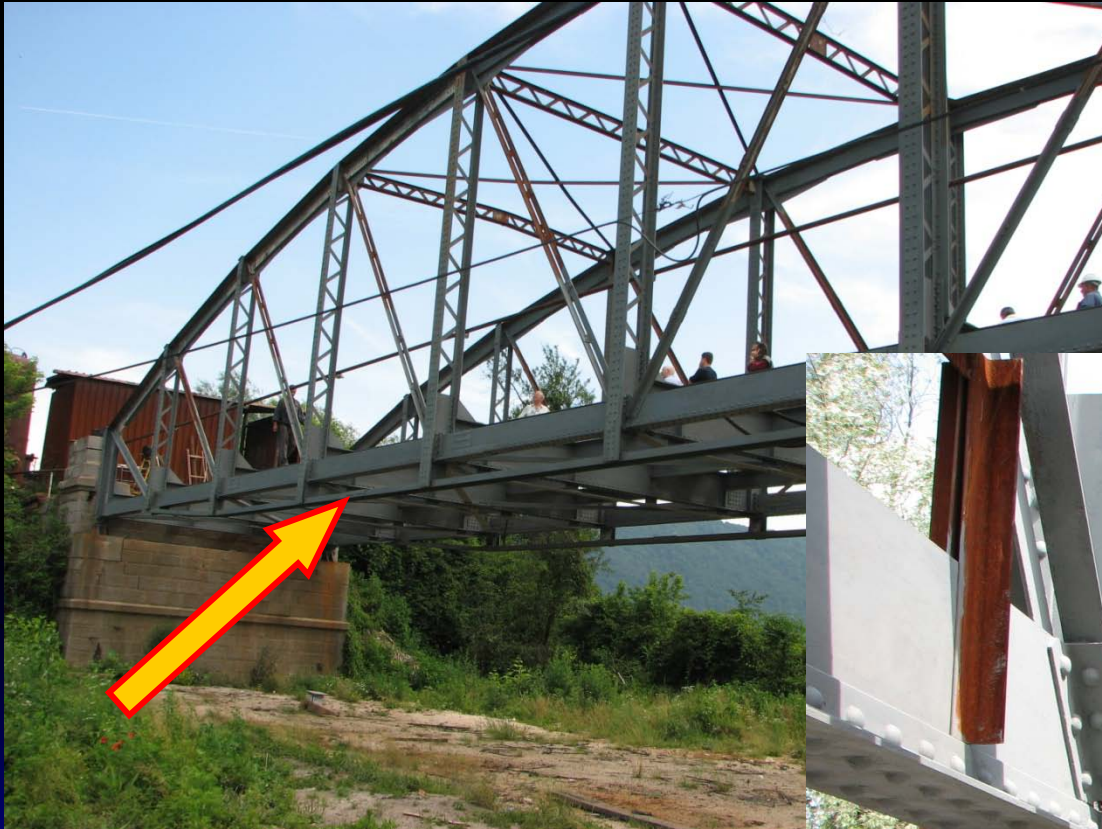
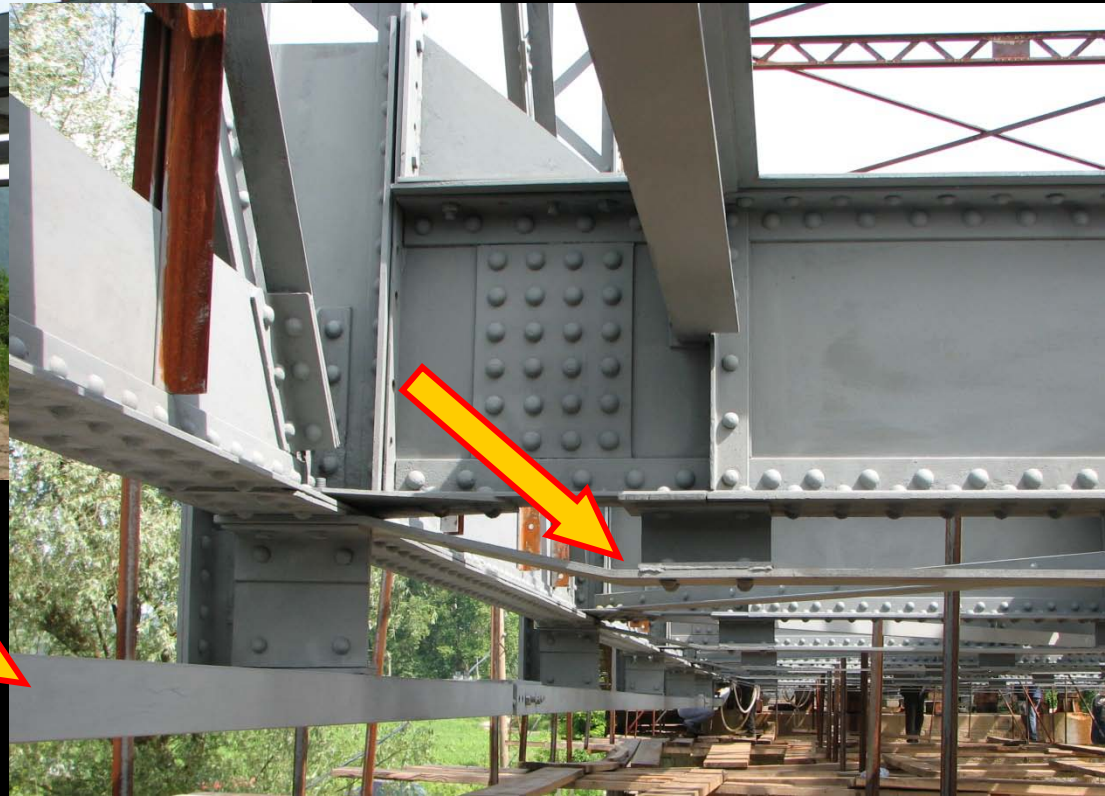
**Tie elements**

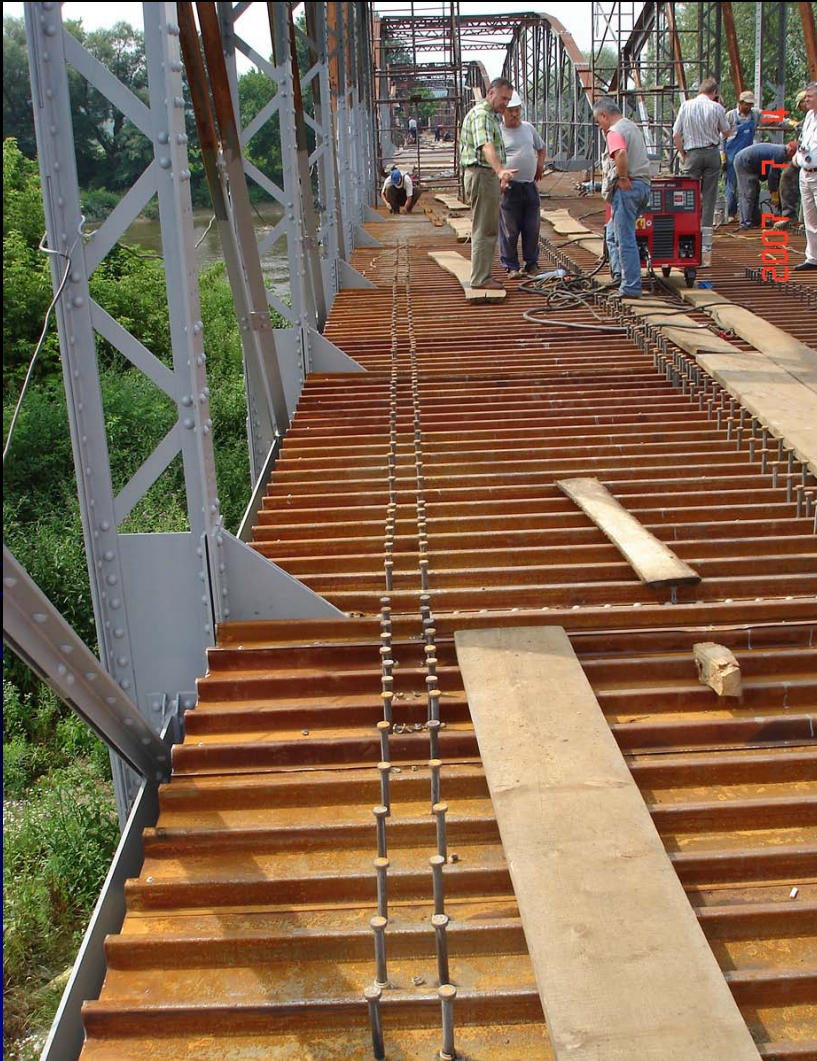
**Stud connector welding**

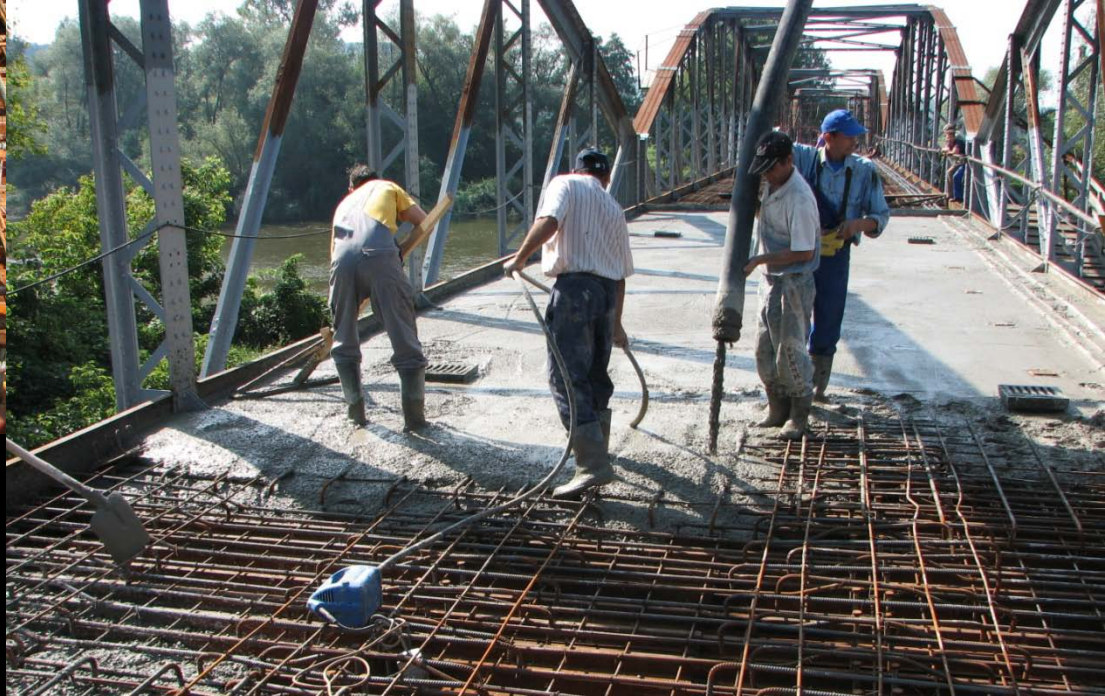
**Concrete deck**
