Robustness experiences from two failed Timber Structures

Robustness experiences from failed Timber Structures - The Bad Reichenhall Ice-Arena Collapse

The Bad Reichenhall Ice-Arena – Collapse on 2. Jan. 2006

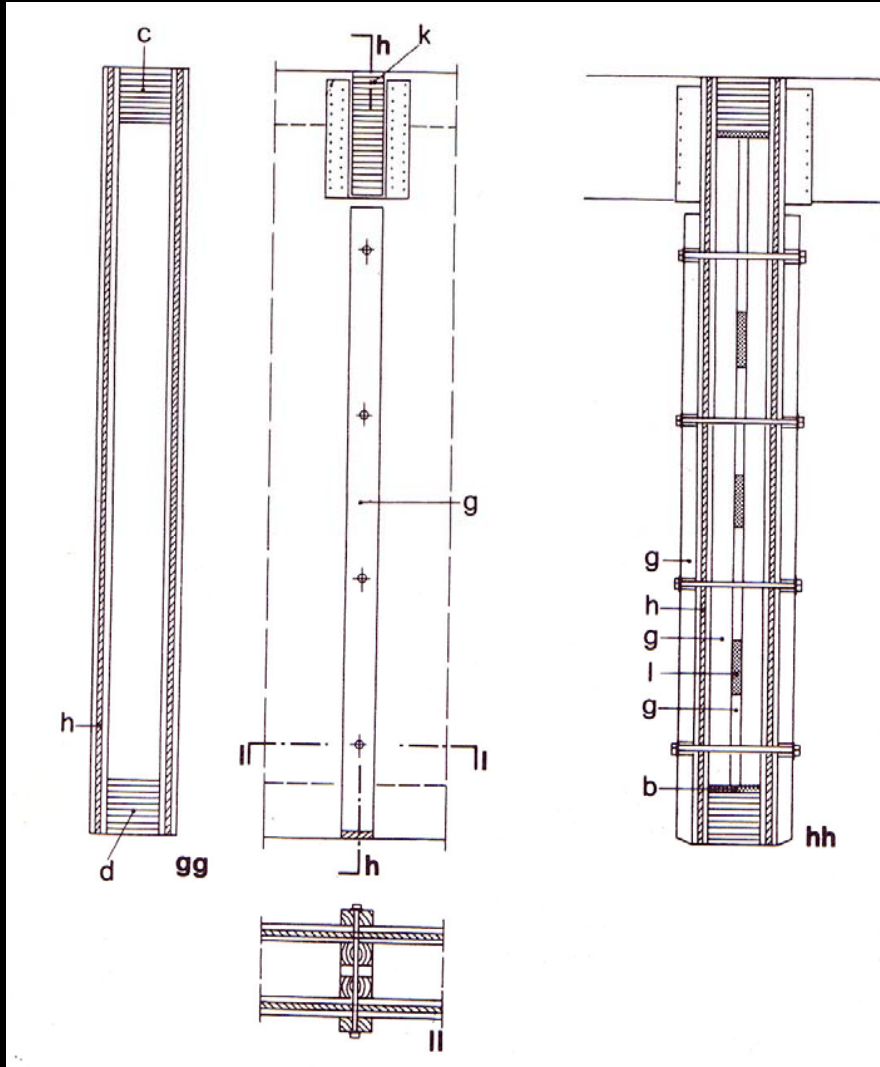
The Bad Reichenhall Ice-Arena – Cross-section of girders

c-upper girder, d-lower-girder, h-Kämpf web-board,
k-purlin, g-reinforcement (to avoid buckling)

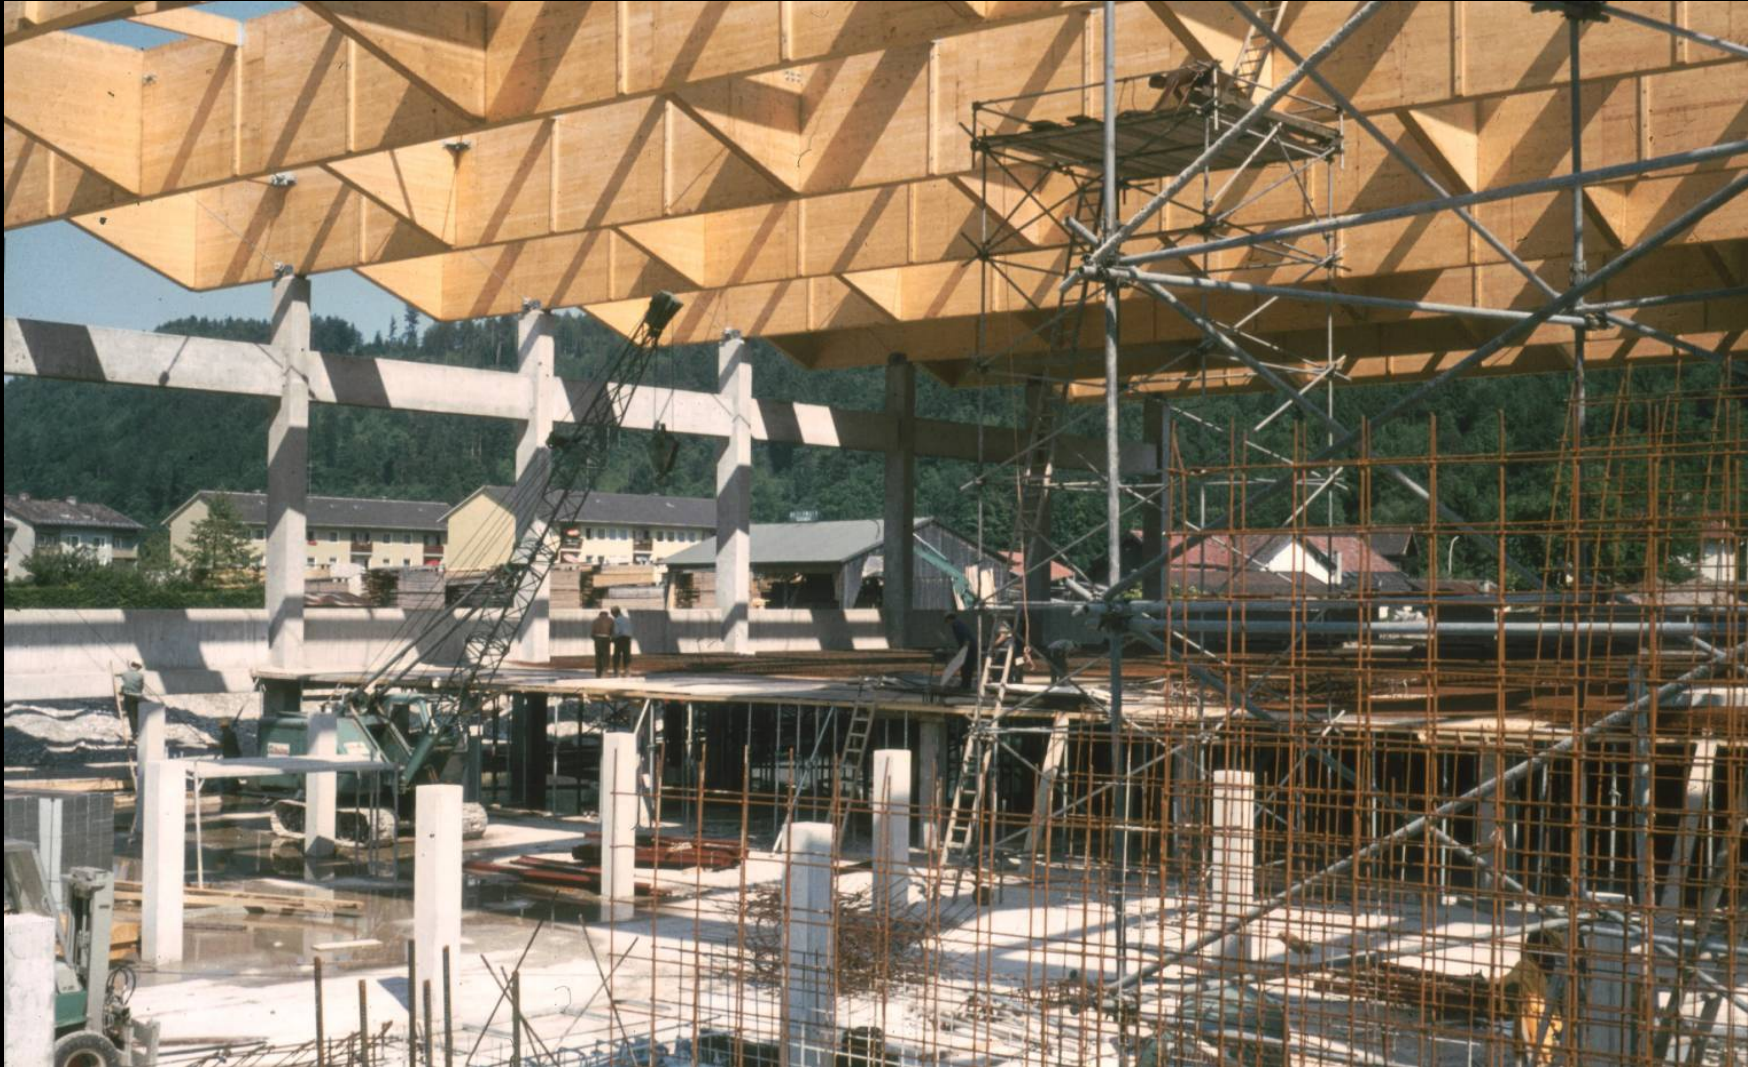
The Bad Reichenhall Ice-Arena – Construction

Eishalle Bad Reichenhall – Year of Construction 1971/72

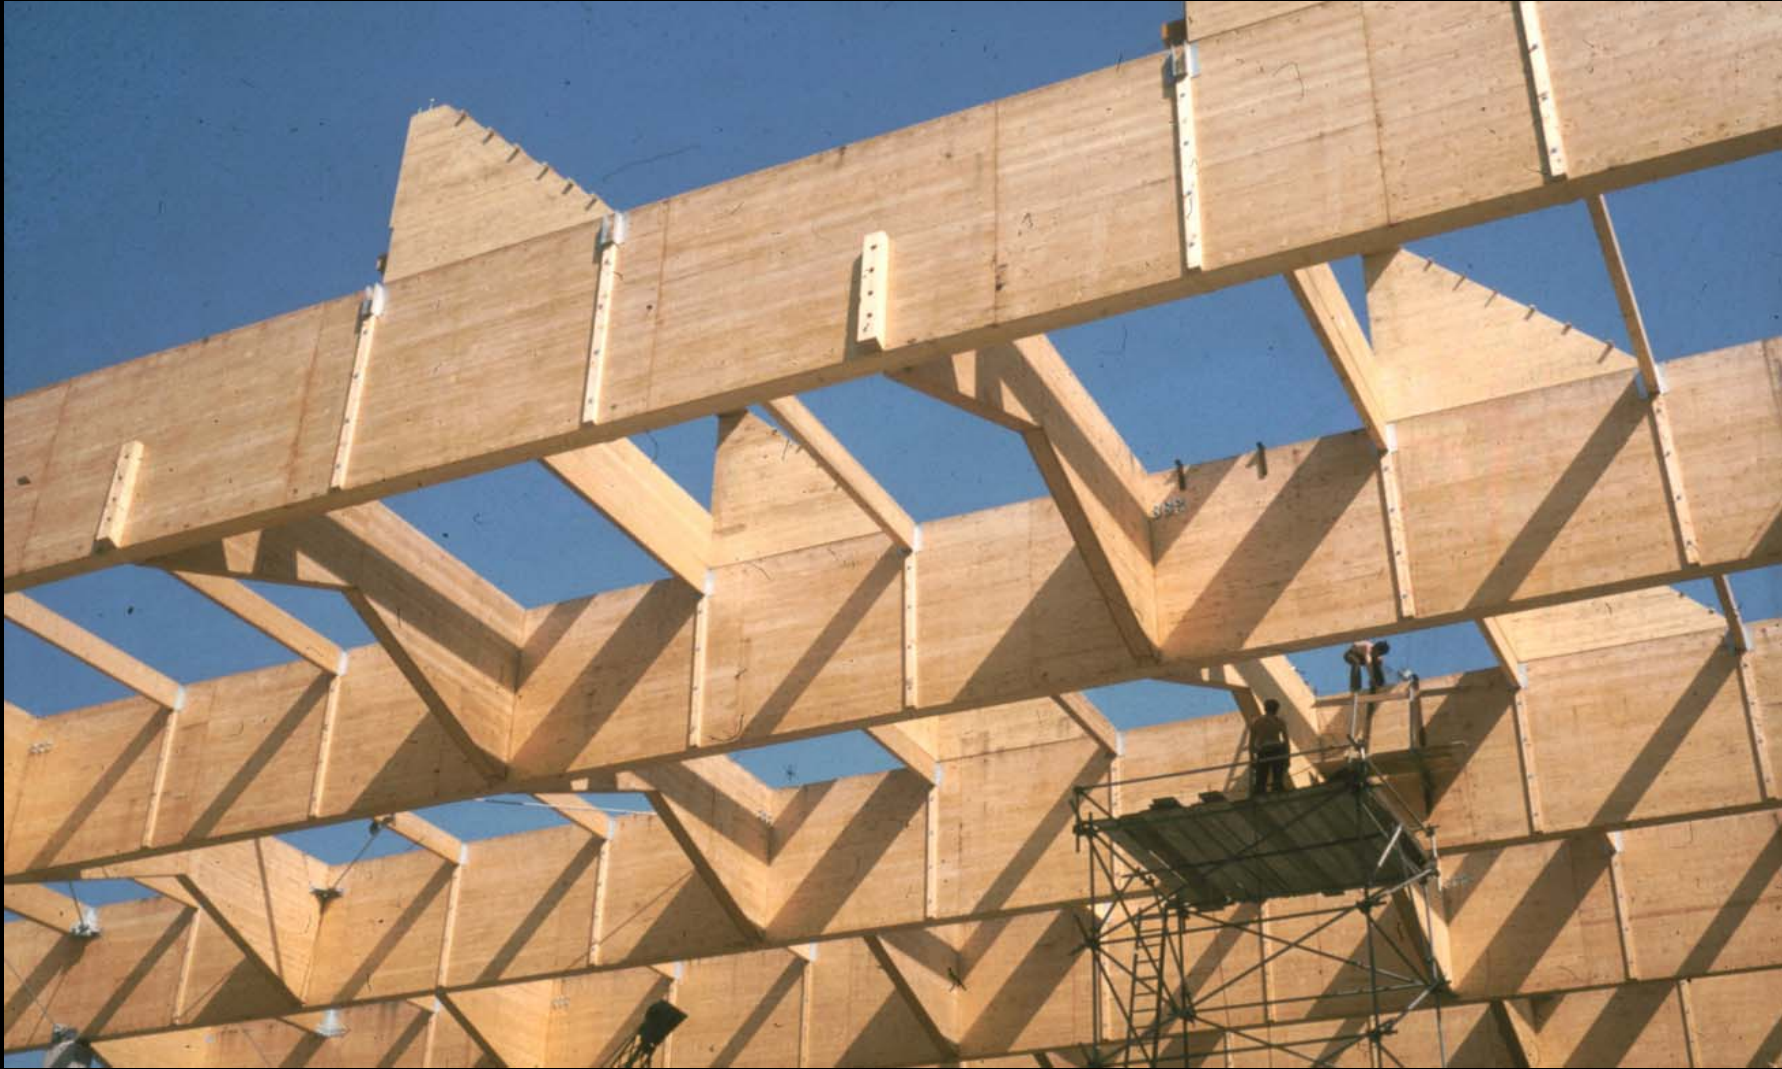
The Bad Reichenhall Ice-Arena – Primary and Secondary System

Eishalle Bad Reichenhall – Year of Construction 1971/72

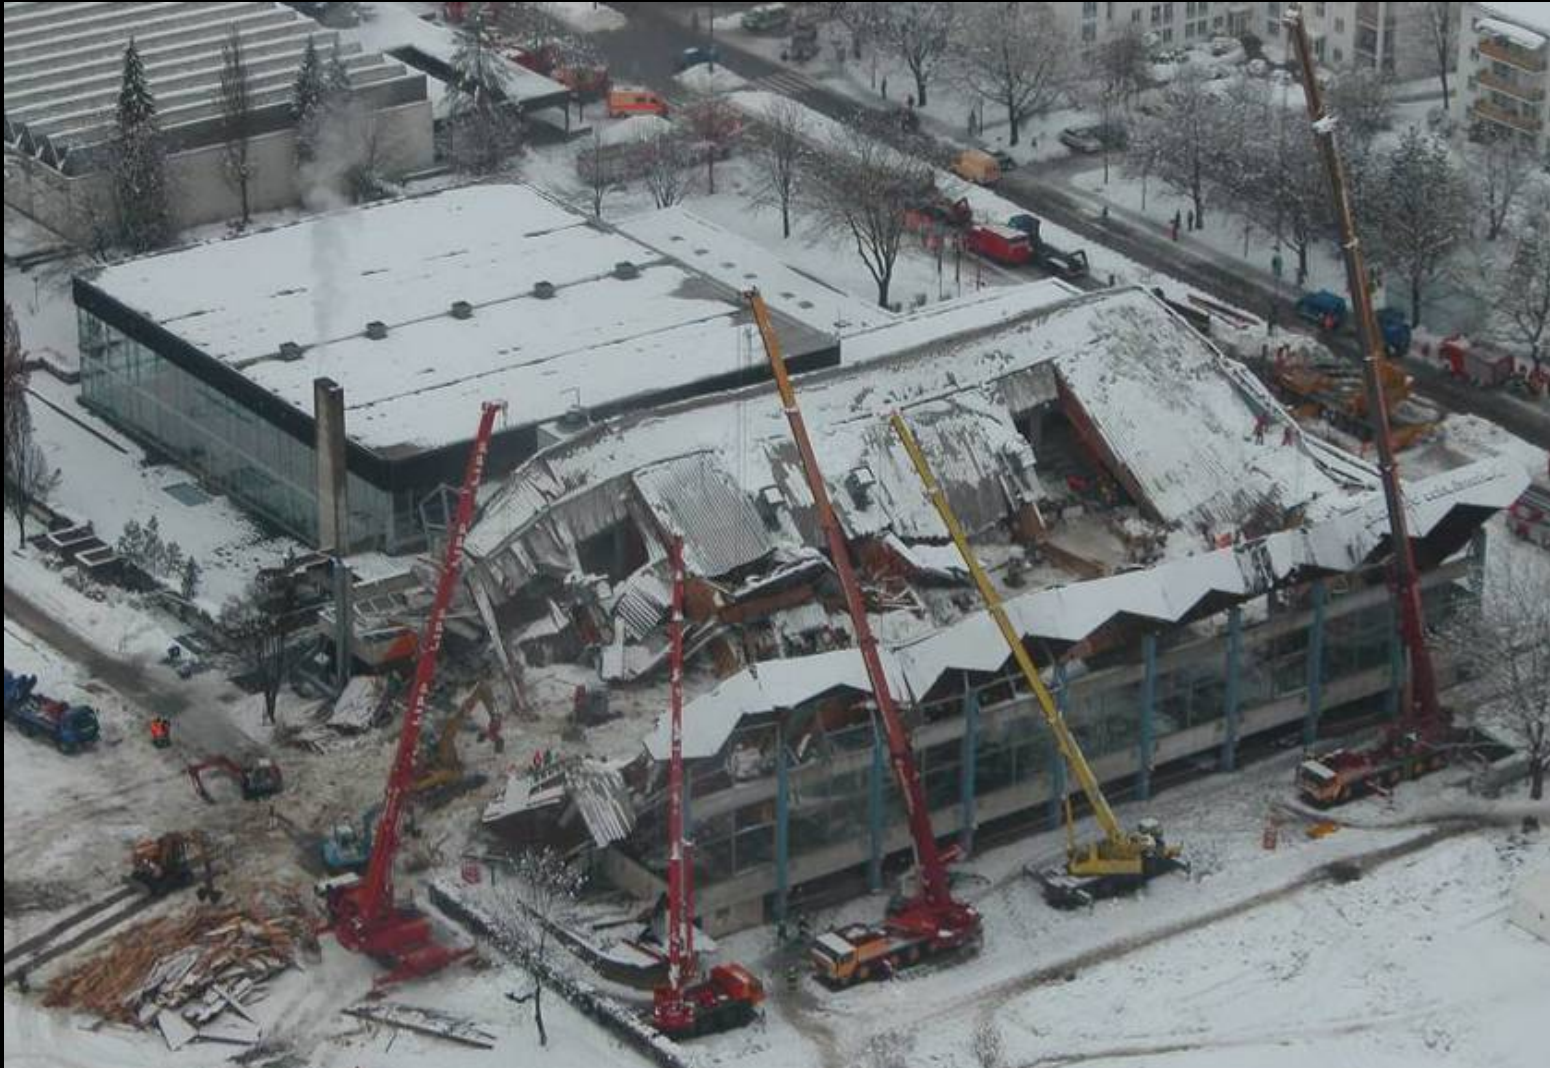
Eishalle Bad Reichenhall – Progressive collapse under char. snow load

- Errors in structural calculations – reduction of safety factor to ≈ 1.5
- “Kämpf”-web boards – not compliant with technical approval (limit 1.20m)
- Gluing process between girder parts not reliable
- Urea-formaldehyde glue used is not permanently moisture-resistant (high ambient humidity and thermal radiation between ice and roof)
- Repeated cases of water penetration as a result of leaks in the roof
- No professional examination of structural integrity during service life

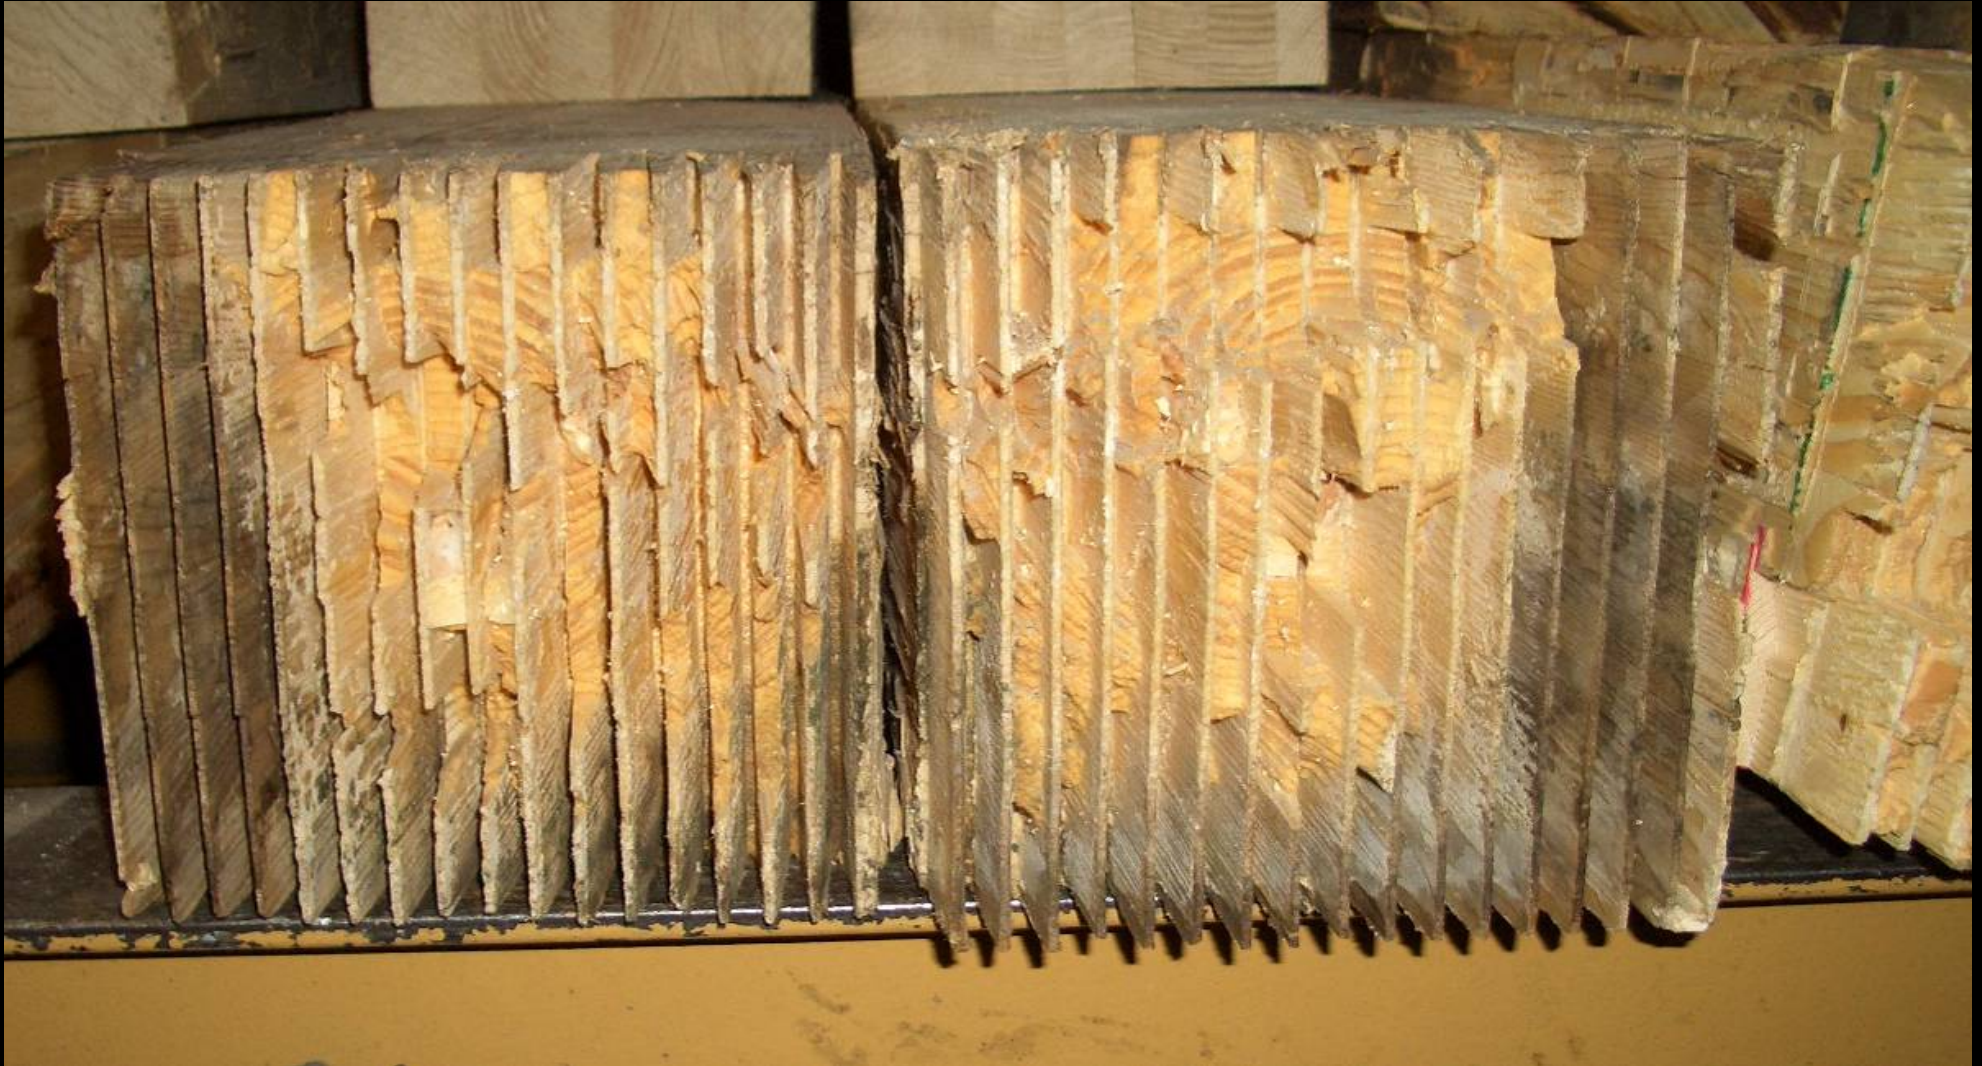
The Bad Reichenhall Ice-Arena – General finger joints

General finger joints – Loss of adhesive effect of UF-glue

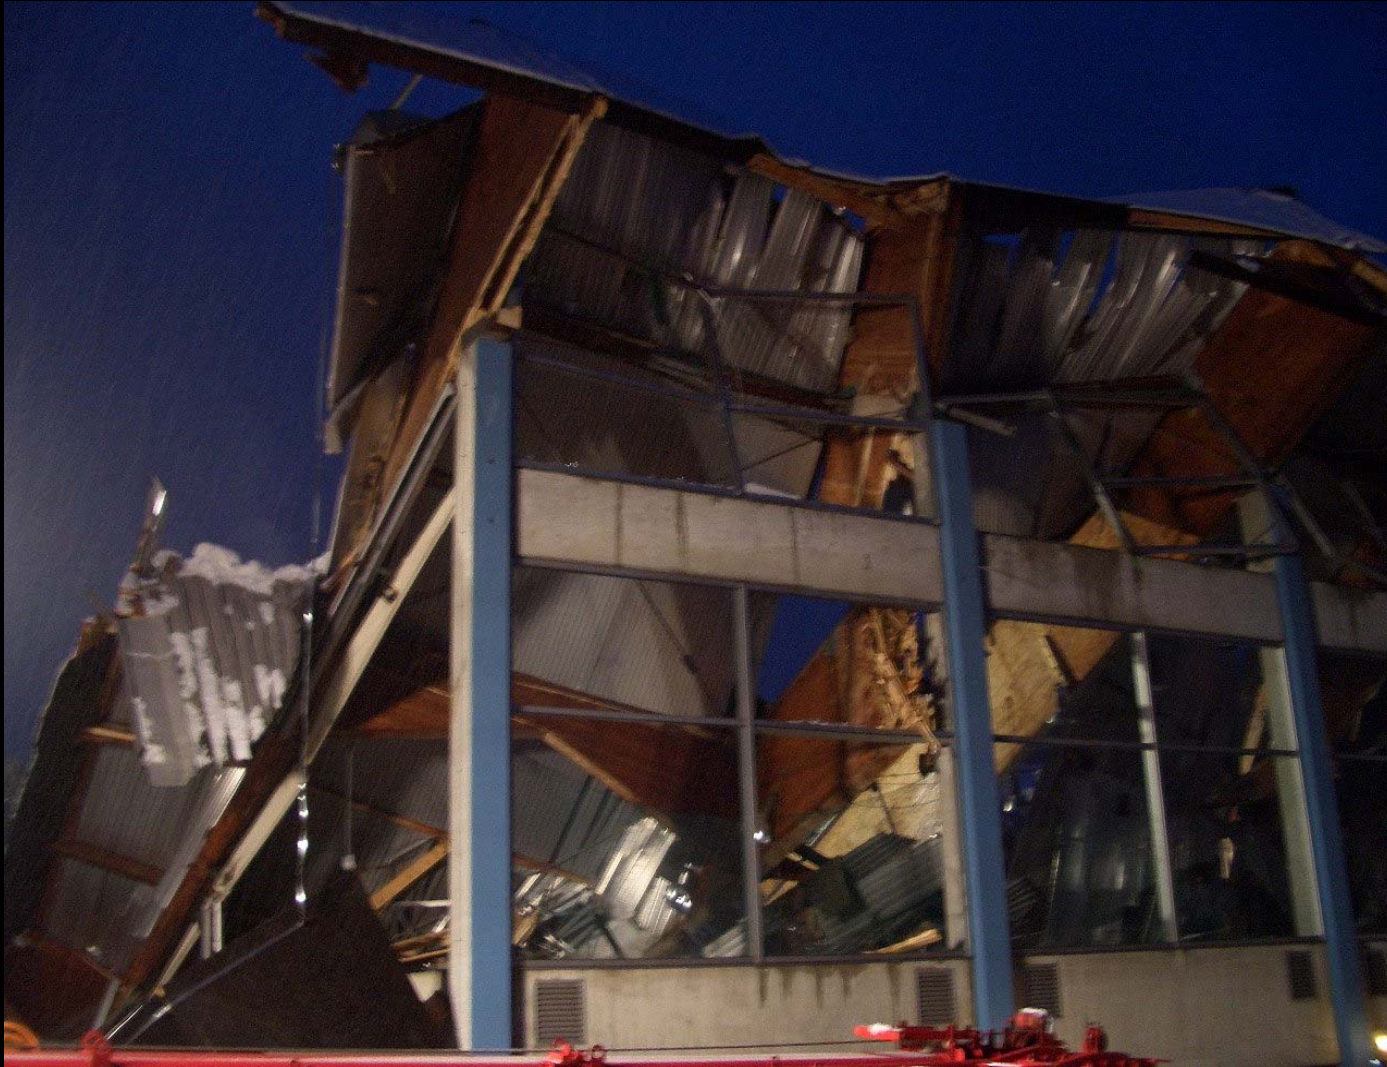
The Bad Reichenhall Ice-Arena – Progressive Collapse

Eishalle Bad Reichenhall – Collapse initiated in one of the three main girders on the east side

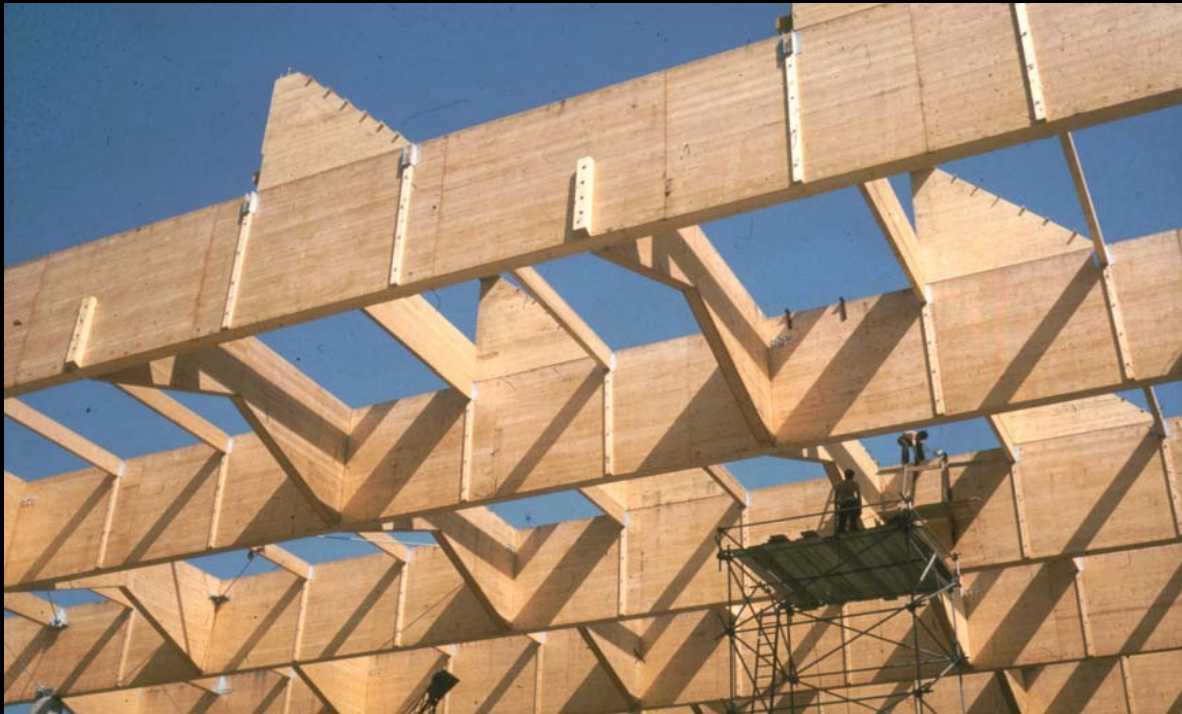
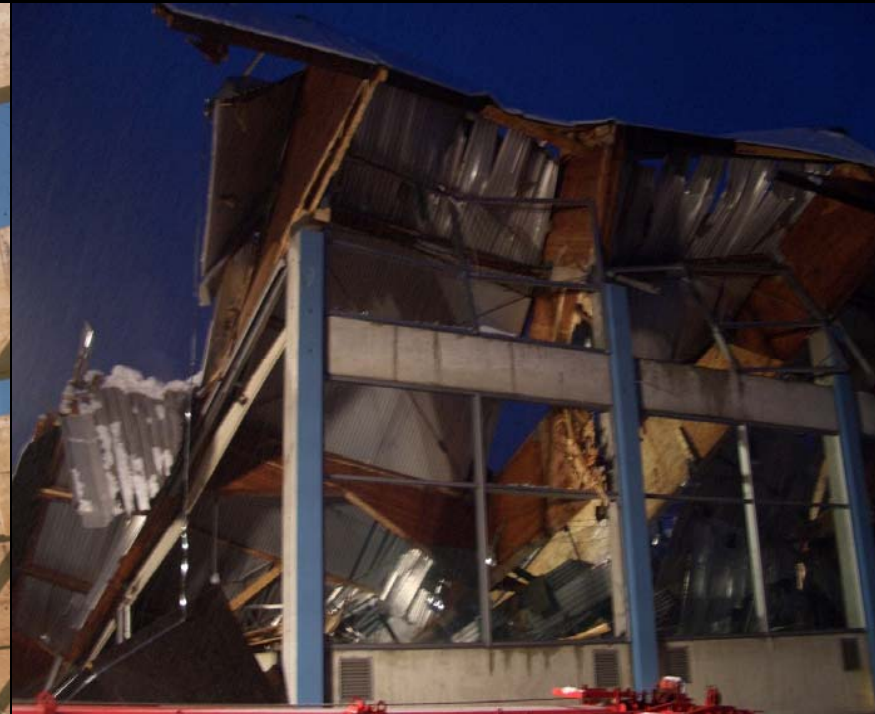
The Bad Reichenhall Ice-Arena – Progressive Collapse

- Stiff cross bracing – redistribution of loads from failing girder to neighbouring girders
- All girders suffered from the same systematic mistakes and degradation processes – no ability to sustain additional load
- Progressive collapse within seconds

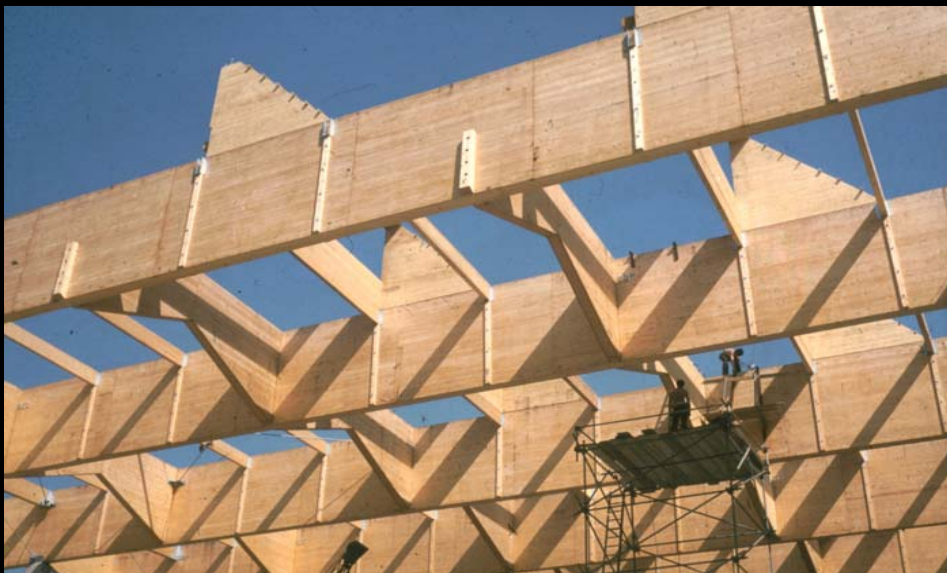
The Bad Reichenhall Ice-Arena – Robustness Considerations

- Strong and stiff cross bracing – shifting of loads without warning through deformations
 - Possible amelioration:
 - Partition between secondary system and bracing against lateral torsional buckling
 - Use of statically determinate secondary system with more flexible connections
 - K-bracing not in every field - compartmentalization
- possibility of one girder failing without inducing progressive (total) collapse
