Robustness Design of Timber Structures – Secondary Structures – Purlin Systems

Philipp Dietsch
Chair of Timber Structures and Building Construction
Technische Universität München

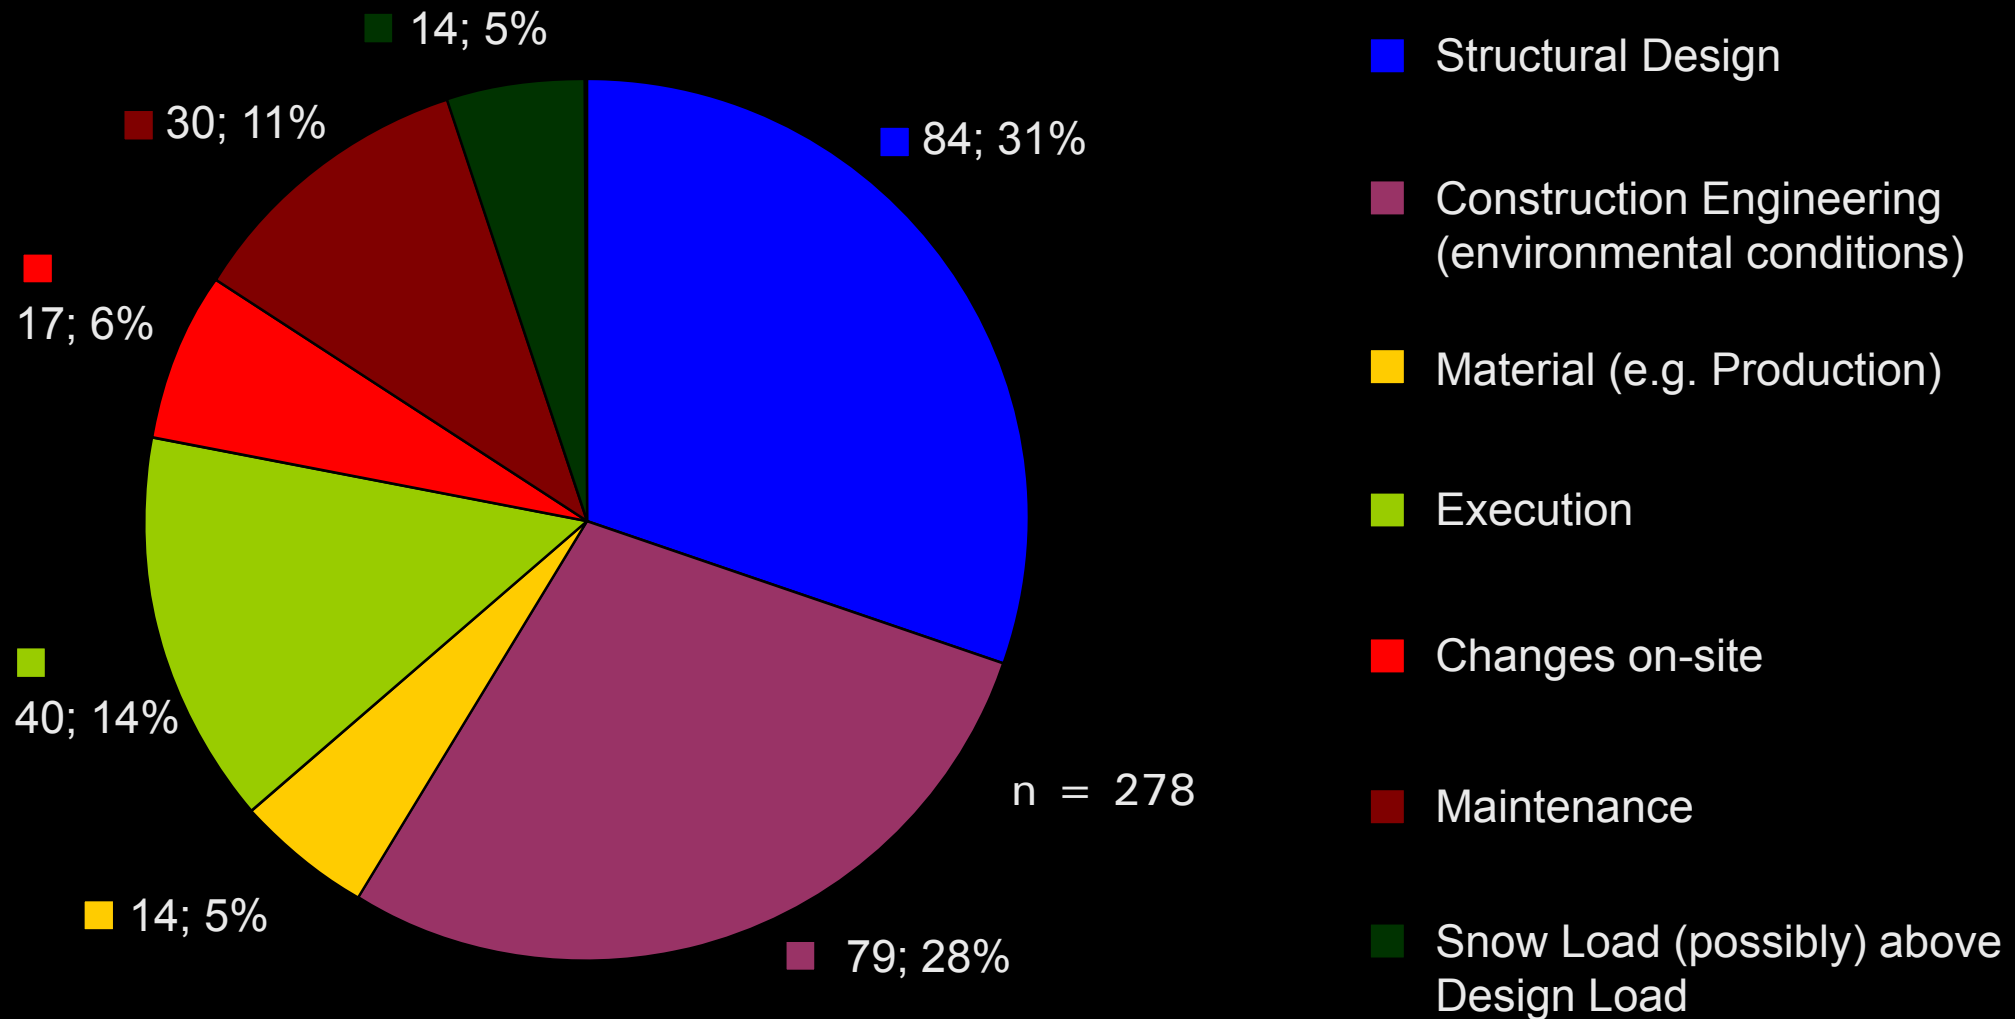
Evaluation of failed Timber Structures - Accountabilities for Failure

- numerous studies on failures in timber structures (Blaß, Frese; Frühwald et al.; Dietsch, Winter) have shown that the majority of failures were not due to local effects or statistically random occurrences, but – in the vast majority – due to systematic mistakes or global deterioration
- Reason is: structures are usually composed of repetitive elements, connected by analogical construction principles
 - mistakes during planning or construction phase, will most likely repeat itself in all identical elements (e.g. Bad Reichenhall, Siemens Arena)
 - structures containing global defects (systematic mistakes or global deterioration) will not be able to withstand a large load increase due to load distribution from one failing member, meaning they are more fragile to collapse progressively

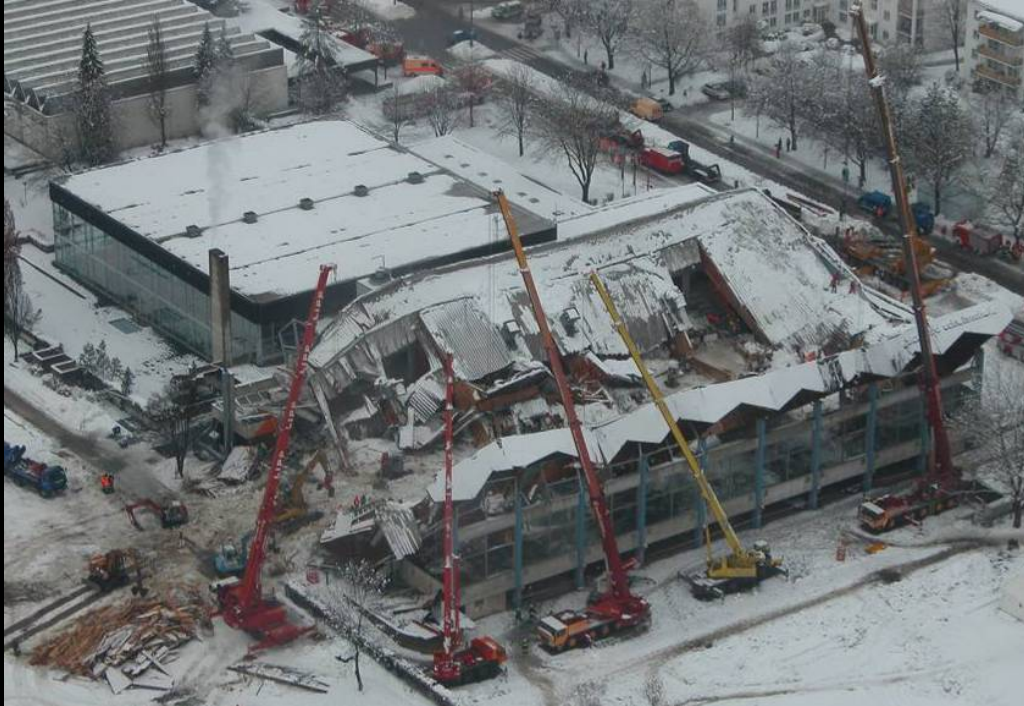
Bad Reichenhall

Examples – redundant secondary systems

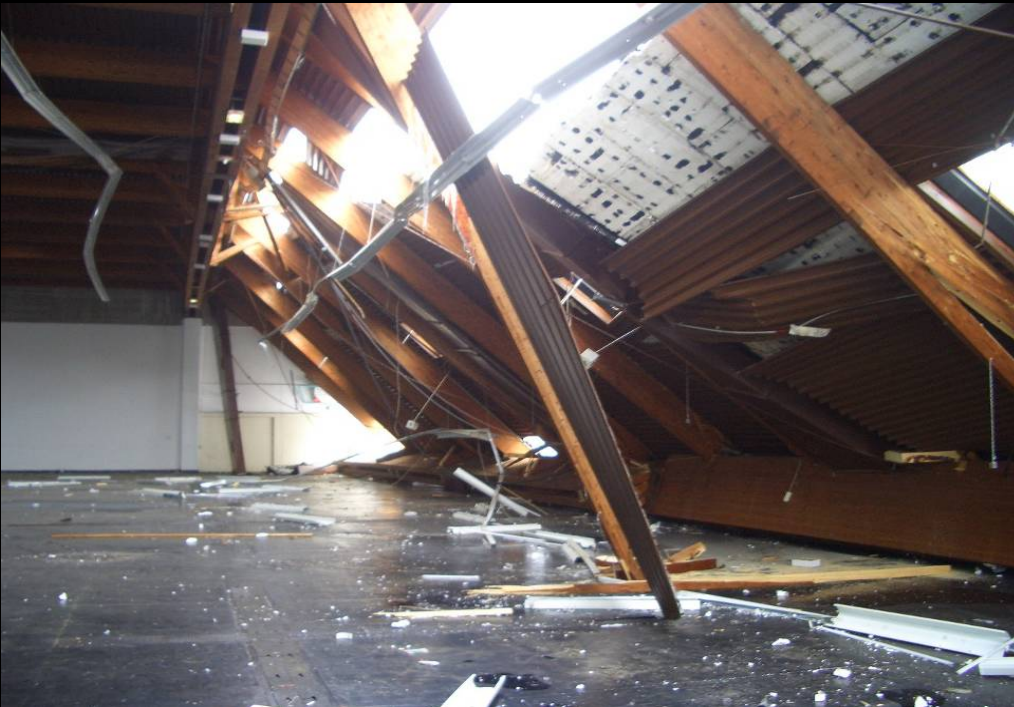
Messe Salzburg, MPA BAU/TUM

Examples – determinate secondary systems
