## **Assessment of failure and malfunctions in steel bridges**

## **Summary**

The verification of existing steel structures especially steel bridges is in present one of the main problems of the structural engineers. The majority of existing railway steel bridges that have been built at the turn of the last century are riveted structures. Today many of these structures have already achieved a considerably age; therefore the establishment of the remaining fatigue safety of these structures is one of the most important tasks of contemporary society. Many of these bridges are still in operation after damages, several phases of repair and strengthening. The problem of these structures is the assessment of the present safety for modern traffic loads and the remaining service life. An assessment of safety may be required as a result of different observations like: displacements, cracks, vibrations, corrosion, etc. In the classical accepted assessment based on the damage accumulation theory, the main considered factors are the following: applied stresses and stress ranges, geometry of the details and number of stress cycles. The paper presents the Romanian Methodology in this field with

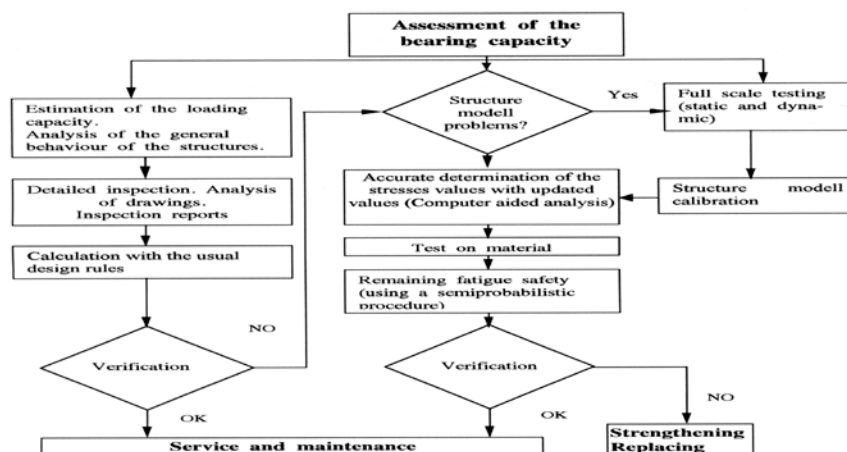
Figure1: Methodology of the Romanian standard SR 1911-98 [4]

This methodology adopted by the Romanian standard is illustrated in Figure 1.

The assessment of the bearing capacity of existing bridges is a complex matter. Beginning with 1986, a systematic checking of bridges built in the last century or at the beginning of this century has begun in Romania. Based on the accumulated experience and according to the UIC (Union Internationale des Chemins de Fer) cards [2], and German Standard [3], a methodology was proposed; it includes the following stages:

**STEP 1:** estimation of the loading capacity of the structure based on a detailed inspection; analysis of drawings, inspection reports, repairs, reinforcements, analysis of the general behavior of the bridge (displacements, vibrations, corrosion, cracks). In this phase the stresses in the structure can be calculated with the usually simplified hypothesis;

**STEP 2:** the accurate determination of the stresses in the structure and of the remaining safety of the elements. This phase includes: tests on materials, computer aided analysis of the space structure, remaining safety calculated on the base of the real time - stress history;

**STEP 3:** in situ static and dynamic tests.

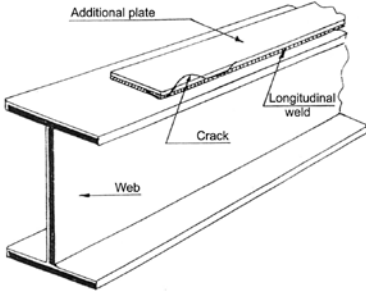
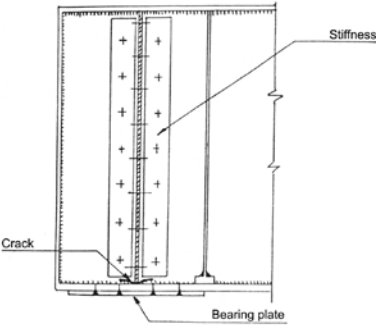
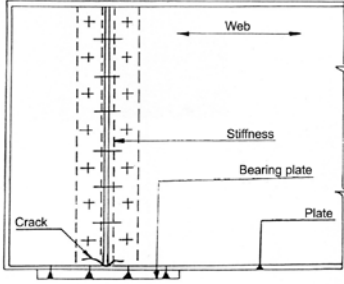
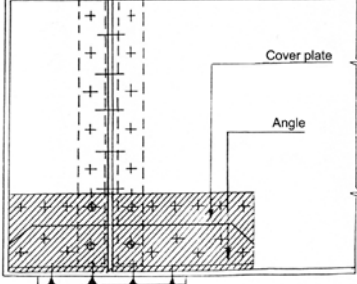
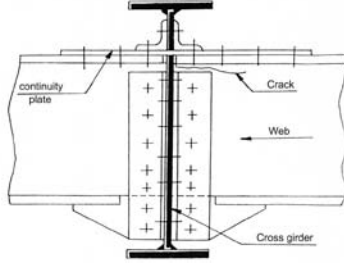
Table 1: Typical defects in welded steel bridges

Element	CRACK	REPAIR
0	1	2
Main girder

<ul style="list-style-type: none"> <li>⇒ Grinding</li> <li>⇒ New additional plate</li> <li>⇒ Observation</li> </ul>
Main girder

Main girder

Stringer

However, from the overall examination of a large number of bridges many defects can be pointed out. The defects are widespread, having a heterogeneous character from the point of view of location, development and development tendency; their amplification was also due to the climate and polluting factors that caused the reduction of the cross section due to corrosion. Statistically, in 283 from among 1088 welded bridges, and in 356 from among 3201 steel riveted bridges cracks were detected and repaired. In Table 1 some typical defects in stringers, cross girders, main girders wind bracings and orthotropic deck and their repair are presented [5].

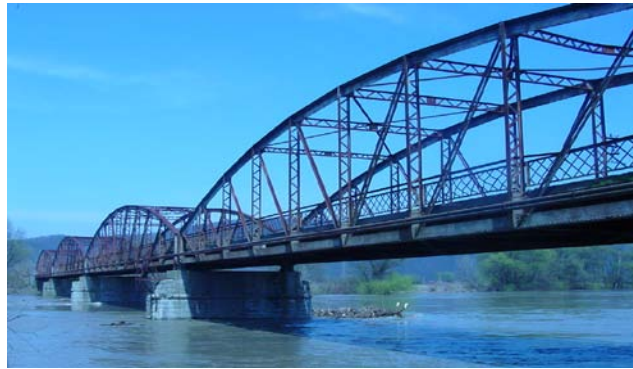
Figure 2: The Bridge in Savarsin

The bridge in **Săvârşin** over the Mureş River on the local highway DJ 707 A was erected in 1897 , with four spans . The steel superstructure has a typical composition for the time period in which it was built, that is: steel deck, main parabolic truss girder with descending diagonals and posts, with trough deck slab laid on profiles of the Zorres type.

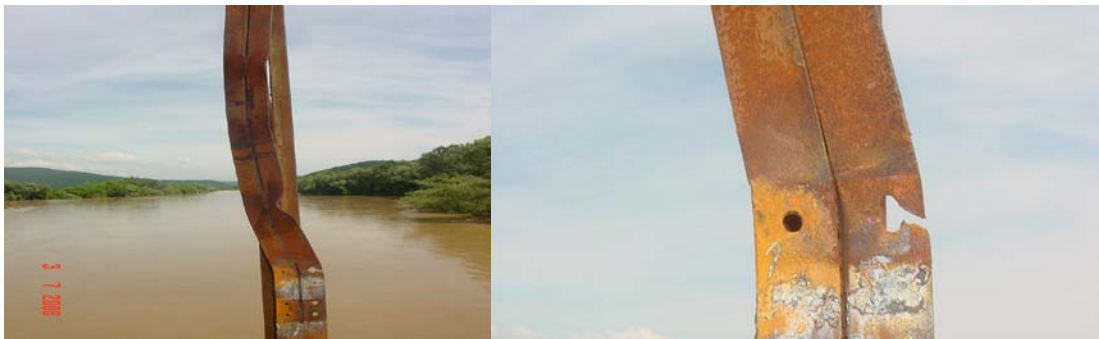
Figure 3: Deformation defects

The technical condition of the bridge was unsatisfactory, the elements were corroded and some verticals and diagonals were damaged by the impact with the vehicles (Fig. 3, 4,).
