Robustness considerations from failures in two large-span timber roof structures

Summary

This sheet deals with the failures of two large span timber roof structures. One is the Siemens Arena in Ballerup, Denmark and the other the Bad Reichenhall Ice-Arena in Germany. The principal structures are described as well as the flaws that are believed to have caused the failures. The robustness of the structures is discussed, including the consequences of the one structure to be statically determined and the other to be in-determined.

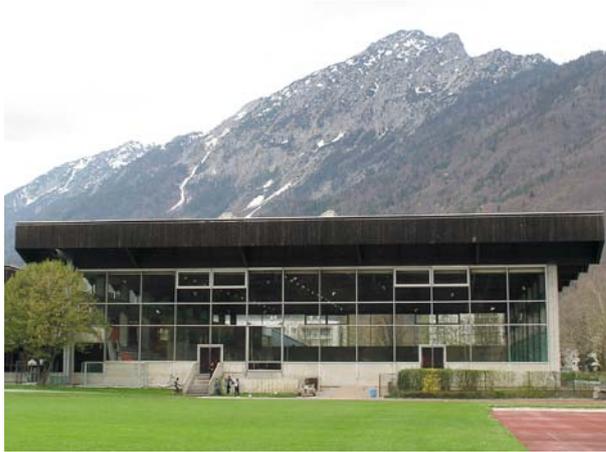
The Bad Reichenhall Ice-Arena, built in 1971/1972, was a structure of approx. 75 m in length and approx. 48 m in width, see Figure 4. The roof was supported by 2.87 m high main girders, which were produced as timber box-girders, see Figure 7. The box-girders featured upper and lower glulam members and lateral web boards made from so-called “Kämpf web boards” - a type of cross laminated timber. The 48 m long girders were produced from three 16 m long sections, which were joined with general finger joints.

Figure 4: The Ice-Arena in Bad Reichenhall

Due to the humidity exposure over the years, the glue-lines and finger joints were significantly damaged. This primarily affected the general finger joints in the lower girder and the bonding between the girders and the web-boards. It was found, that in some cases, there was no adhesive effect to a depth of 50 mm to 80 mm in the lower girders. In combination with the errors in the structural calculations, this represents the most significant cause for the collapse of the Bad Reichenhall Ice-Arena.

In addition, there were repeated cases of water penetration as a result of leaks in the roof membrane and in the area of the roof drainage. These were not permanently rectified and the roof structure did not receive renovation paint during the use of the arena. Whether such measures would have significantly delayed the damage to the glue lines of the roof structure cannot be answered.
