CONCRETE BUILDINGS SUBJECTED EARTHQUAKES IN TURKEY

Mehmet Inel

This study presents damaged concrete buildings during 2003 Bingol earthquake. All presented data and pictures are obtained from May 1, 2003 Bingol Earthquake report by Ozcebe et al. [11].

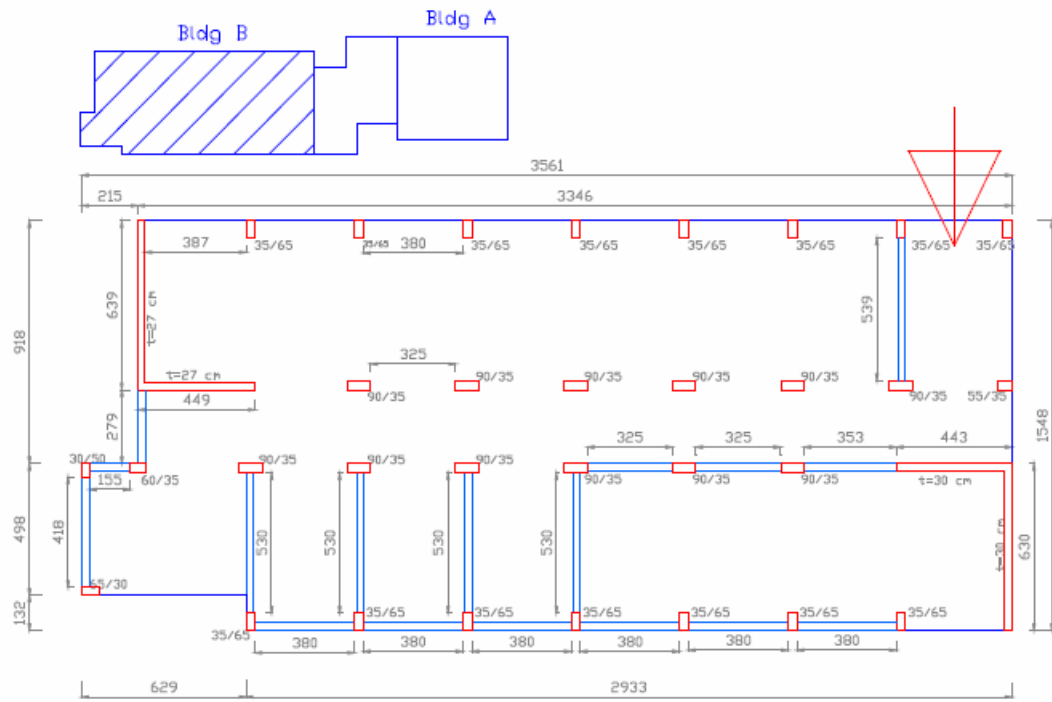
Figure 1. Plan view of Bingol High School

Building Type	School
Construction Year	NA
# of floors	4
Type	RCSW
Damage	Light

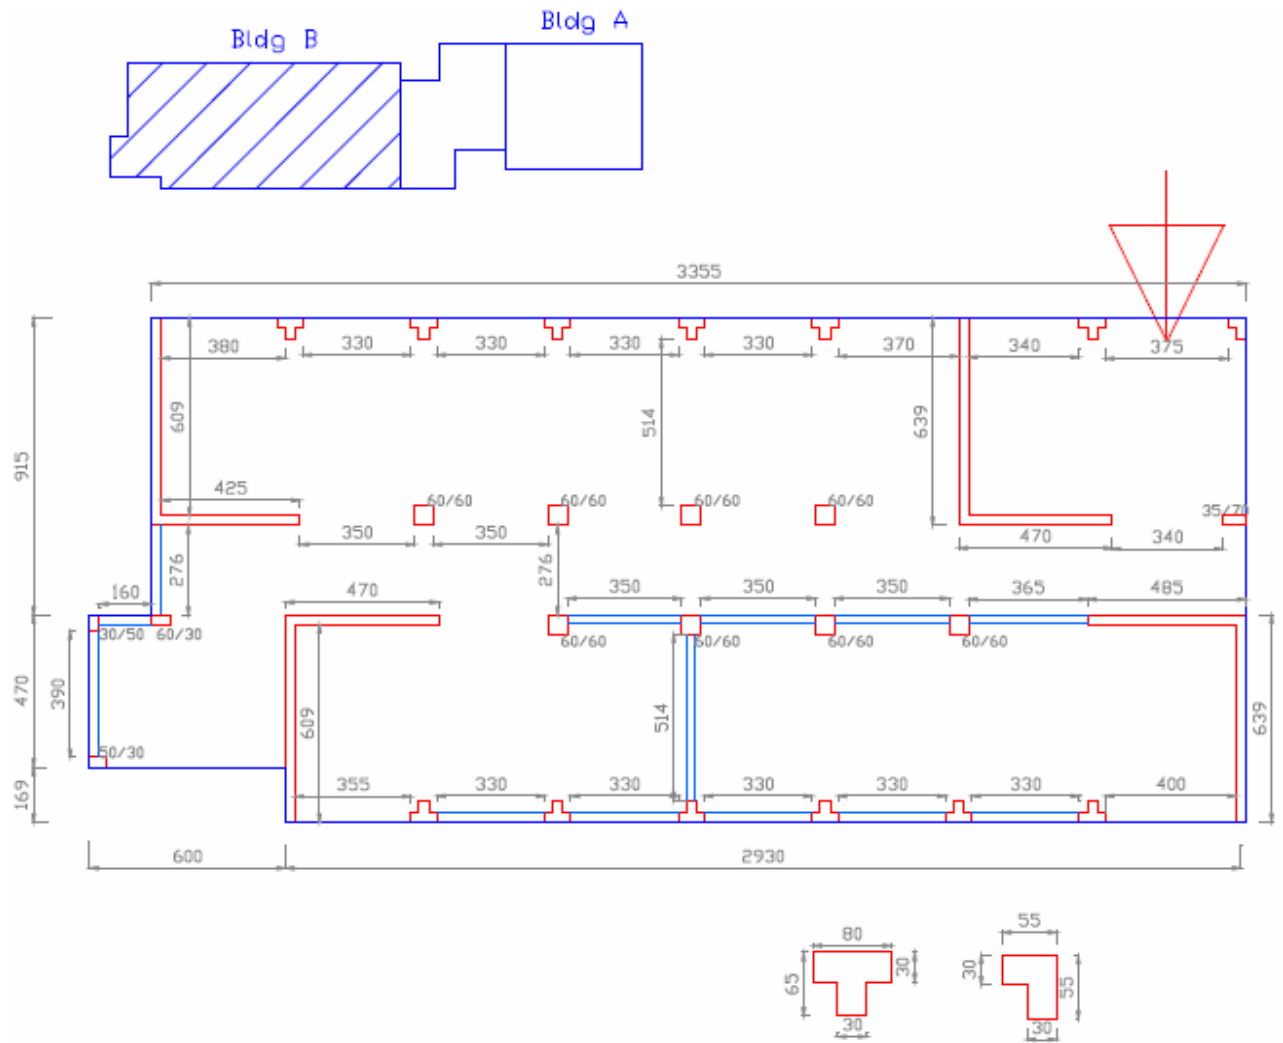
Figure 3. Plan view of Rekabet Kurumu High School

Building Type	School
Construction Year	NA
# of floors	3
Type	RCSW
Damage	Light

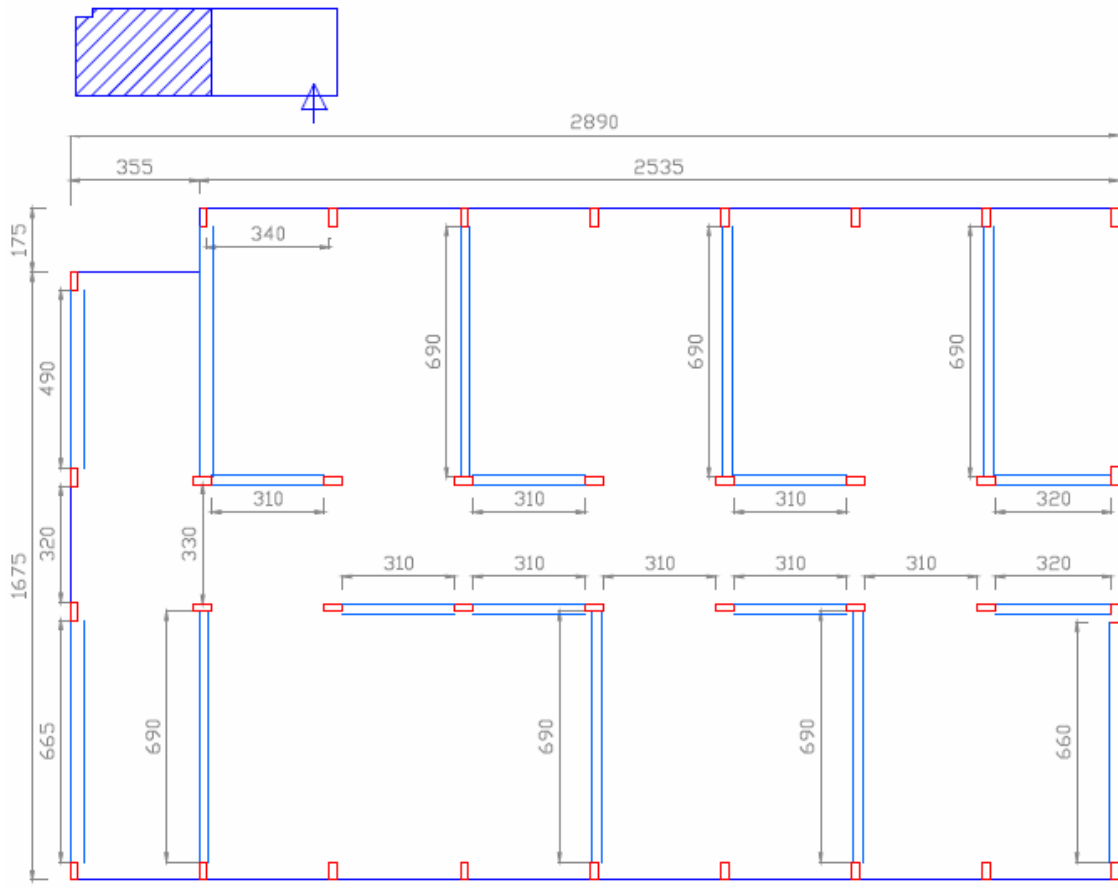
Figure 5. Plan view of Anadolu Ogretmen High School

Building Type	School
Construction Year	1974
# of floors	3
Type	RCSW
Damage	Moderate

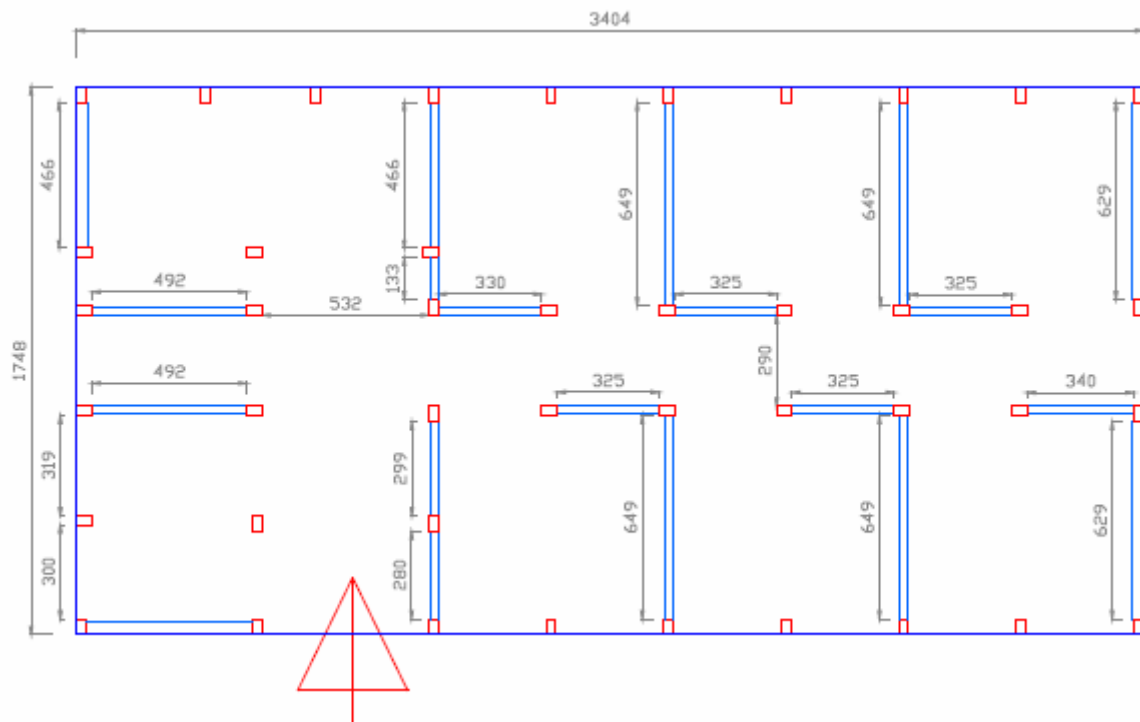
Figure 7. Typical school plan without shear walls. All the walls shown in the drawing refer to those occupying a full span. Walls with openings are excluded. All the columns have dimensions of 0.3m x 0.5m. The arrow indicates the entrance to the building. Dimensions are in cm.

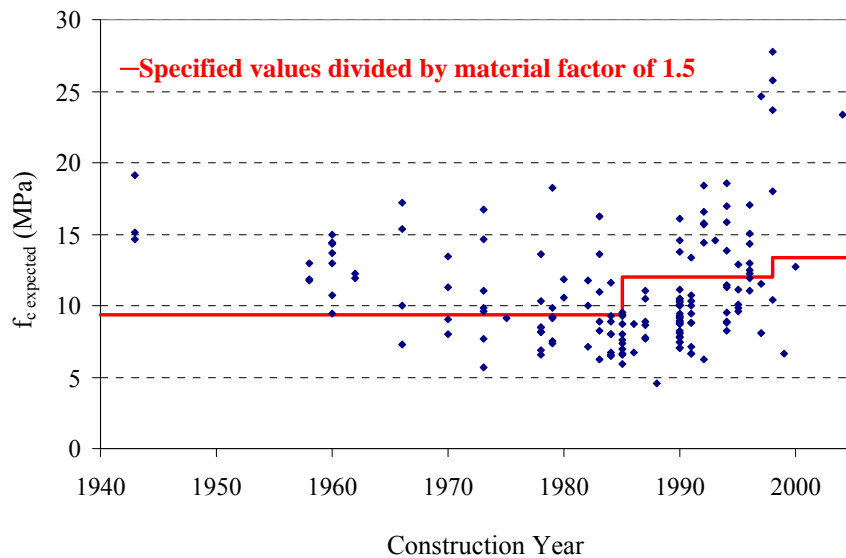
Figure. 13. Expected concrete strength values according to construction year of buildings (Inel et al. 2007).
