Robustness of Lifeline Systems

**Selcuk TOPRAK, A. Cem KOC, Engin
NACAROGLU, Orhan A. CETIN**

**Civil Engineering Department
Pamukkale University
Denizli, Turkey**

**Robustness of Structures
COST Action TU0601
1st Workshop, February 4-5, 2008,
ETH Zurich, Zurich, Switzerland**

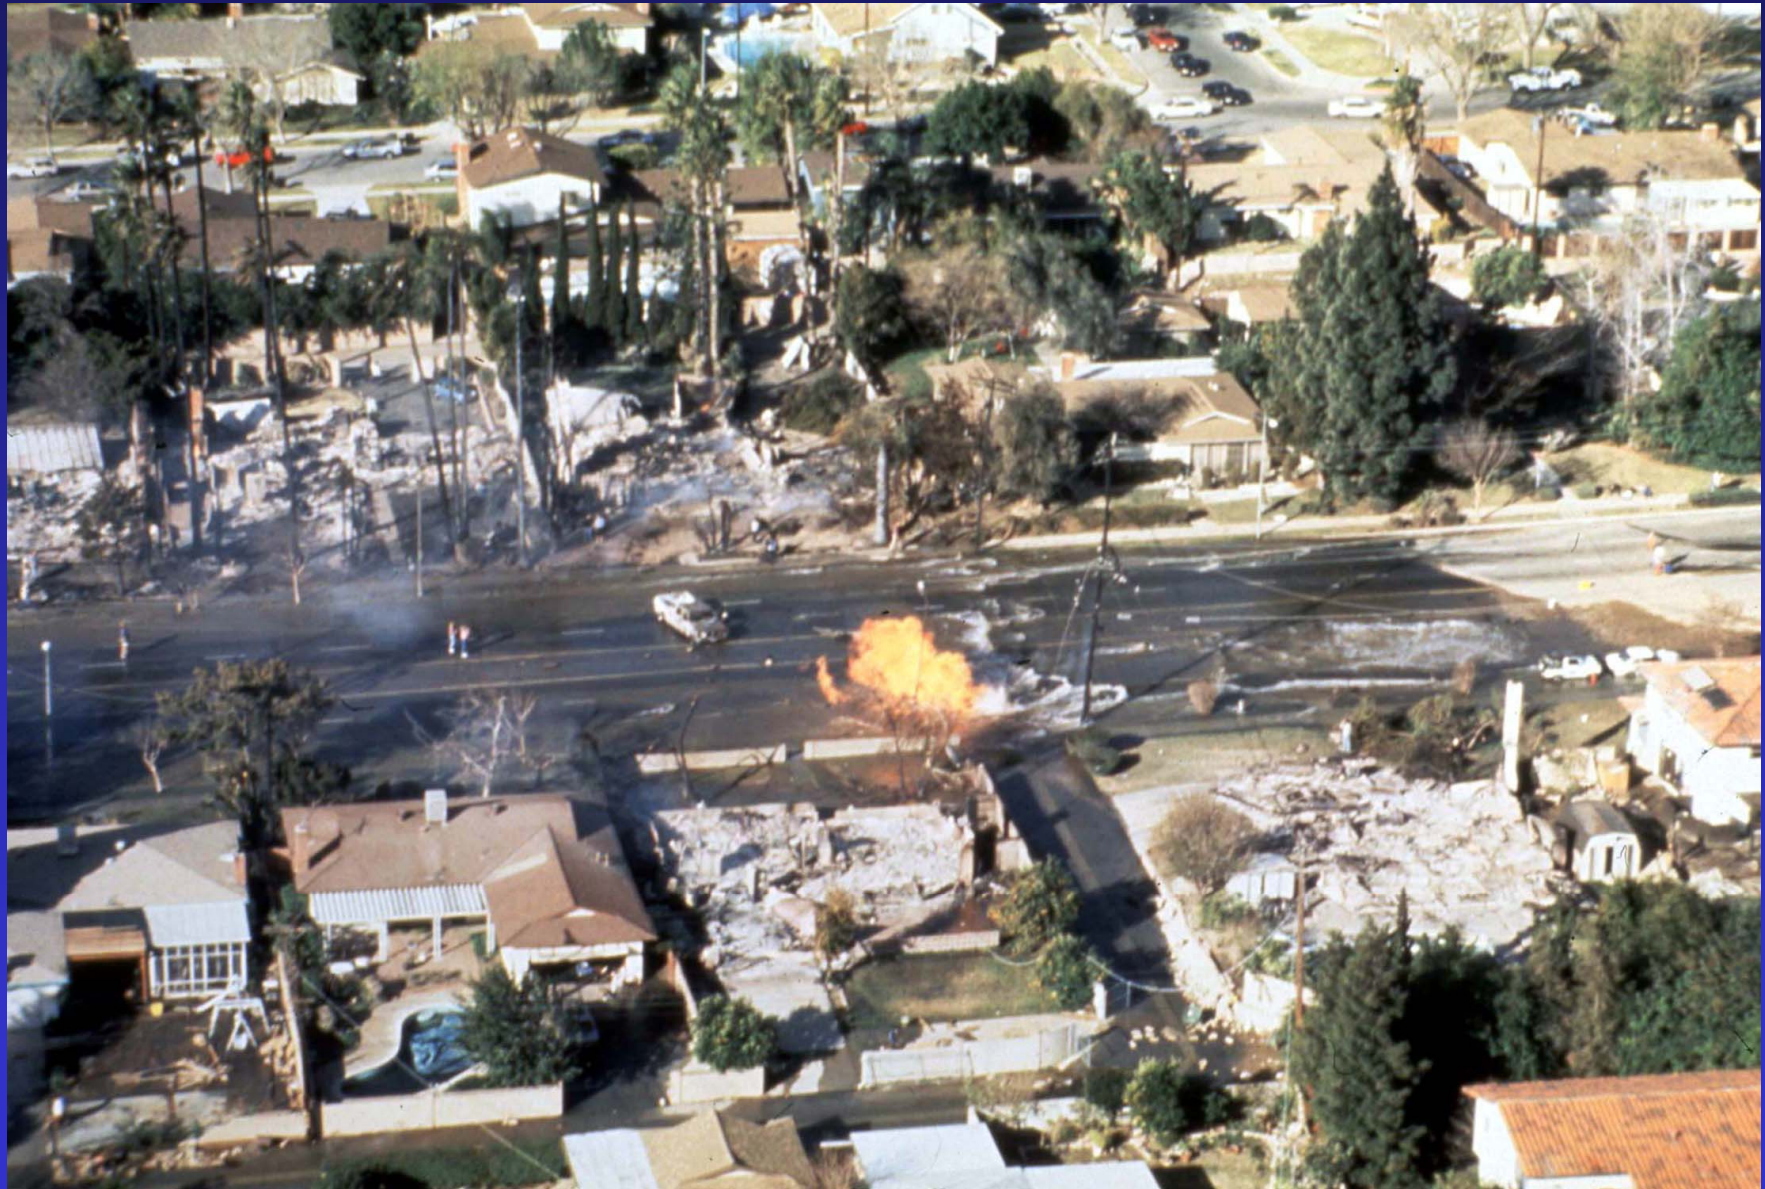
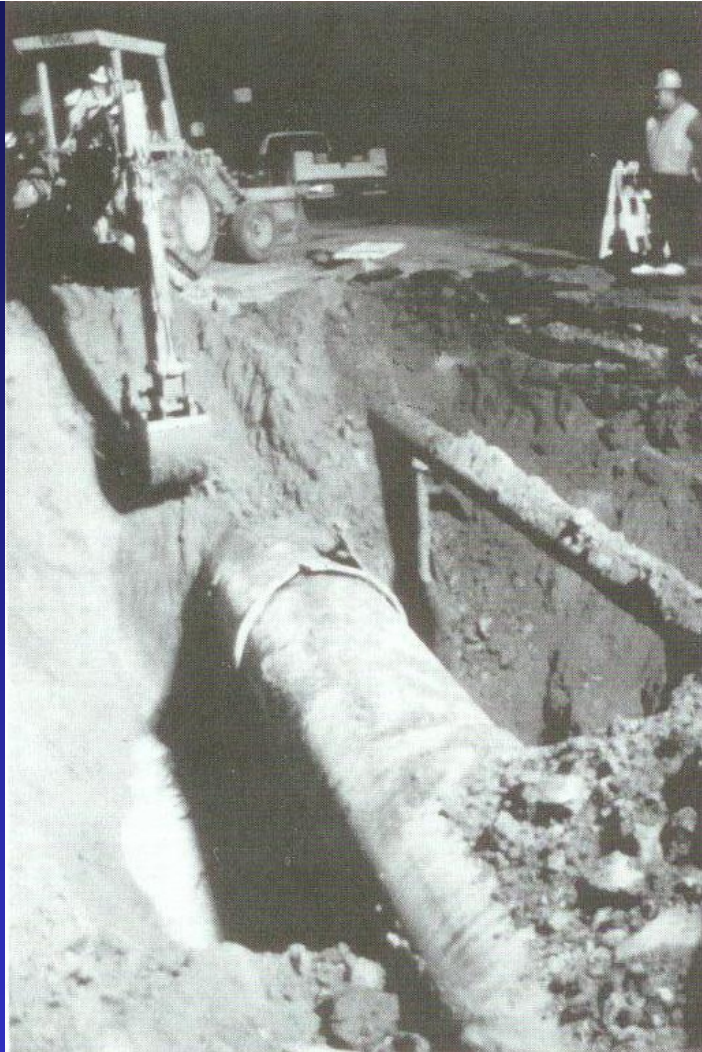
1994 Northridge Earthquake, USA, Balboa Blvd.

Backhoe uncovering compression damage to 48-inch welded-steel pipe in the zone of ground compression along Balboa Boulevard at Halsey during Northridge earthquake of January 17, 1994 Street (from Lund,1995)

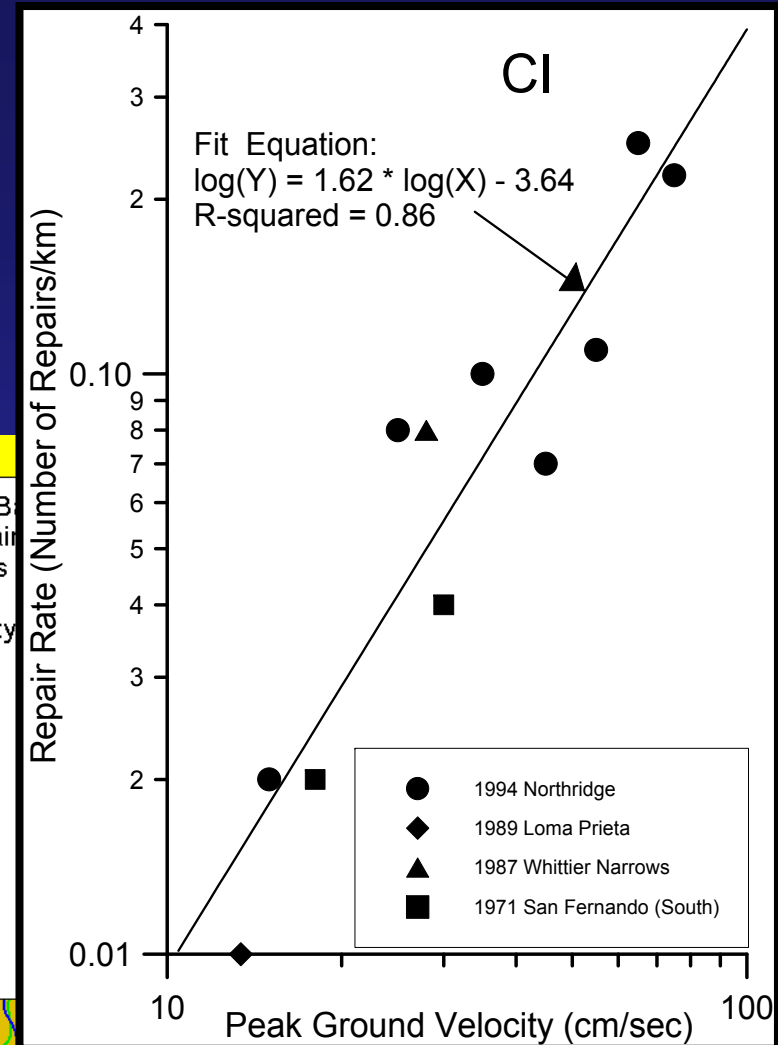
Pipeline Damage Correlation with Peak Ground Velocity (PGV)

Repair rate:
The number of
repairs/km

Seismic Parameters	Equation	r²
Peak Ground Velocity	Log (RR)= 1.62 Log (X) - 3.64	0.86
Peak Ground Acceleration	Log (RR)= 1.36 Log (X) - 0.61	0.81
Modified Mercalli Intensity	Log (RR)= 0.52 X - 5.26	0.74
Spectrum Intensity	Log (RR)= 0.78 Log (X) - 2.21	0.68
Arias Intensity	Log (RR)= 0.67 Log (X) - 1.43	0.55
Spectral Acc., T=0.3 sec.	Log (RR)= 0.9 Log (X) - 1.07	0.45
Spectral Acc., T=1 sec.	Log (RR)= 0.49 Log (X) - 0.91	0.43
Peak Ground Displacement	Log (RR)= 0.64 Log (X) - 1.8	0.39

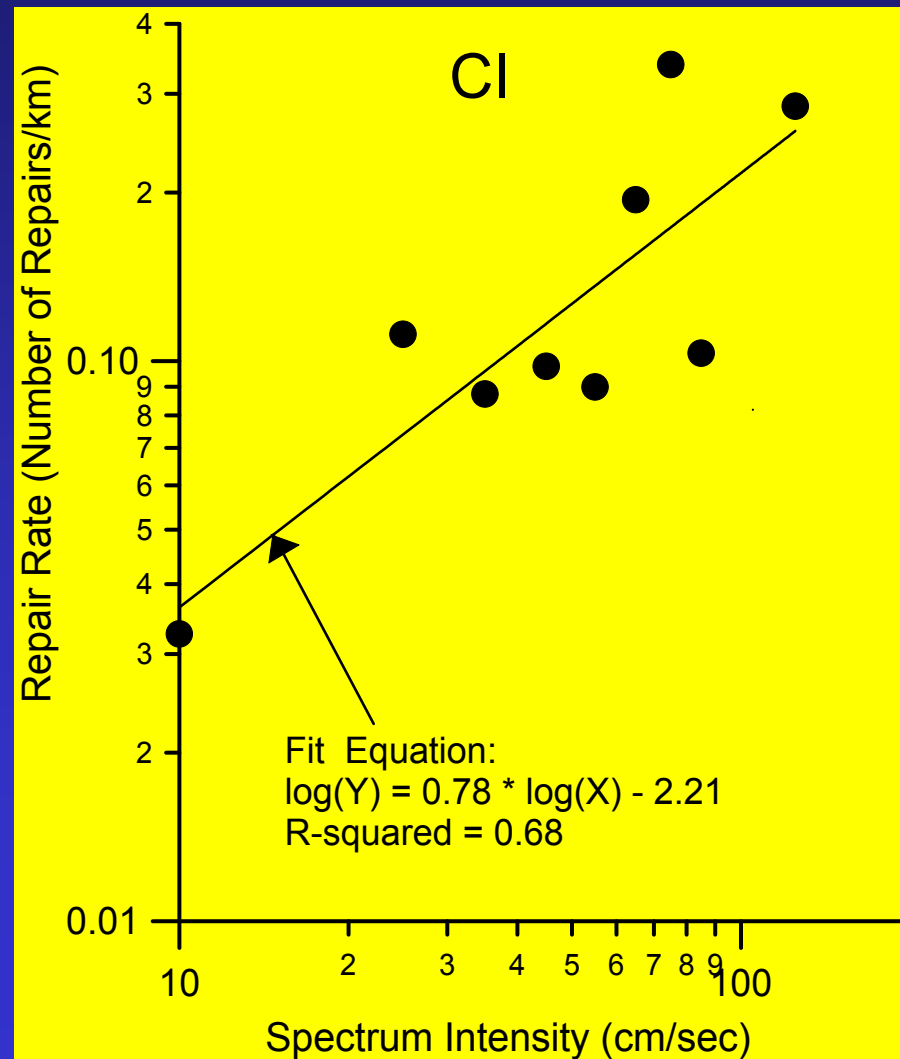
Repair Rate with respect to Spectrum Intensity

$$SI = \frac{1}{2.4} \int_{0.1}^{2.5} SV(T, \zeta) dT$$

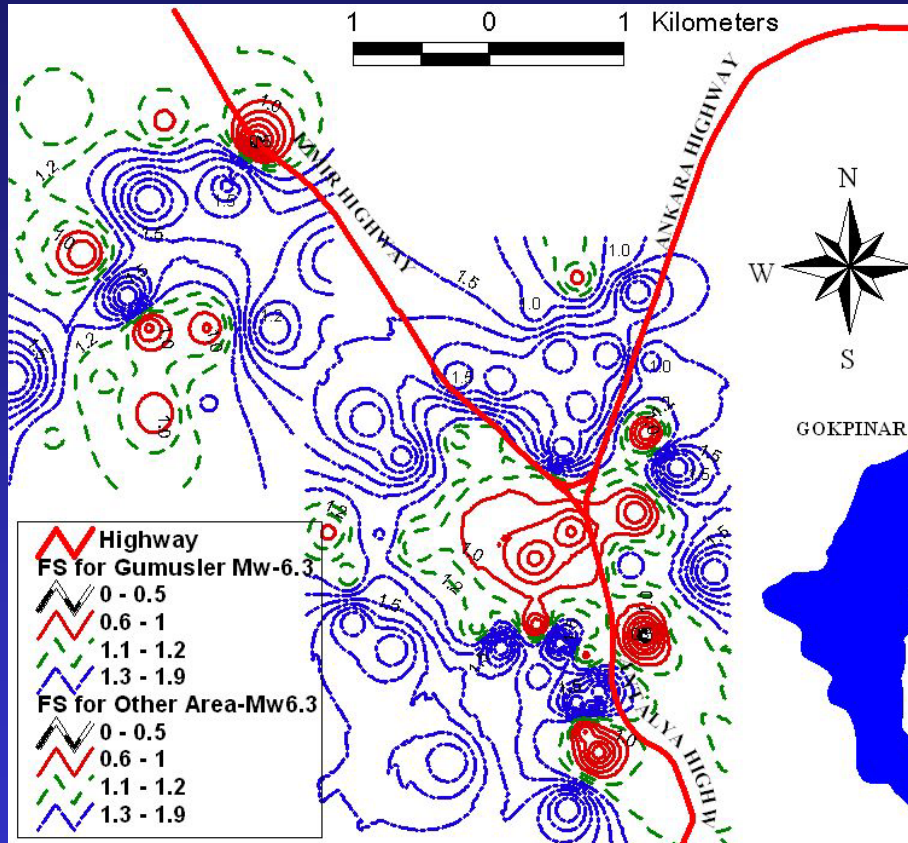
Contours of Factor Safety against Liquefaction for M6.3 Scenario Earthquake

a) Pamukkale Fault

Using Seed and Idriss (1971) procedure with modifications from Youd et al (2001)

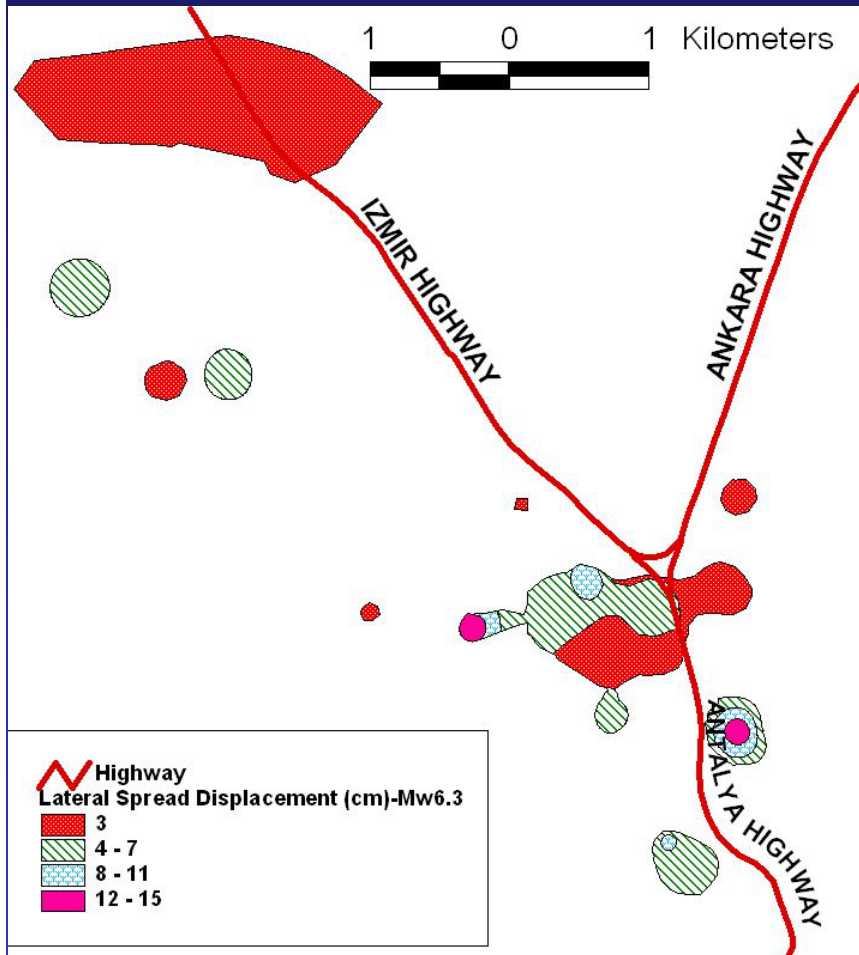
Predicted Lateral Displacements for M6.3 Scenario Earthquake

a) Pamukkale Fault
