Robustness considerations from failures in two large span roof structures, Part 2 Jørgen Munch-Andersen, Danish Timber Information Philipp Dietsch, TU München

Case: Siemens Arena, Ballerup, Denmark

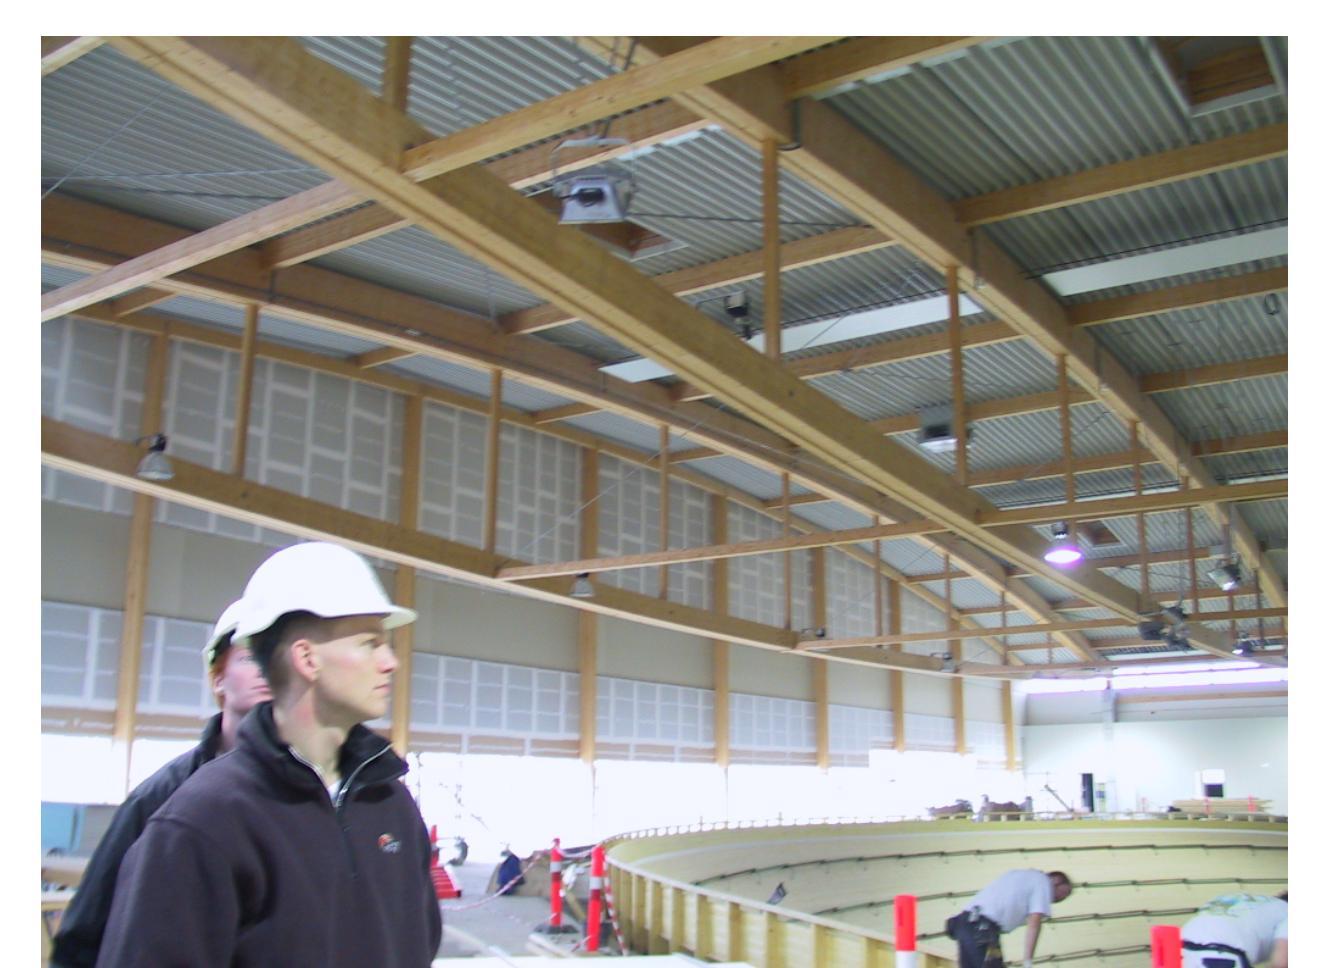
Structure

- 12 'cigar'-shaped glulam trusses with concealed steel plates
- 73 m span with 12 m between trusses
- Simply supported purlins between trusses

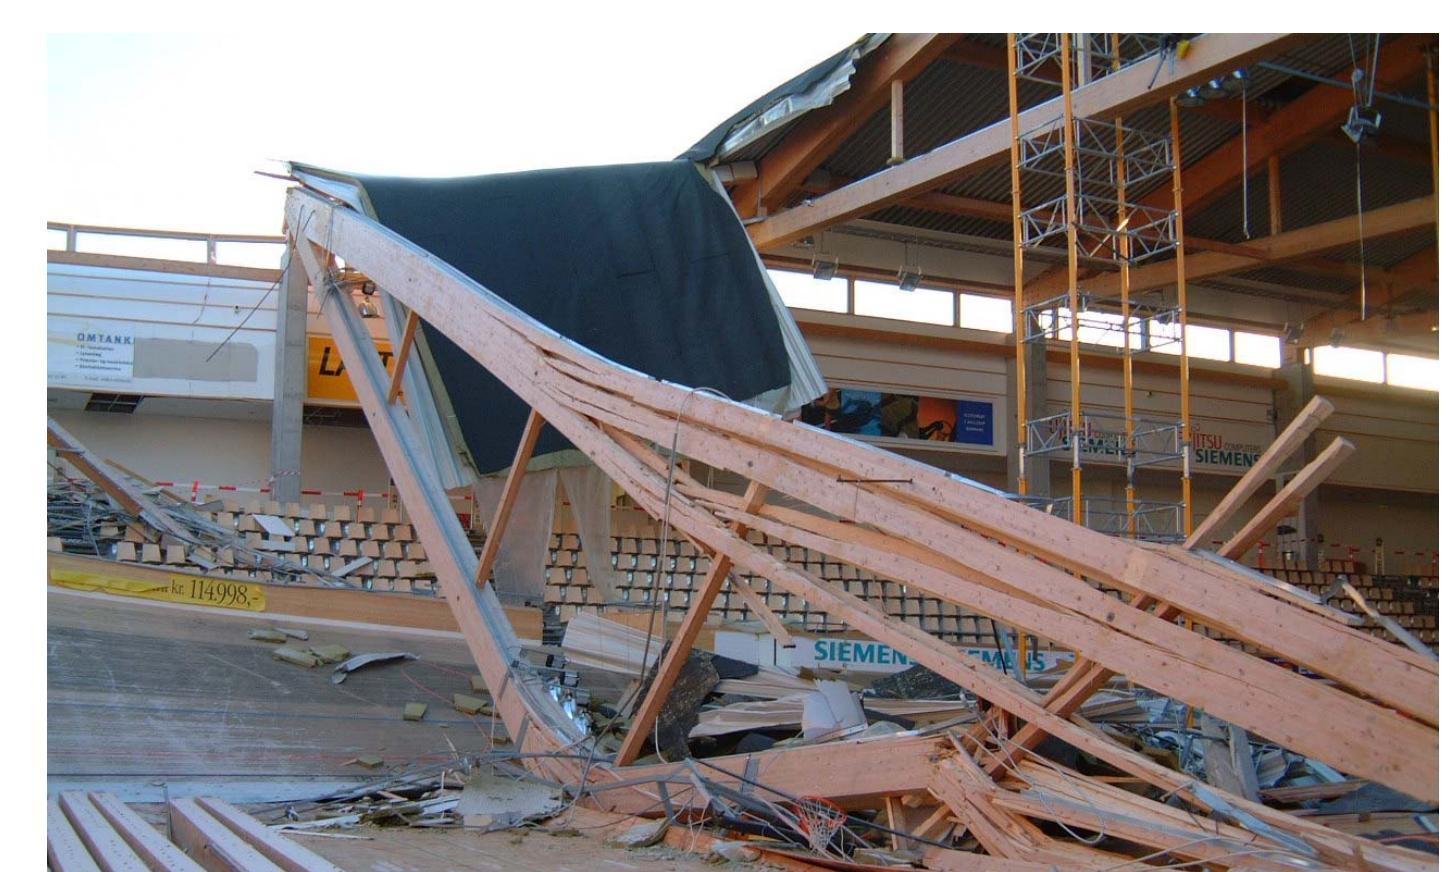
Failure

- Two trusses collapsed without warning a few months after the inauguration of the arena
- Almost no wind and a few millimetres of snow
- No people was present in the arena during the collapse

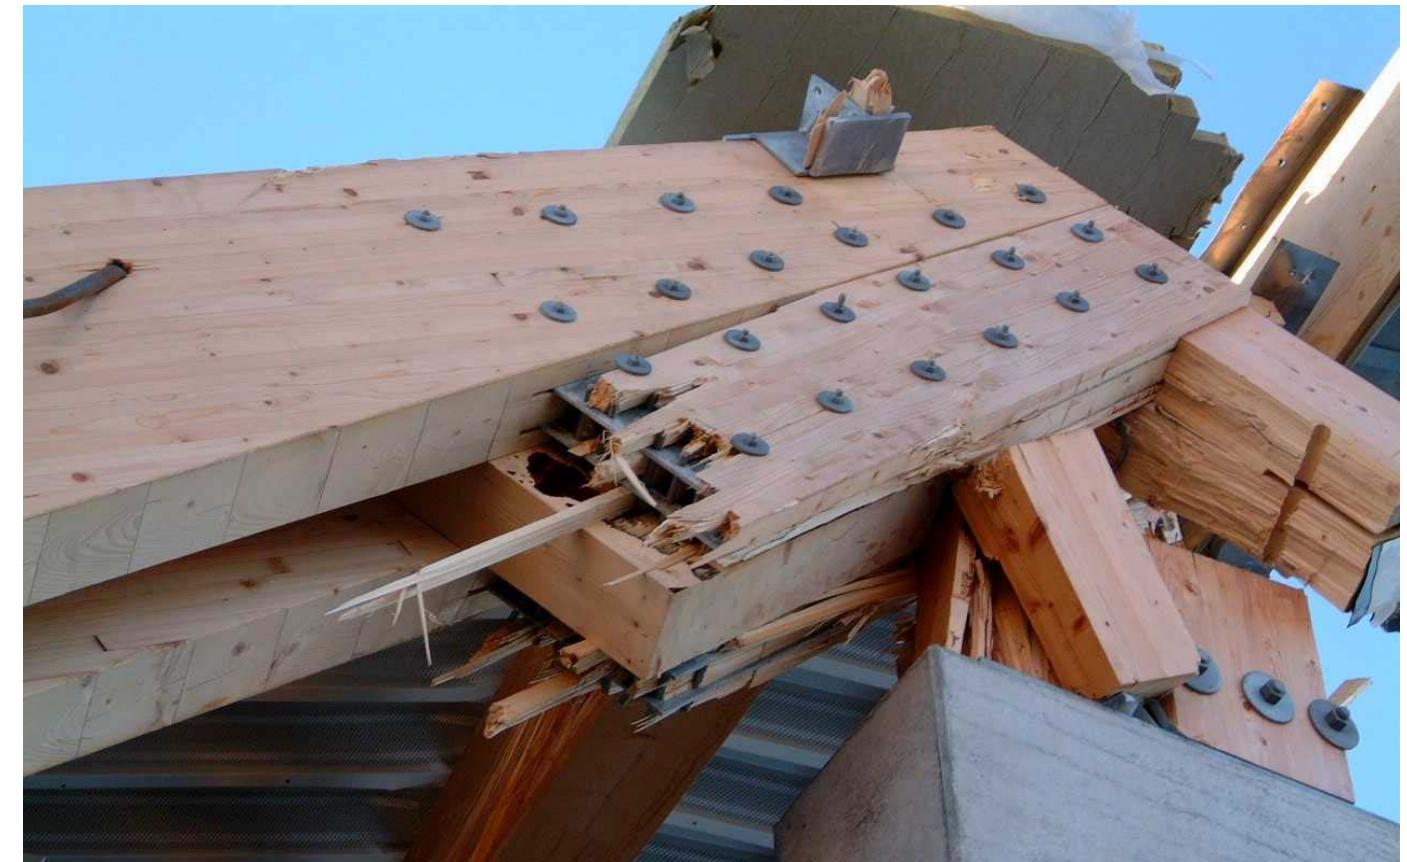
Causes

- Failure in tension arch near to support
- This cross-section was not considered in the design
- Strength between 25 and 30% of the required strength
- Close to stresses from permanent load

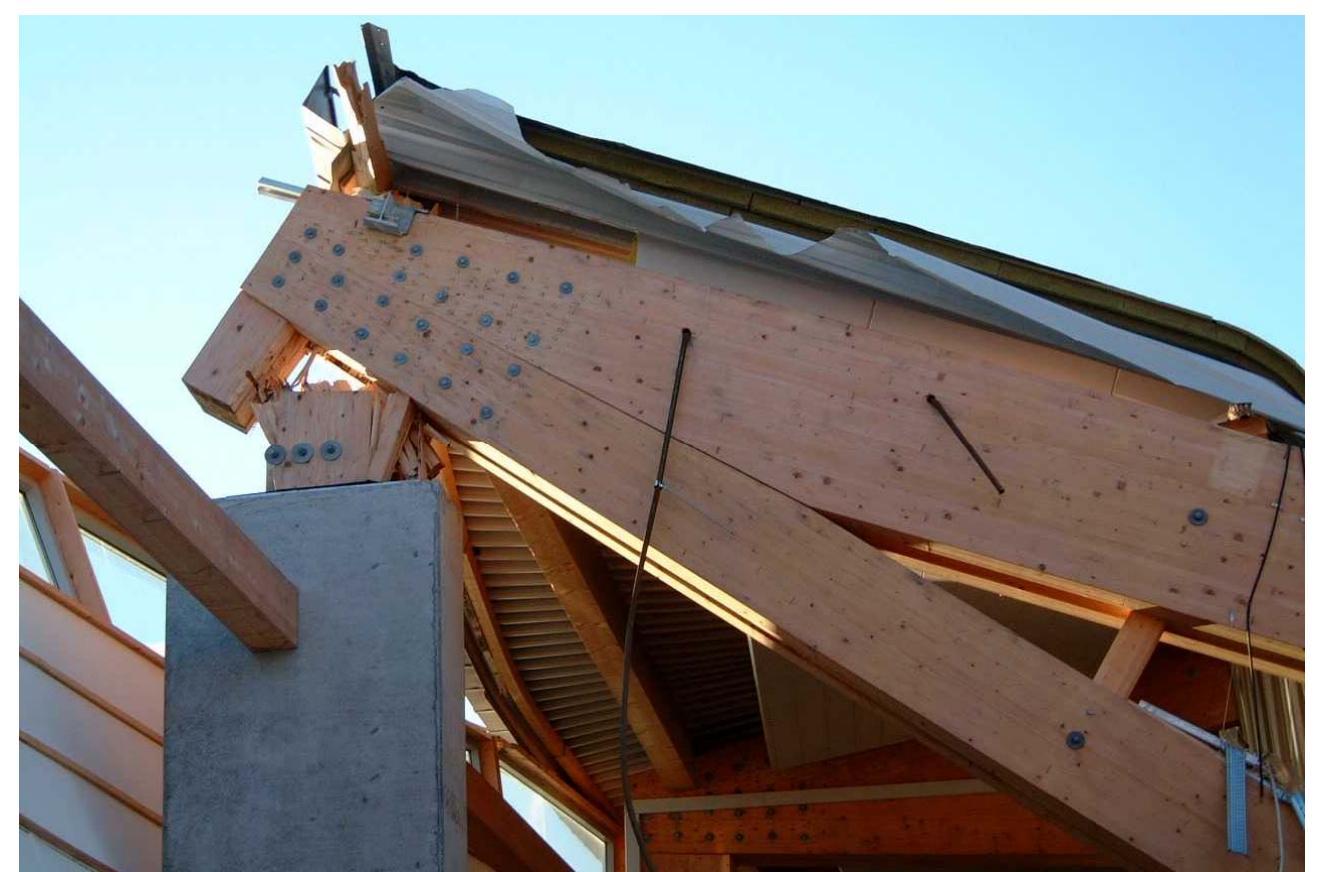
3 critical design errors

- A 48% too high design strength was used
- The reduced height of the cross section was not considered
- The reduction of the cross section due to holes in the timber for steel plates, bolts and dowels were not considered
